BEARA BREIFNE WAY TRAIL PLAN

Technical Trail Audit and Design

Section B - Trail Audit Findings

Prepared by Outdoor Recreation NI
on behalf of Fáilte Ireland

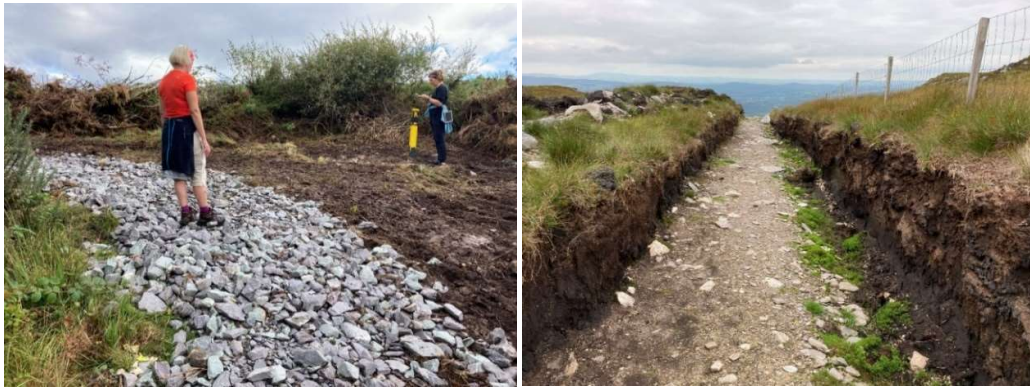
Another difficulty that needs to be flagged is construction on steep slopes using aggregate – there are a number of places where this ‘track-building’ technique has been used and results in loose aggregate (Figure 1).

Figure 1 Path built from loose aggregate and cut through deep peat

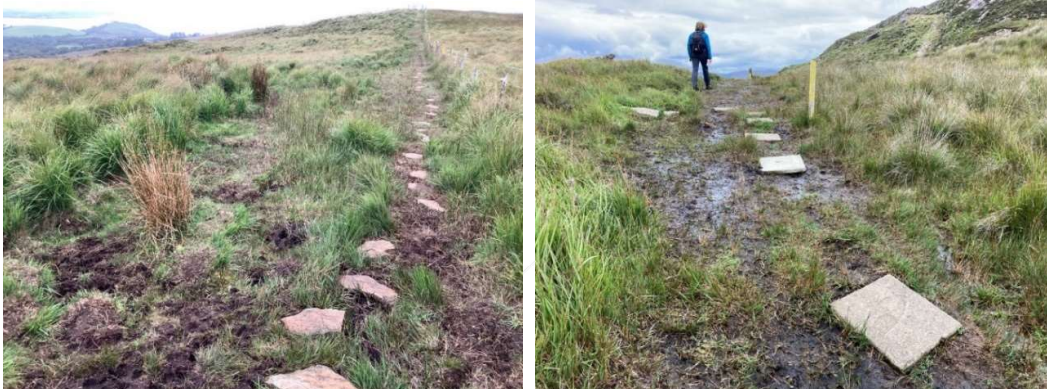
Construction across wet areas or deep peat has not been fully considered, which has left gaps in the built trail, and the use of individual stepping stones, rather than designed built trail, has not resulted in a functional path.

Figure 2 Use of stepping stones to traverse wet areas

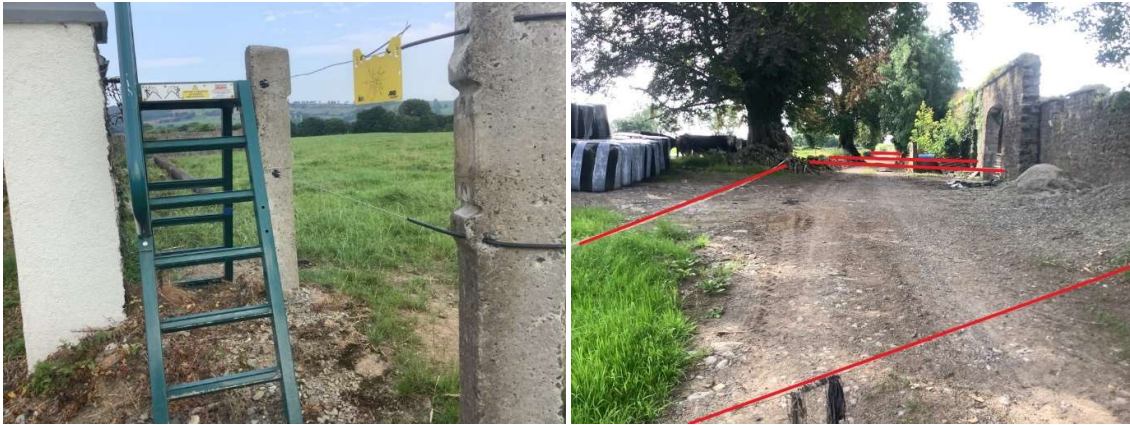
The trail audit found that the use of electric fencing is extensive along the length of the trail. There were multiple occasions where the electric wire was too close to where the walker was expected to walk, or where warning signage and/ or protective tubing was missing. Electric fencing or barbed wire should

Figure 7 Exposed electric fencing adjacent to stile, location where walker navigates 5 electric fences

Where an electric fence is on or adjacent to the route in a location where it might be touched by a walker, a warning sign should be used. For longer sections repeat usage of the sign as appropriate. If it is necessary to cross or open such a fence at any point, a means of passing safely should be provided e.g. protective tubing attached to the fence to prevent users coming in contact with it or a system which allows walkers to open the fence to pass through and then put it back in place.

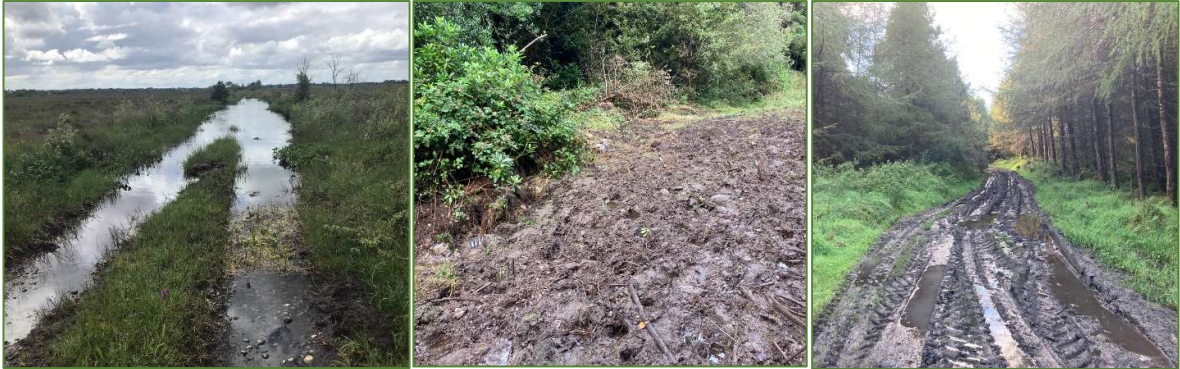
Figure 9 shows several sections of trail that are impassable due to poor drainage, poaching by livestock and damaged by vehicles.

Figure 9 Poor condition trail - standing water, badly poached, damaged by vehicles

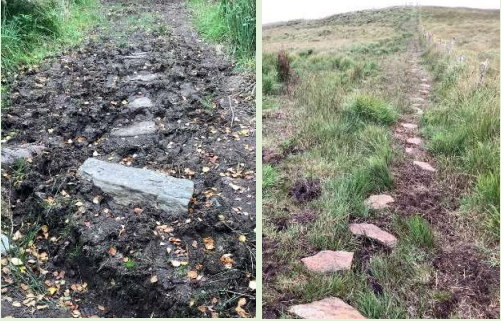
<p>Stepping stones</p>	<p>Stepping-stones have been used to bypass areas that have significant drainage issues. This technique does not address the core drainage issue and is also not appropriate visually or environmentally.</p> <p>Stepping-stones also prove to be a health and safety issue as they are not anchored in the ground to provide a stable walking surface.</p>

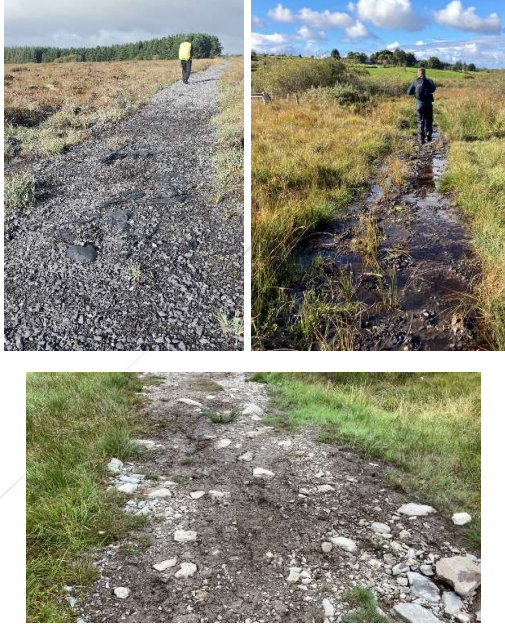
<p>Geotextile</p>	<p>Geotextile can be used to create sustainable trails, in situations where there is significant clay content in the soil (i.e. the soil is soft and 'sticky' when wet) and where the soil is very weak (i.e. it contains a lot of organic material such as peat).</p> <p>If the soil formation is hard or well drained and the sub-soil is granular with little or no clay content, a geotextile will not be required.</p> <p>The use of geotextile is only successful when combined with appropriate use of mixed gravel and dust subbase and finishing layer, along with compaction and settling techniques. Terram appearing through the gravel indicates that appropriate trail finishing techniques have not been completed.</p>

<p>Geotextile appearing through gravel, a gravel trail sinking where geotextile hasn't been used, gravel trail spongy and cracking where geotextile hasn't been used.</p>

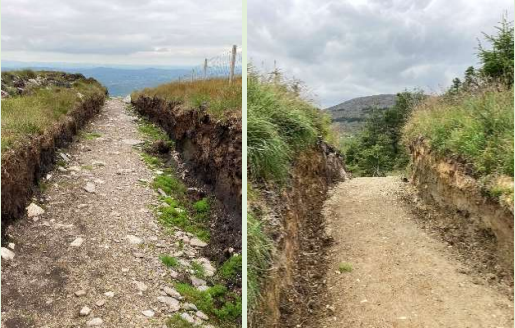
<p>Excessive removal of substrata</p>	<p>Sustainable trail build requires ground vegetation and topsoil to be removed to expose firm sub-soil and to form a formation tray for the trail to sit on.</p> <p>The depth of formation tray will depend on the strength of the sub-soil.</p> <p>Deep/ active peat should not be excavated to accommodate path construction due to its important properties in carbon sequestration.</p> <p>A sustainable trail will not cut through the landscape, but rather flow through the landscape.</p>

<p>Removal of peat and excessive removal of substrata to accommodate existing trail build on the BBW.</p>

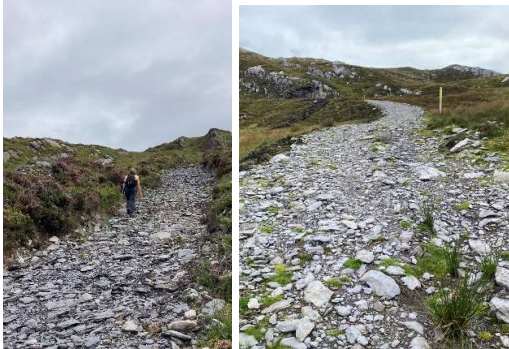
<p>Inappropriate trail width</p>	<p>Wider trails are required where vehicular access is necessary either for agricultural purposes or for emergency access. Where the purpose is walking only, unnecessarily wide trails detract visually from the landscape. See Section Error! Reference source not found. for recommendations on trail width.</p>

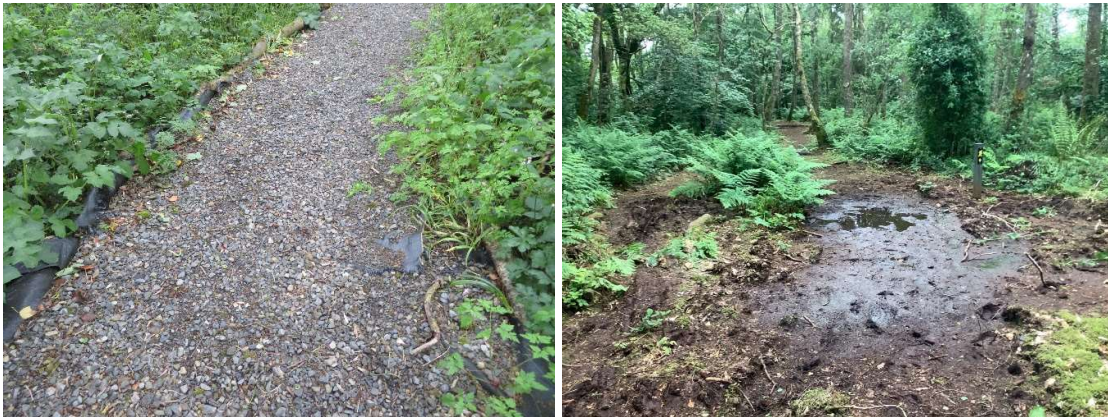
Figure 30 Trail in poor condition on the Suck Valley Way

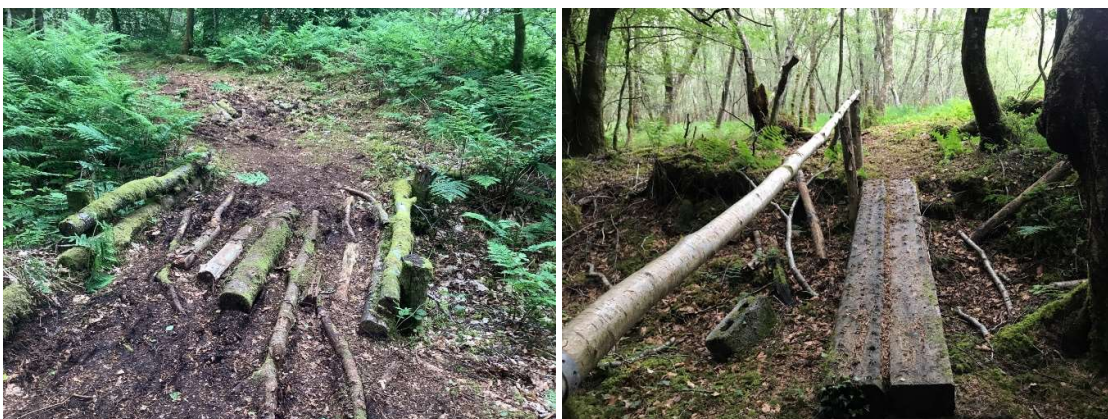
Figure 31 Infrastructure not fit for purpose on the Suck Valley Way

Wooden infrastructure should be replaced with durable metal or recycled plastic infrastructure such as bridges and A-frame stiles. For detail on the infrastructure recommendations see Section C.

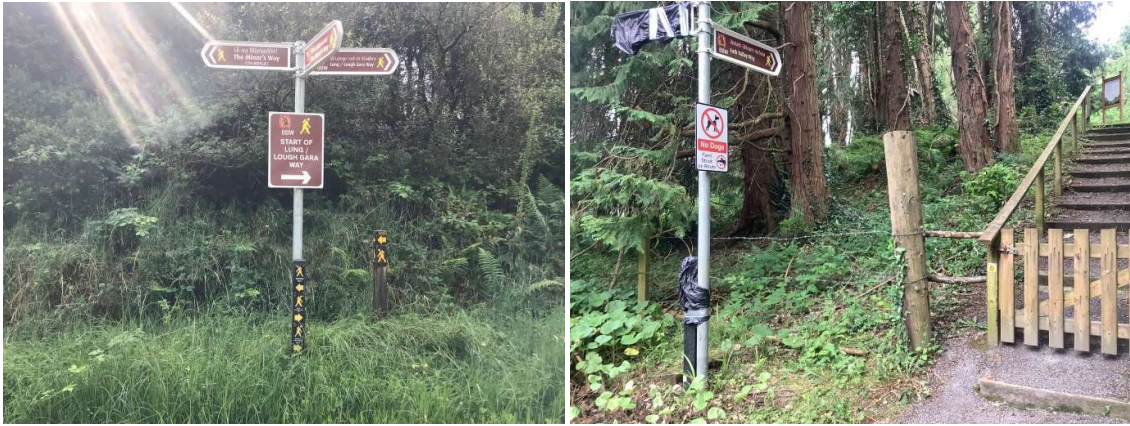
Waymarking for the BBW on the Lung Lough Gara Way section of the BBW is poor. The route is well waymarked using existing National Waymarked Trail signage, in this case, the Lung Lough Gara Way. But BBW signage is sporadic and the types of BBW signage varies between plate and finger post. At the time of audit, several Lung Lough Gara Way waymarker post arrows were taped over at several locations resulting in route confusion. The start of the route at Clonalis House also had taped over signage, again contributing to trail confusion (Figure 35).

Figure 35 Excessive and taped up signage on the Lung Lough Gara Way
