Environmental Surveying and Monitoring Programme

Bray Head 2023

National Tourism and Environmental Monitoring Programme

Annual Report for Bray Head 2023

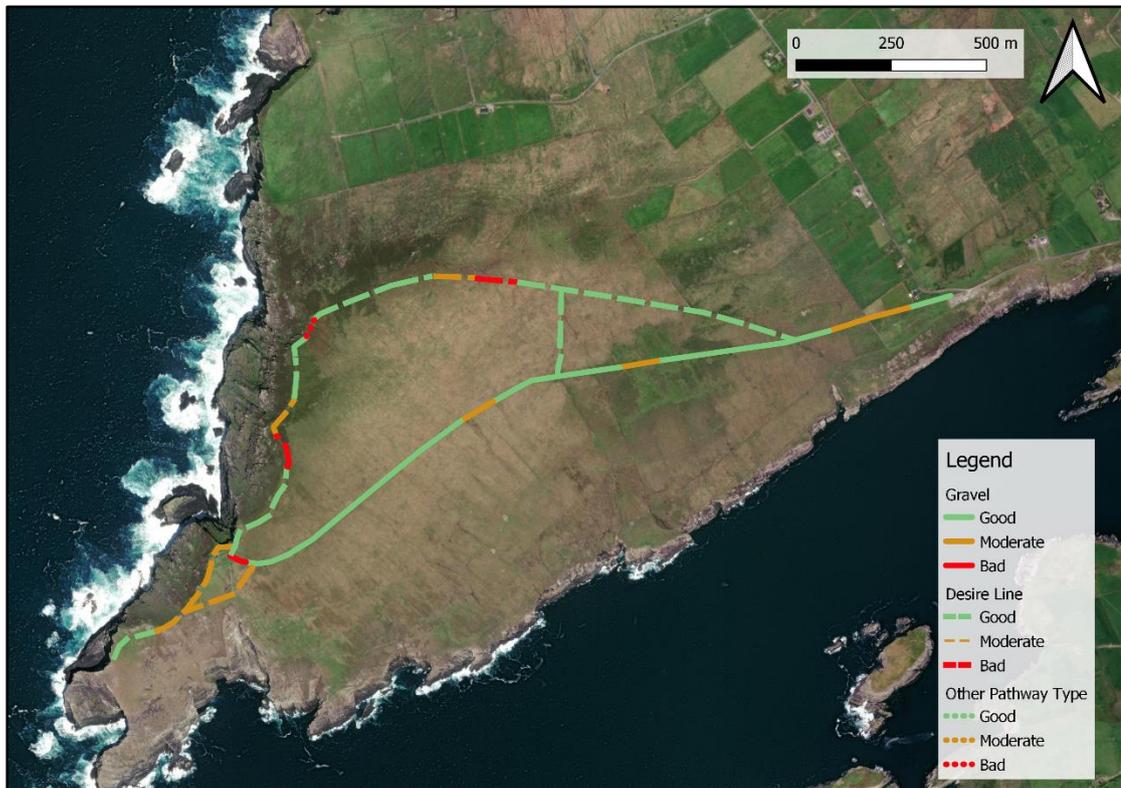
The condition (good, moderate, bad) of the main pathway types (gravel, desire line, other) are illustrated below in Figure 3.10. Examples of each of these pathway types are presented below in Plate 3.1. There was only one recorded 'other pathway' type during the survey, which is shown in Plate 3.1c.

Overall, the pathways were in good condition. Any formalisation of the desire lines would lead to greater habitat degradation and habitat loss than is currently occurring.

Figure 3.10 Colour-coded condition of the main pathway types recorded on the site.

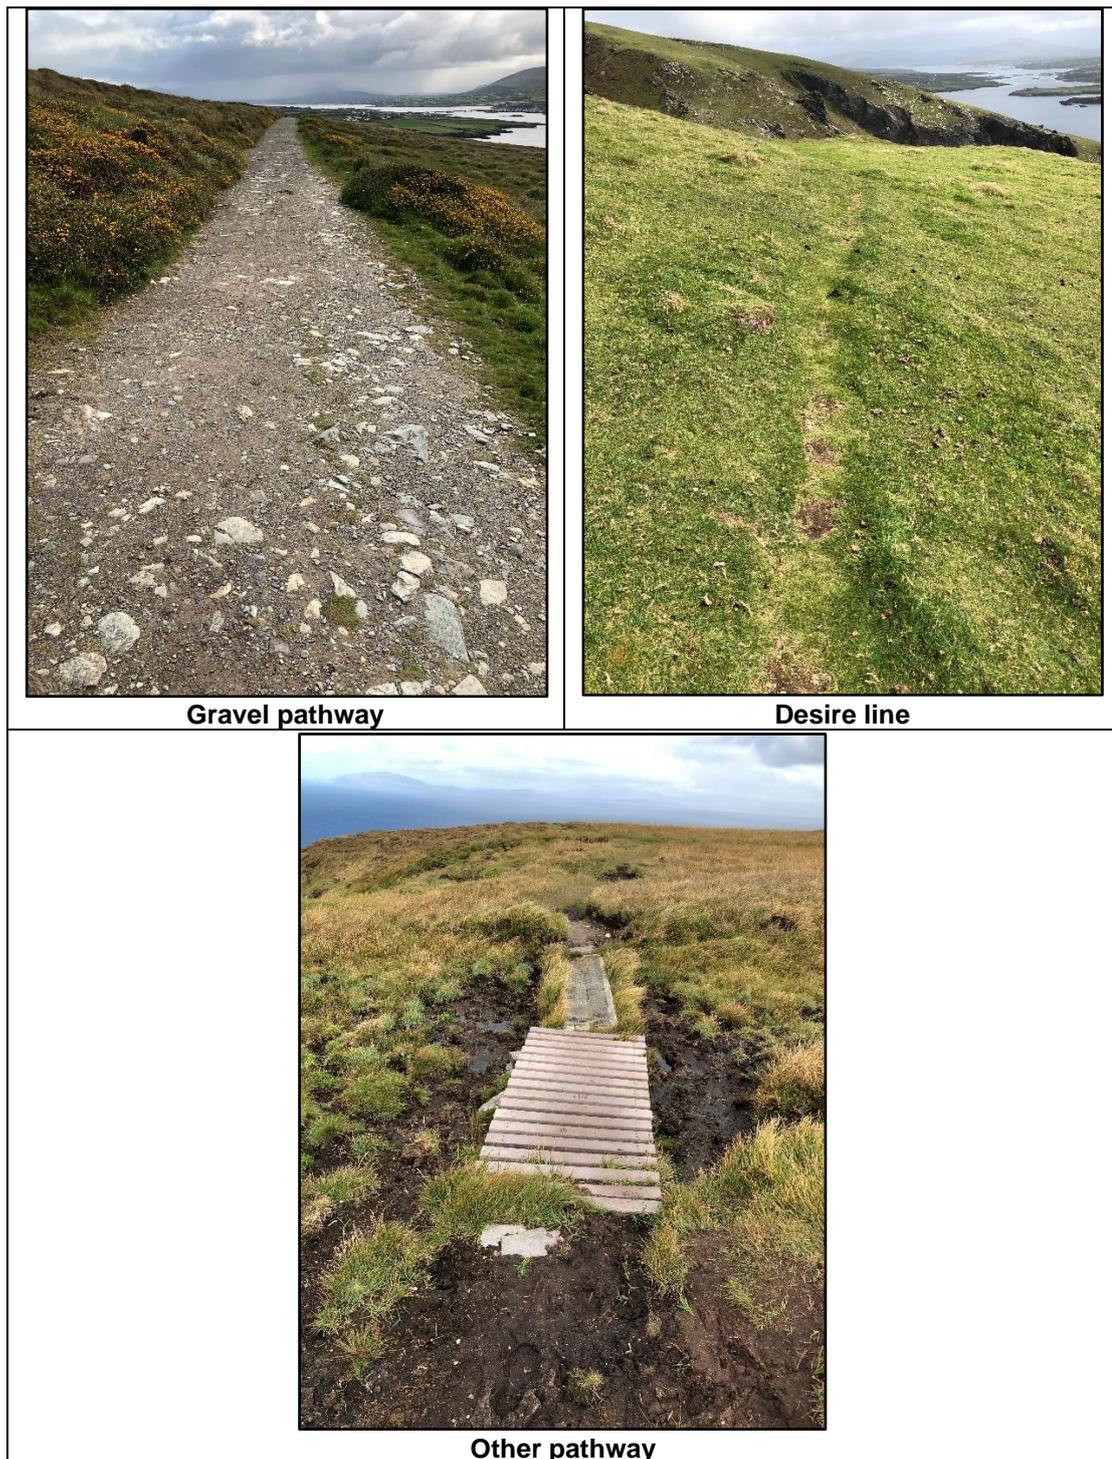
Plate 3.1 The main pathway types recorded on Bray Head.

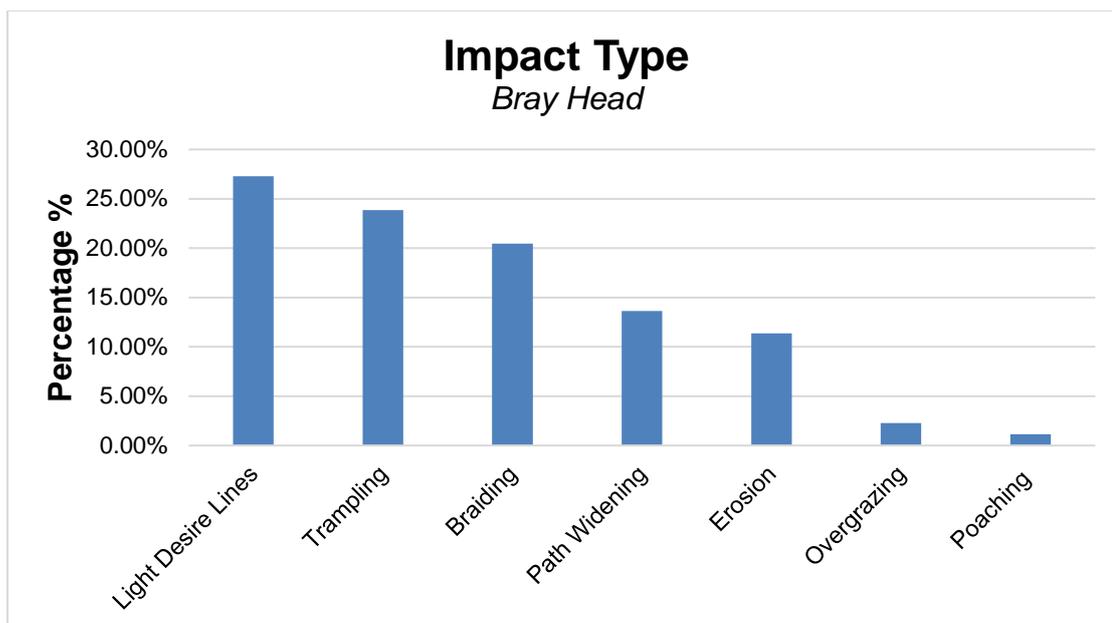
Figure 3.11 represents the pathway impact type at the site. The types of impact observed was light desire lines at over 27%, trampling at almost 24%, braiding at over 20%, path widening at almost 14% and erosion at over 11%. Overgrazing by livestock only made up over 2% of the impact types observed and livestock poaching (damage to soil by many livestock standing in one location for prolonged periods of time) only made up over 1%.

Figure 3.11 Impact Type Observed at Bray Head

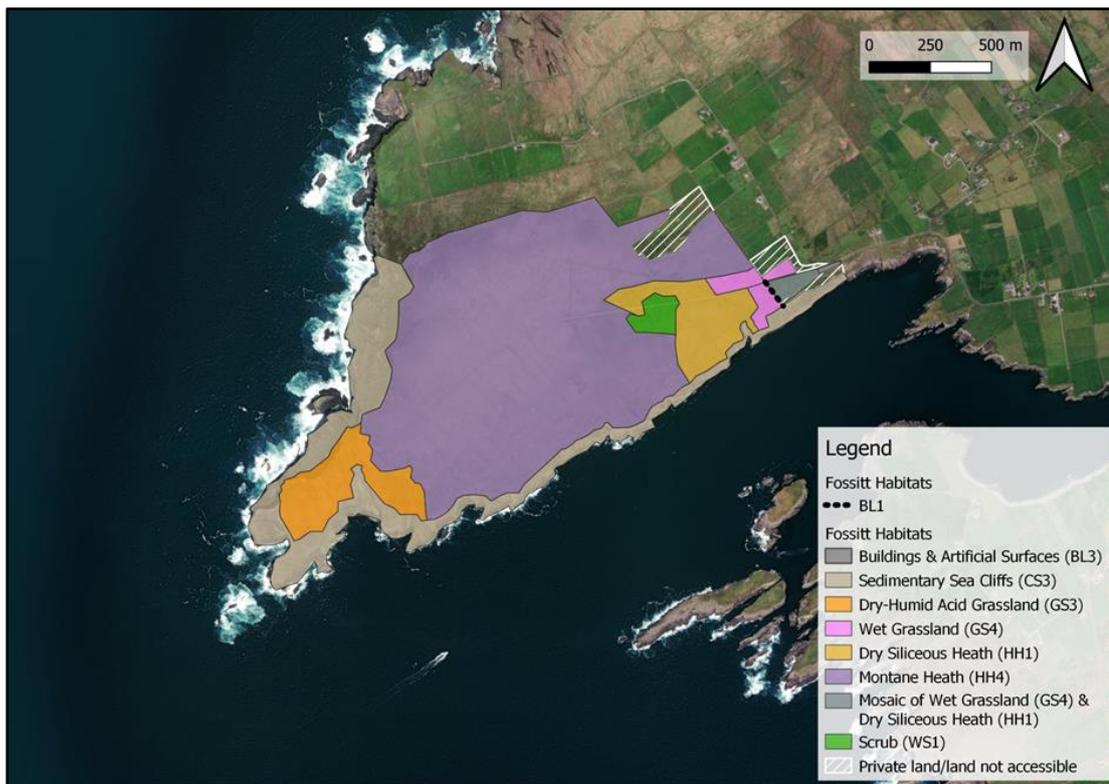
There are a range of habitats present on site (see Figure 3.12). Habitat damage of varying degrees was reported on approximately 78% of the transect walked by surveyors. Damage percentage ranged from approximately 0% to 90% of the area damaged. Out of the 50 no. 100 m sample stations located along the habitat condition assessment, 38% of samples contained no evidence of any habitat degradation, 40% contained localised habitat degradation which was slight and capable of rapid recovery, and 22% contained widespread habitat degradation but was slight and capable of rapid recovery. No samples contained any levels of habitat degradation that would require intervention to allow full recovery. The causes of the damage were identified to be livestock poaching, overgrazing, path widening and desire lines from people leaving the existing trail.

Figure 3.12 Habitat Map of Bray Head.

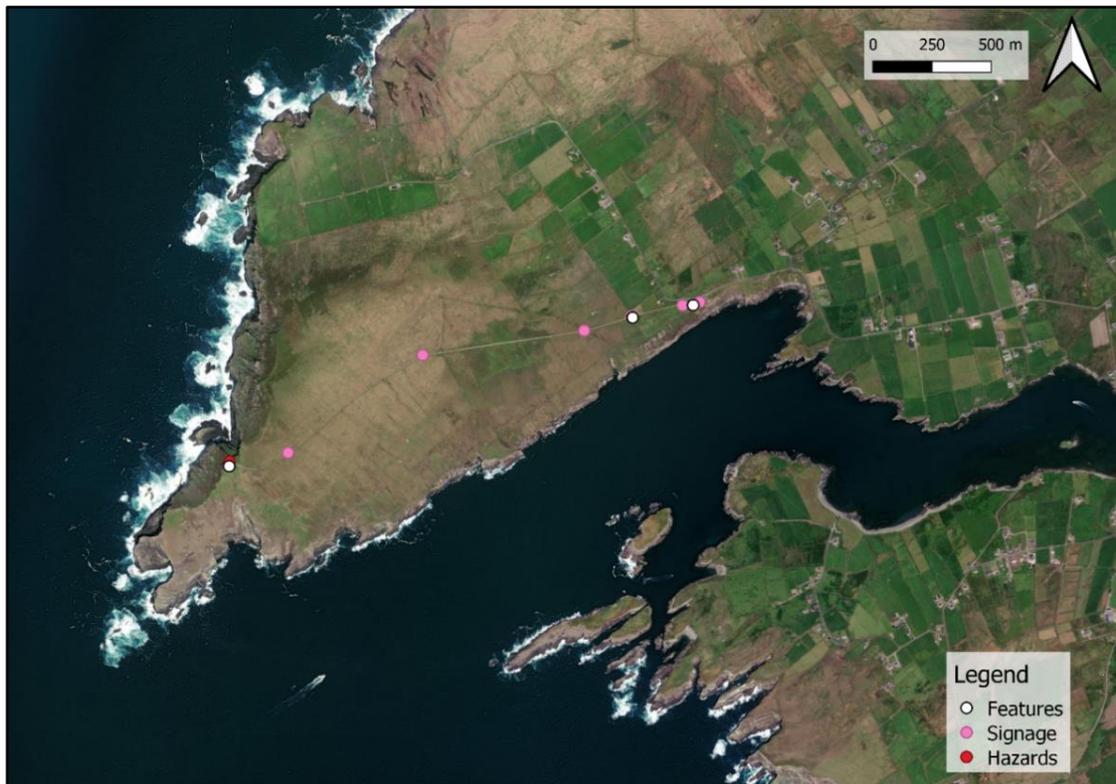
There are various trail markings across the site. However, there is minimal signage relating to the ecological value of biodiversity at the site and this is considered to be a missed opportunity for environmental awareness. Informative signage on the heritage of Bray Head as a Wild Atlantic Way site would further highlight its historic importance. Examples of features and signage on the site are shown in Plate 3.2. A map illustrating the locations of these signs, features and hazards are presented in Figure 3.13.

Figure 3.13 Features, signage and hazards mapped at Bray Head.

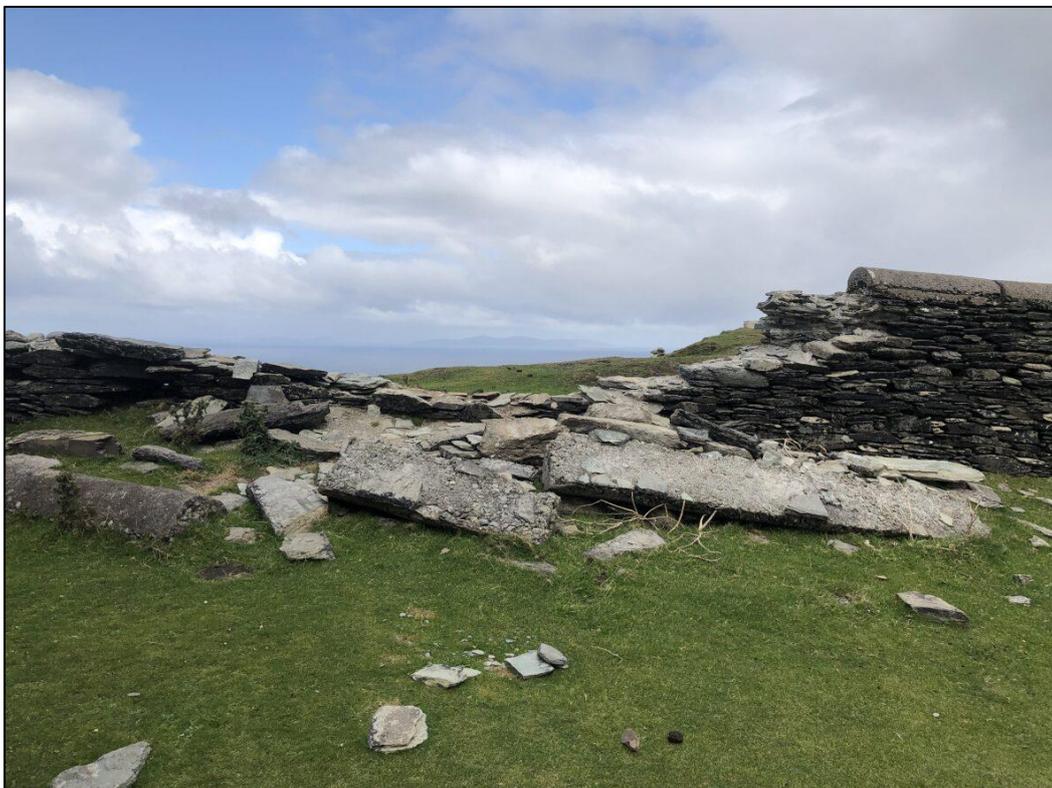
Although the hazard assessment identified no obvious safety issues or hazards for the site, upon site visitation, there is a collapsed wall which is adjacent to the tower viewpoint as show in Plate 3.4. Surrounding walls are in need of urgent upgrade to improve the safety and visual aspect of the site. The locations of the hazards which were recorded are included in Figure 3.13 above.

Plate 3.3 Collapsed wall adjacent to Bray Head Watchtower at viewpoint.

- Repair of the collapsing stone wall located adjacent to the Bray Head Tower. This currently poses a tripping hazard and/or falling/dislodged debris could cause injury.

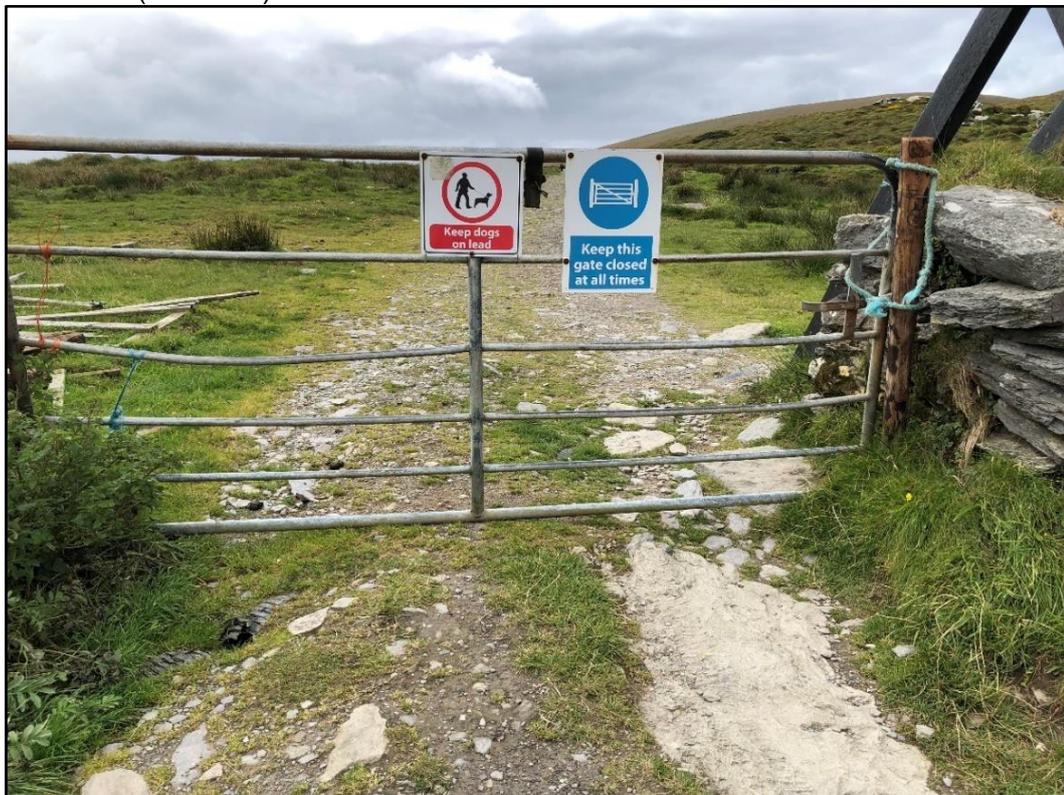
Plate 4.1 Field gate access to main path

- Access to the main path is currently via a style next to a field gate. It is recommended that access is improved to allow accessibility for visitors to Bray Head (Plate 4.1).
