# National Tourism and Environmental Monitoring Programme Dursey Island 2023

# National Tourism and Environmental Monitoring Programme

## Annual Report for Dursey Island 2023

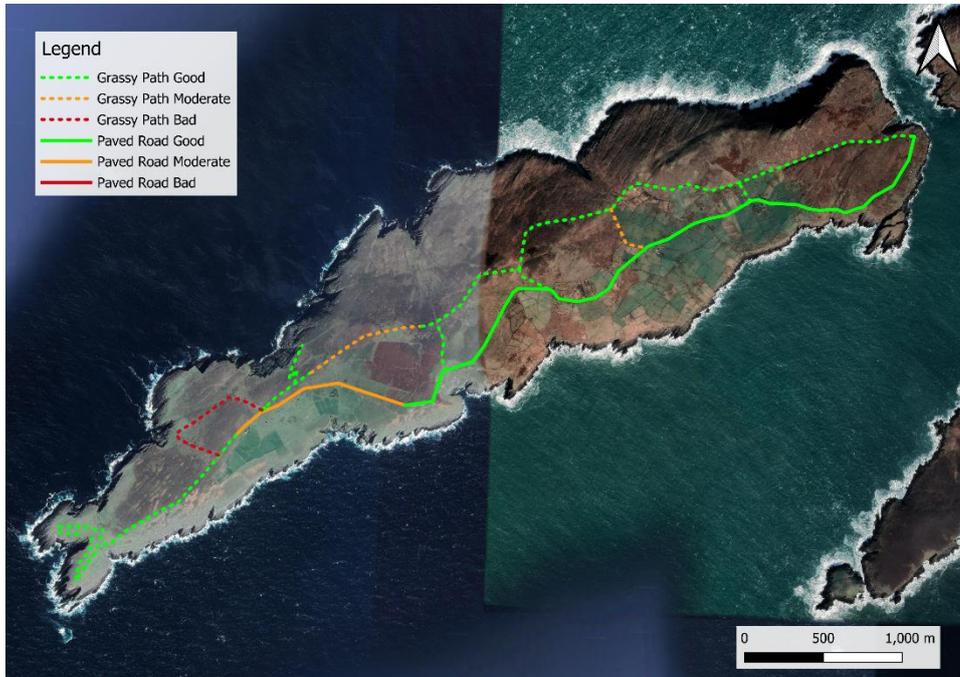
Overall, the majority of the pathways were in good condition, however, a number of the pathways were in moderate to bad condition. An qualitative assessment of the paths on the island has concluded that given the low levels of use (See Plate 3.5), any formalisation of the paths would lead to greater habitat degradation and habitat loss than is currently occurring, and therefore the formalisation of paths has not been recommended. It should be noted that no major desire lines were mapped, but many small desire lines were noted as impacts, and as such, are discussed in the sub-sections below.

**Figure 3.9** Colour-coded condition of the main pathway types recorded on the site. Basemap provided by Google

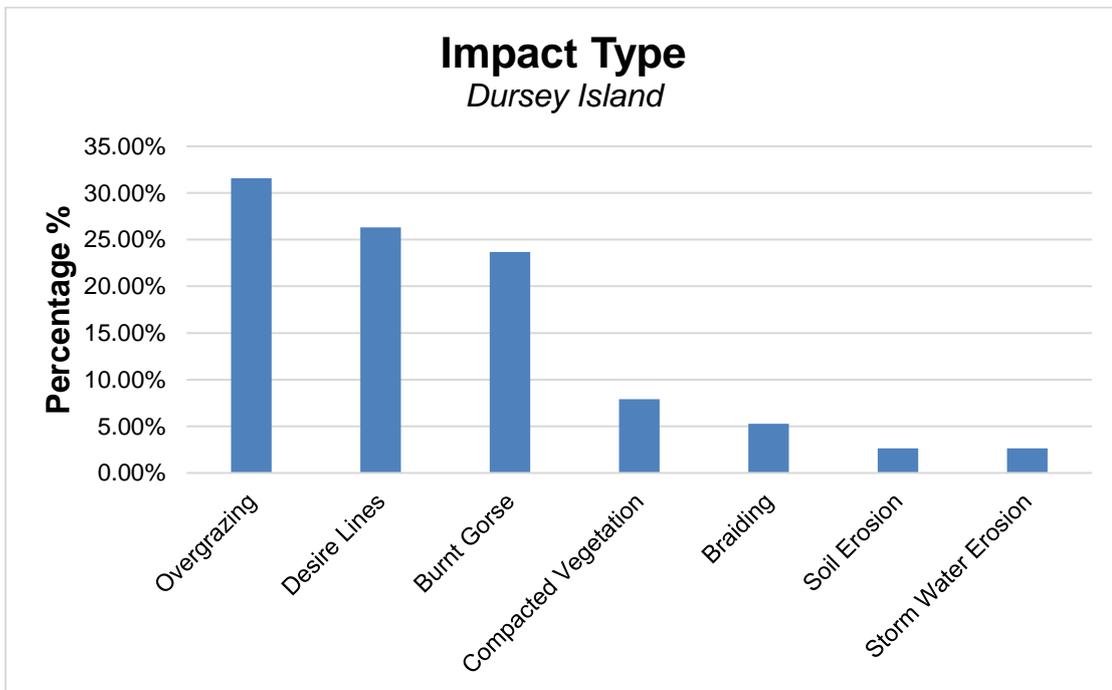
Figure 3.10 represents the pathway impact type at the site. The types of impact observed was overgrazing at 31%, desire lines at 26%, burnt gorse at 24%, compacting vegetation at 8%, and braiding at 5% of the impact types observed. Soil erosion and storm water erosion both made up made up 3% of the impact types observed. Further details of the impacts are provided in Section 3.2.2.

**Figure 3.10** Impacts on Pathway Condition

- Appropriate land management is recommended to promote sustainable farming practices and reduce overgrazing. This would lead to improved habitat quality and resilience.

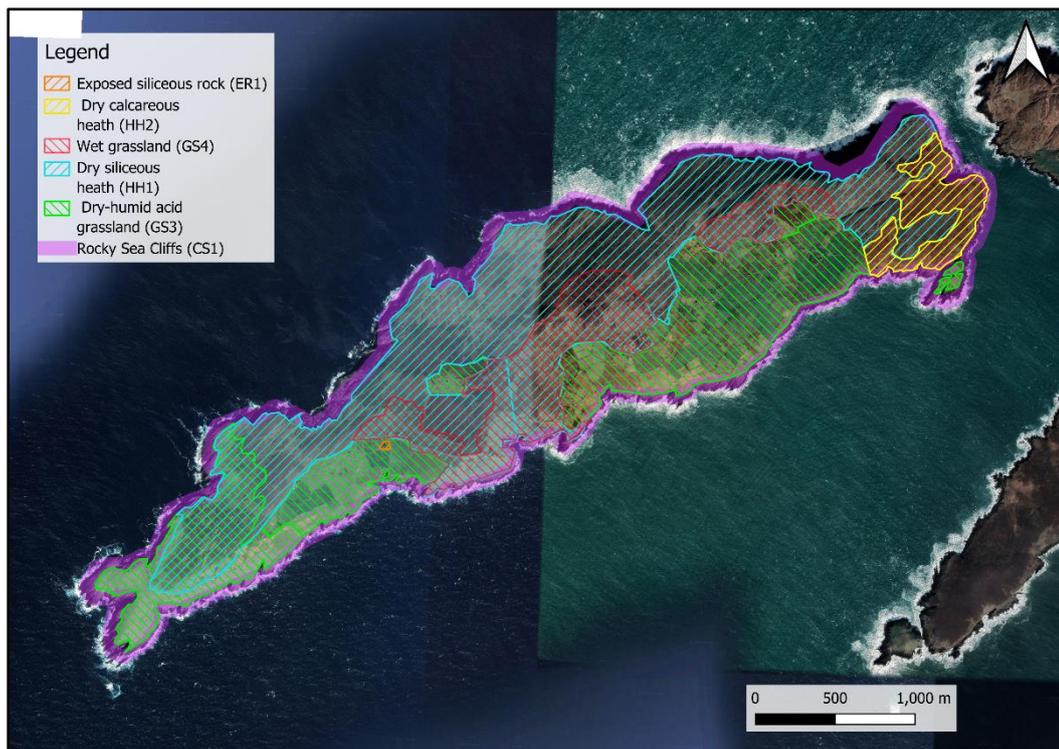
There are a range of habitats present on site (see Figure 3.11). Habitat damage of varying degrees was reported on approximately 45% of the transect walked by surveyors. Damage percentage ranged from approximately 0% to 75% of the area damaged. Out of the 44 no. 100m sample stations located pathways, 55% of samples contained no evidence of any habitat degradation. 34% of samples contained localised habitat degradation, capable of rapid recovery, while the remaining 11% contained widespread. habitat degradation, capable of rapid recovery. No samples contained any levels of habitat degradation that would require intervention to allow full recovery. The causes of the damage were identified to be tourist movements, storm water, scrub management and livestock (sheep) and overgrazing. Overgrazing was recorded on 27% of samples, and was prevalent in all areas, but less so in the areas of hard infrastructure on the southernmost pathways (the second half of the transect). Burnt gorse was recorded on 20.5% of samples and was noted intermittently on the northern most pathways (the first half of the transect).

**Figure 3.11** Habitat Map of Dursey Island. Basemap provided by Google

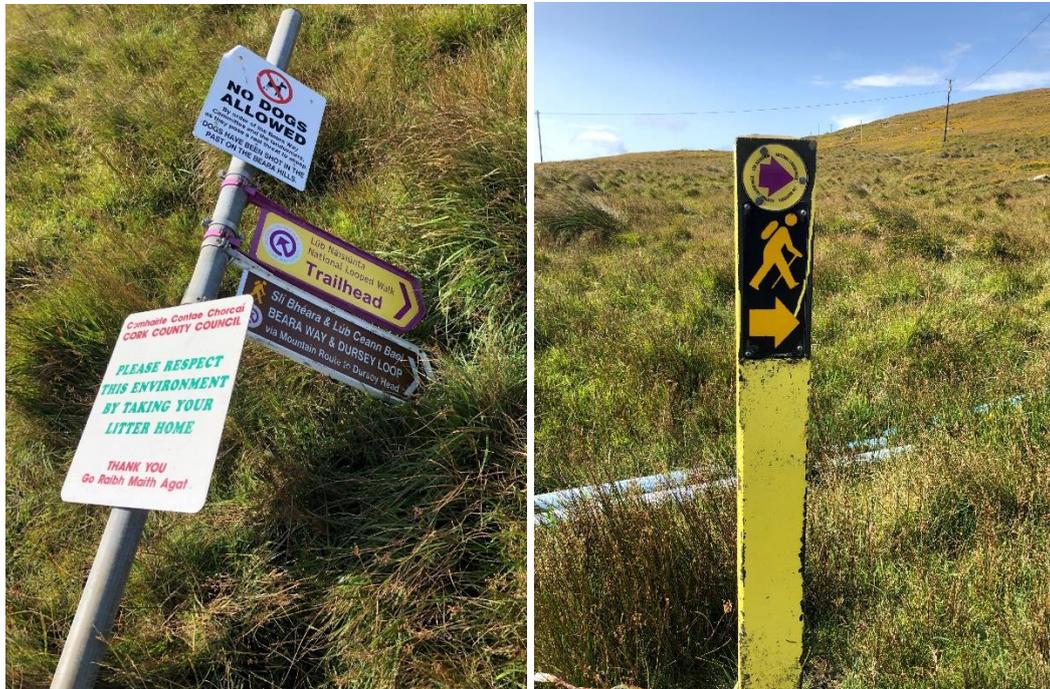
Plate 3.3 Fallen signage indicating walks, prohibition of dogs and littering (L) and Trail Marker Signage (R) at Dursey Island

- Signs and trail markers which have become damaged or have fallen over (see Plate 3.3) should be reinstated with durable and weatherproof materials.
