National Tourism and Environmental Monitoring Programme Malin Head, 2023

National Tourism and Environmental Monitoring Programme

Annual Report for Malin Head 2023

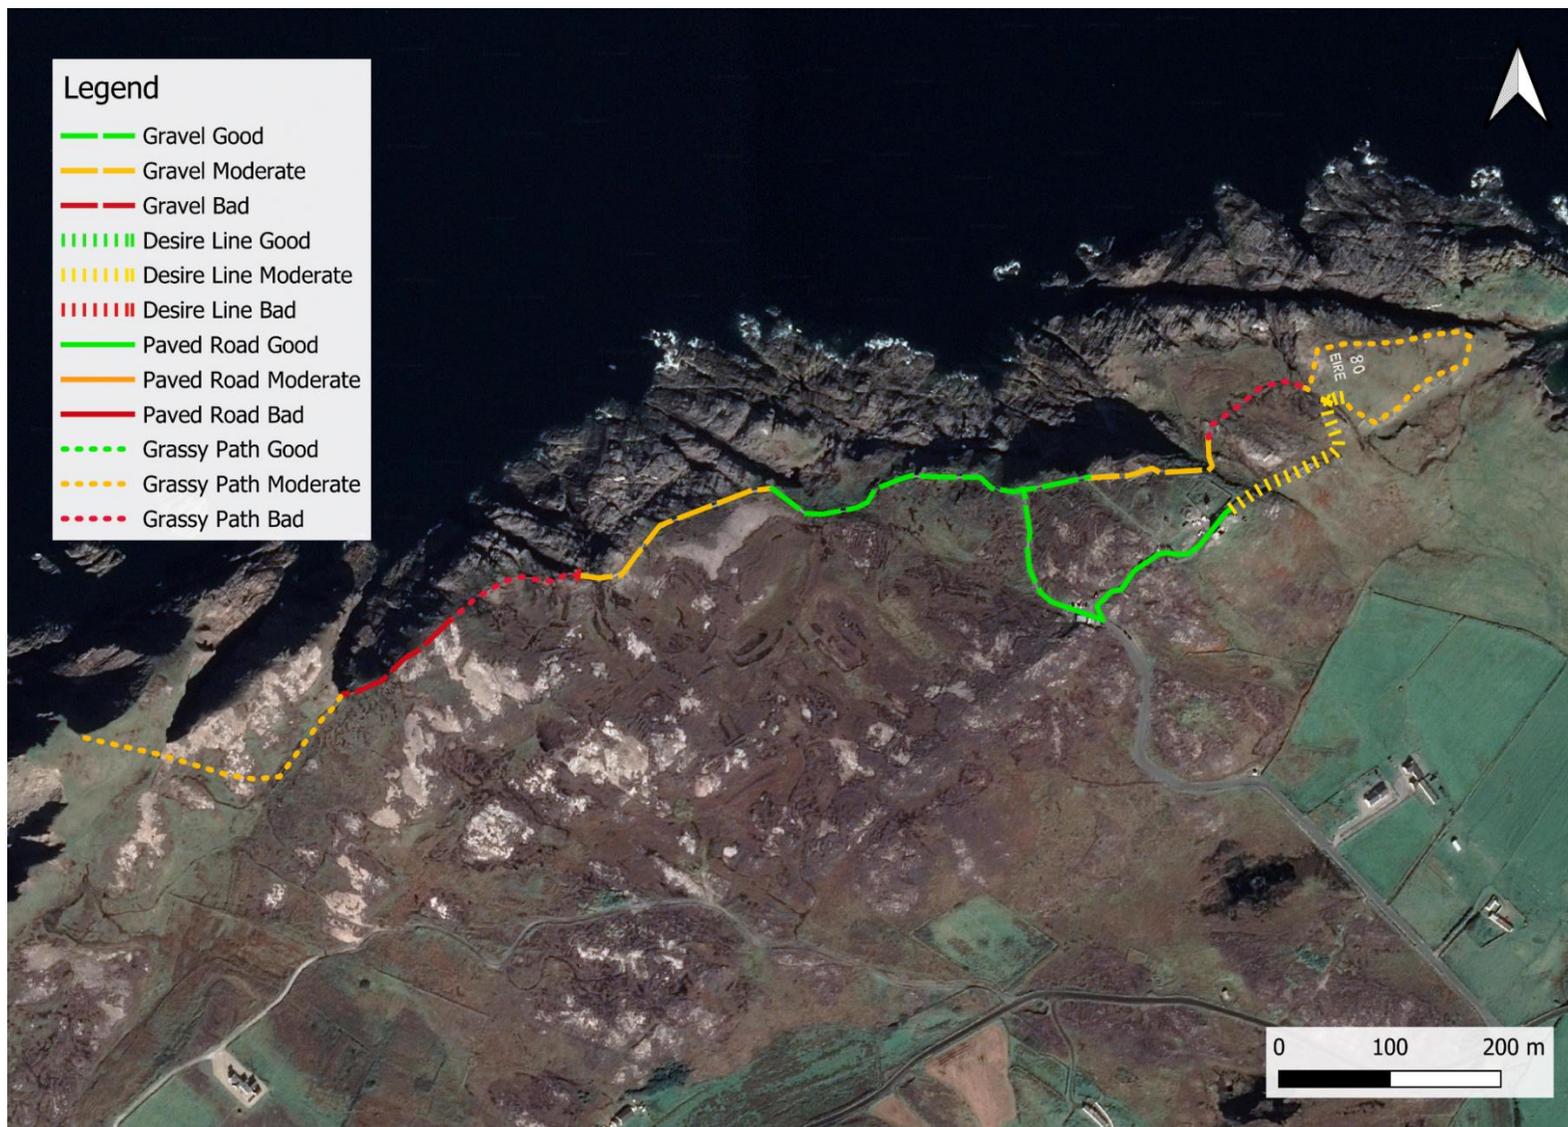
Figure 3.10 Colour-coded condition of the main pathway types recorded on the site. Basemap provided by Google.

There is a gravel path from the lower car park to the coast, where it leads to Pólifreann to the west and the signal tower to the east. The path is stone steps for short steeper sections. Further west, beyond Pólifreann the track is not formalised, but it is well used. Path widening, braiding and erosion are present in this area. Erosion is also present in places along the gravel path, where people leave the path to take photographs. The Strava map in figure 3.9 provides a good indication of their locations. A paved road leads from the R242 to Lloyd's Signal Tower. Pathway conditions at this site varied, with erosion of pathways varying in degrees from 0% to 90%. Approximately half of pathways were reported to be uneven. Examples of each of the pathway types are presented below in Plate 3.1. Pathway types and conditions are mapped in Figure 3.10 below.

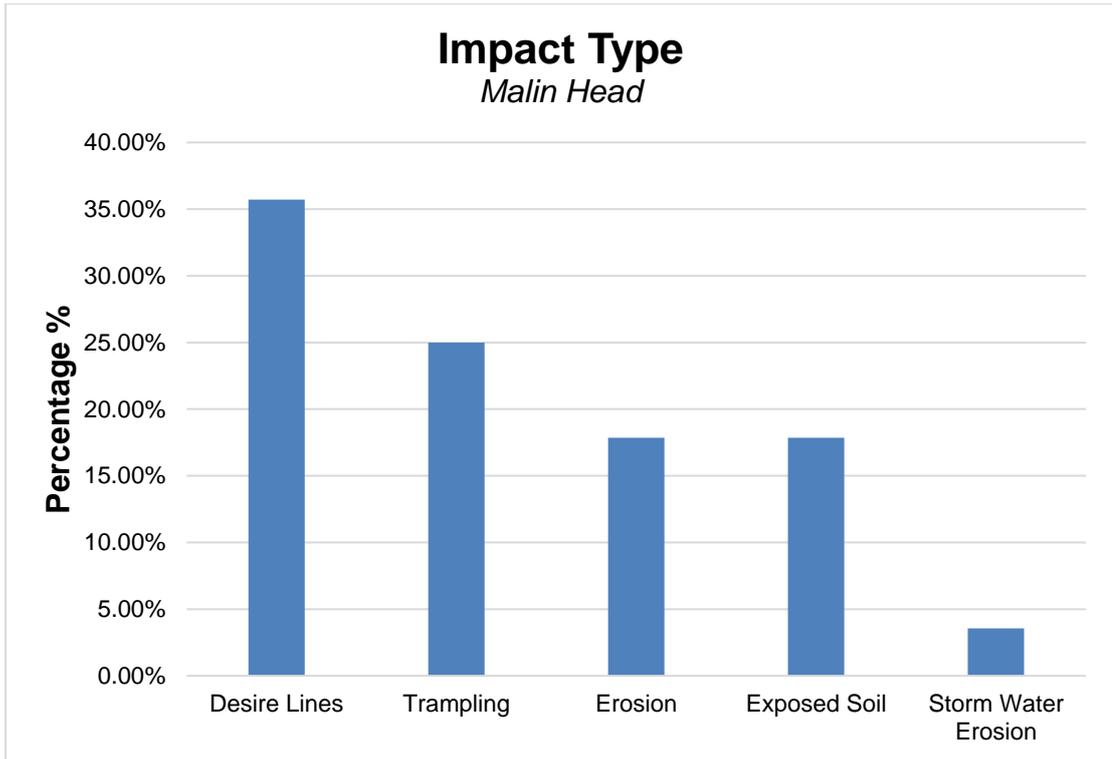
Figure 3.11 Impacts on Pathway Condition

Figure 3.11 represents the pathway impact type at the site. The types of impact observed were desire lines at 36%, trampling at 25%, erosion at 18%, exposed soil at 18%, and stormwater erosion at 3% of the impact types observed.

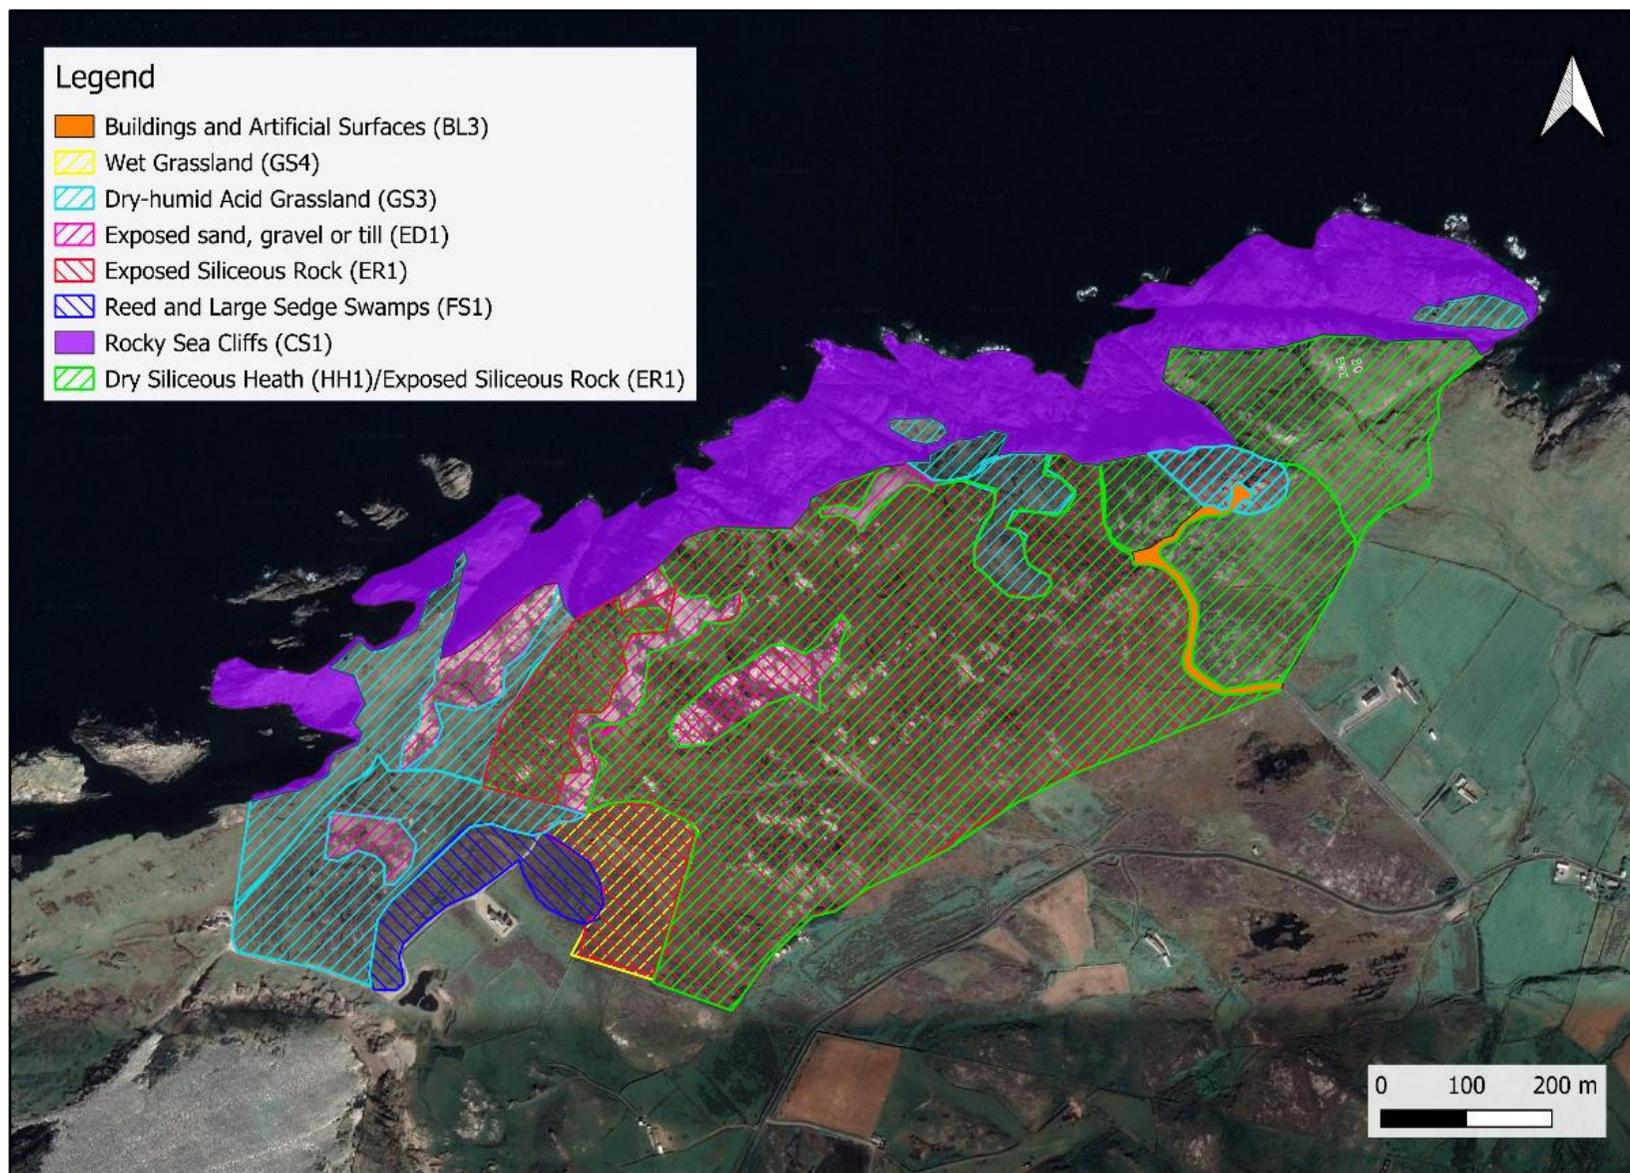
Figure 3.12 Habitat Map of Malin Head. Basemap provided by Google.

There are a range of habitats present on site (see Figure 3.12). Habitat damage of varying degrees was reported on 100% of the transect walked by surveyors. The degree of damage to habitats ranged from 5% to 80% of the area damaged. 46% of samples from the transect contained localised damage while 54% of samples contained habitat with widespread damage. 26% of samples contained localised habitat degradation capable of rapid recovery, and 20% contained widespread capable of rapid recovery. 20% contained localised damage with intervention required for full recovery, and 34% of samples contained widespread damage with intervention required for full recovery. The causes of the damage were identified to be tourist movements and desire lines, storm water erosion, and livestock (sheep) overgrazing.

- Appropriate land management is recommended to promote sustainable farming practices and reduce overgrazing. This would lead to improved habitat quality and resilience. Any recommendation related to land management should be considerate of the EU Corncrake Life Project.

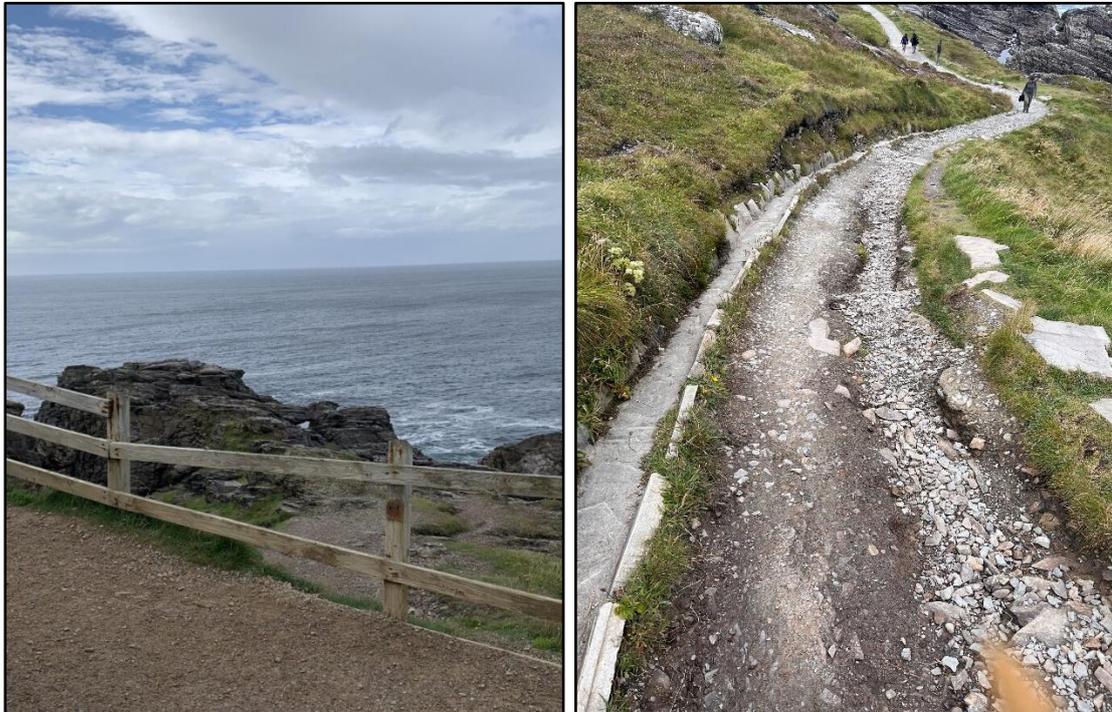
Plate 3.4 Broken fence (L) and an eroded and uneven path (R).

A broken fence was recorded at Malin Head and is displayed in Plate 3.4. This is a hazard, particularly given its proximity to rocks and the ocean. As discussed in section 3.2.1, approximately half of the pathways assessed were uneven, which is also a hazard for visitors.

- The local bus route serving Malin Head and/or a shuttle bus should be promoted as an alternative mode of transport to visit Malin Head.
- Sections of the gravel path have been damaged by rain. These should be repaired (See Plate 3.4).

- The broken fence at Póilfreann should be repaired.
- The formalisation of the trail west of Póilfreann should be considered to address path widening and erosion. This should include areas adjacent to the paths which are popular for taking photographs.
