National Tourism and Environmental Monitoring Programme

Banagher 2025

Report for Banagher 2025

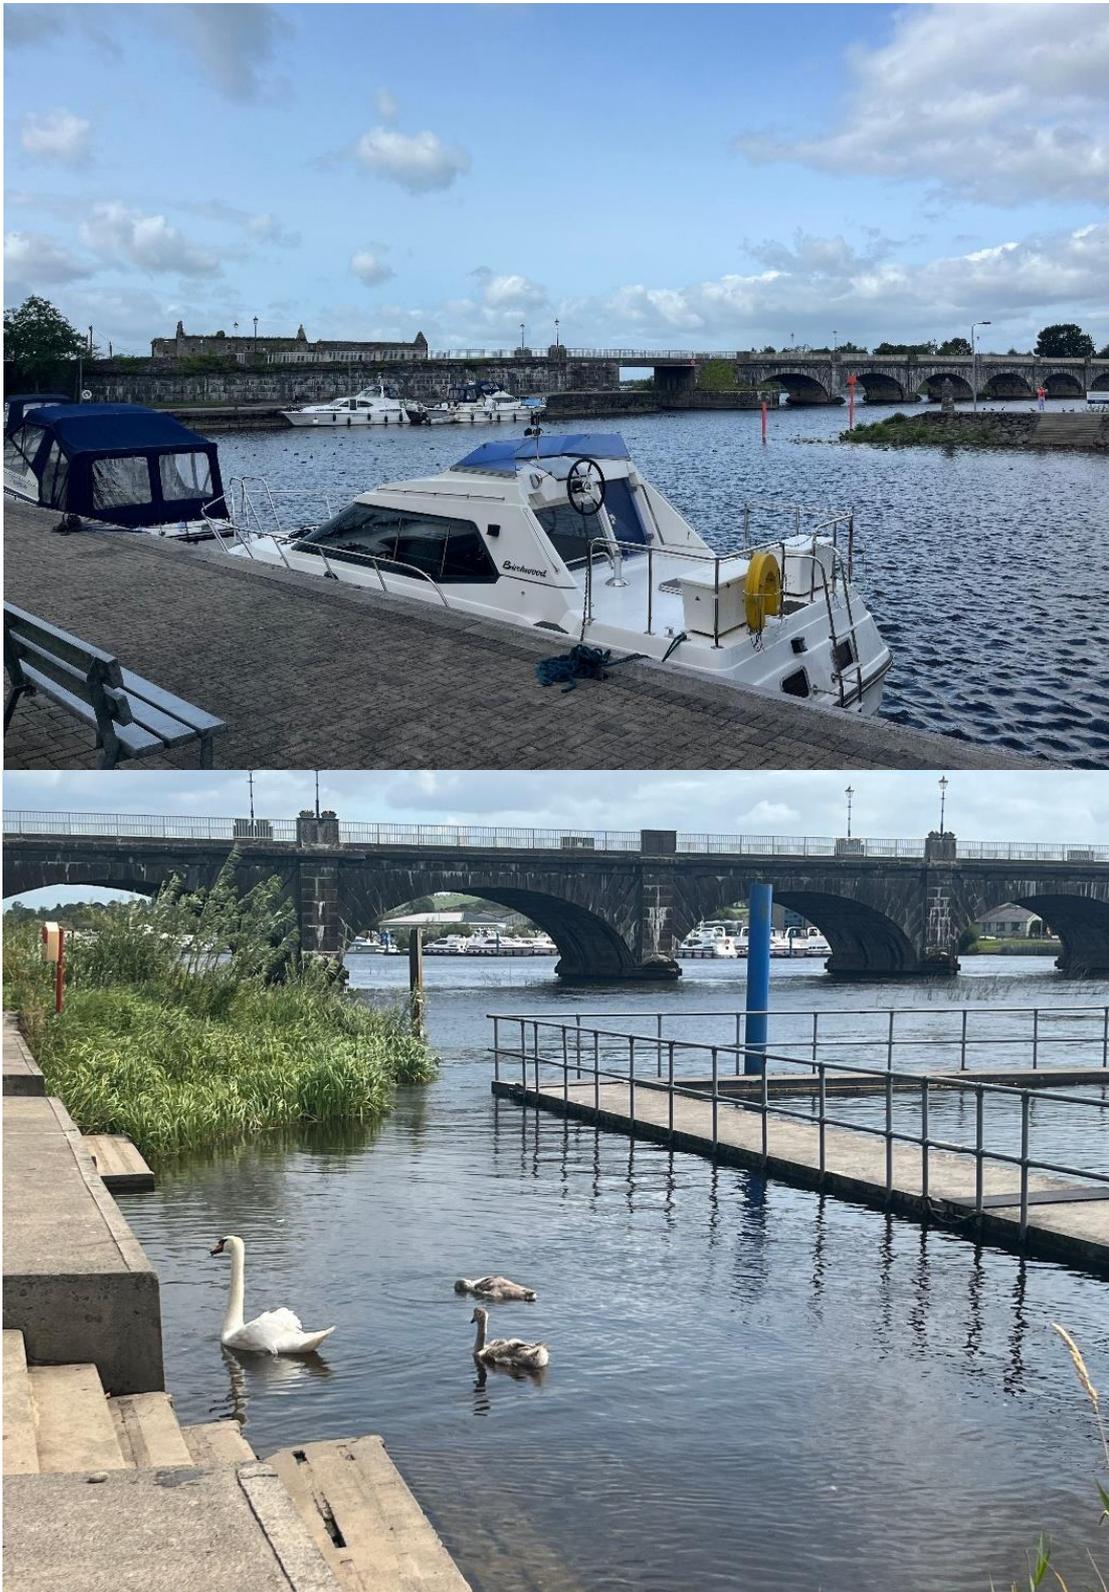
The River Shannon runs through the study area, separating counties Galway and Offaly. The site is used by visitors for boating, swimming, walking and fishing. Banagher Outdoor Pool at Banagher Park is segregated from the main river channel. Some litter is noted in the water at the marina, however it is unclear whether this originated locally or from upstream. Mallard ducks were common around the marina, and appeared habituated to the human activity in the area. In the outdoor pool, an adult

mute swan with two cygnets were present, and displayed signs of stress when approached by visitors. Plant species recorded along the river verges are discussed further below. Photos of the River Shannon at Banagher are presented in Plate 3.1 below.

Plate 3.1 Banagher Marina (top) and the outdoor pool at Banagher park with reed habitat in the background and mute swans (bottom).

- Visitors utilising the outdoor pool in Banagher park were observed approaching a swan with signets, which caused it to exhibit stress behaviour. The implementation of signage at key locations on the site should be considered to discourage people from approaching wildlife. Where signage is being implemented, teleological signage (signage with instruction and justification for the instruction) should be used.

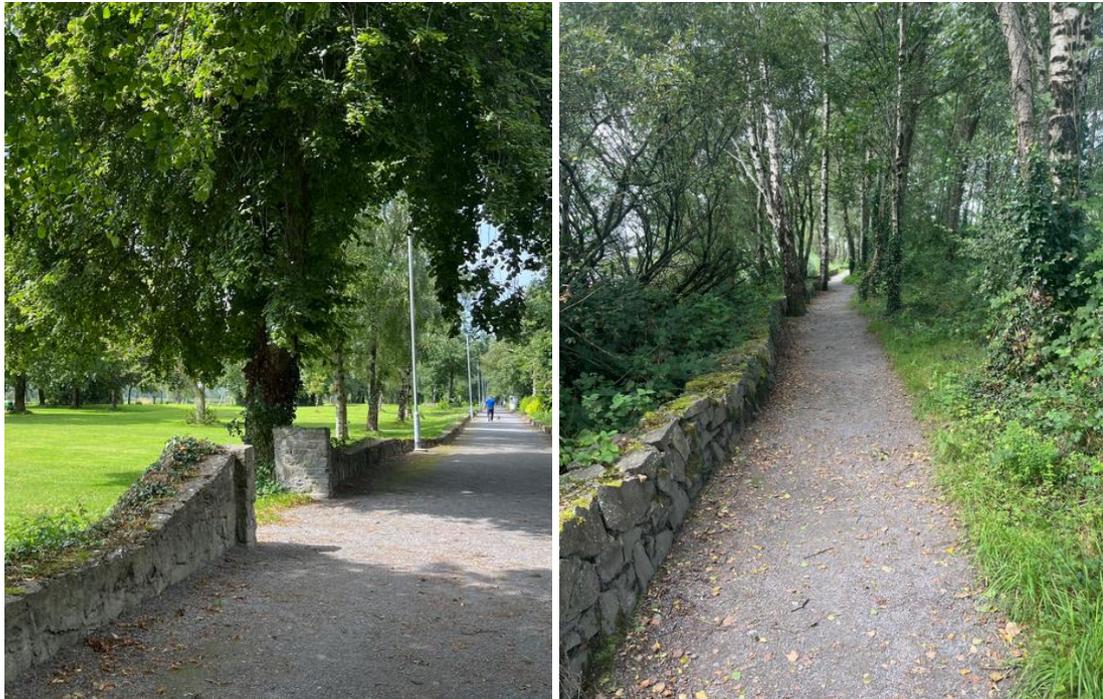
Plate 3.5 Gravel pathways in Banagher park.

In Banagher Park, a paved road leads from the R356 into a gravel car park. A gravel path then leads from the car park around the park in a loop, and is connected to the small island in the west of the site by two small wooden pedestrian bridges. This gravel path is displayed in Plate 3.5 below. A paved path leads from the park area to Cromwell's Castle and the outdoor pool.

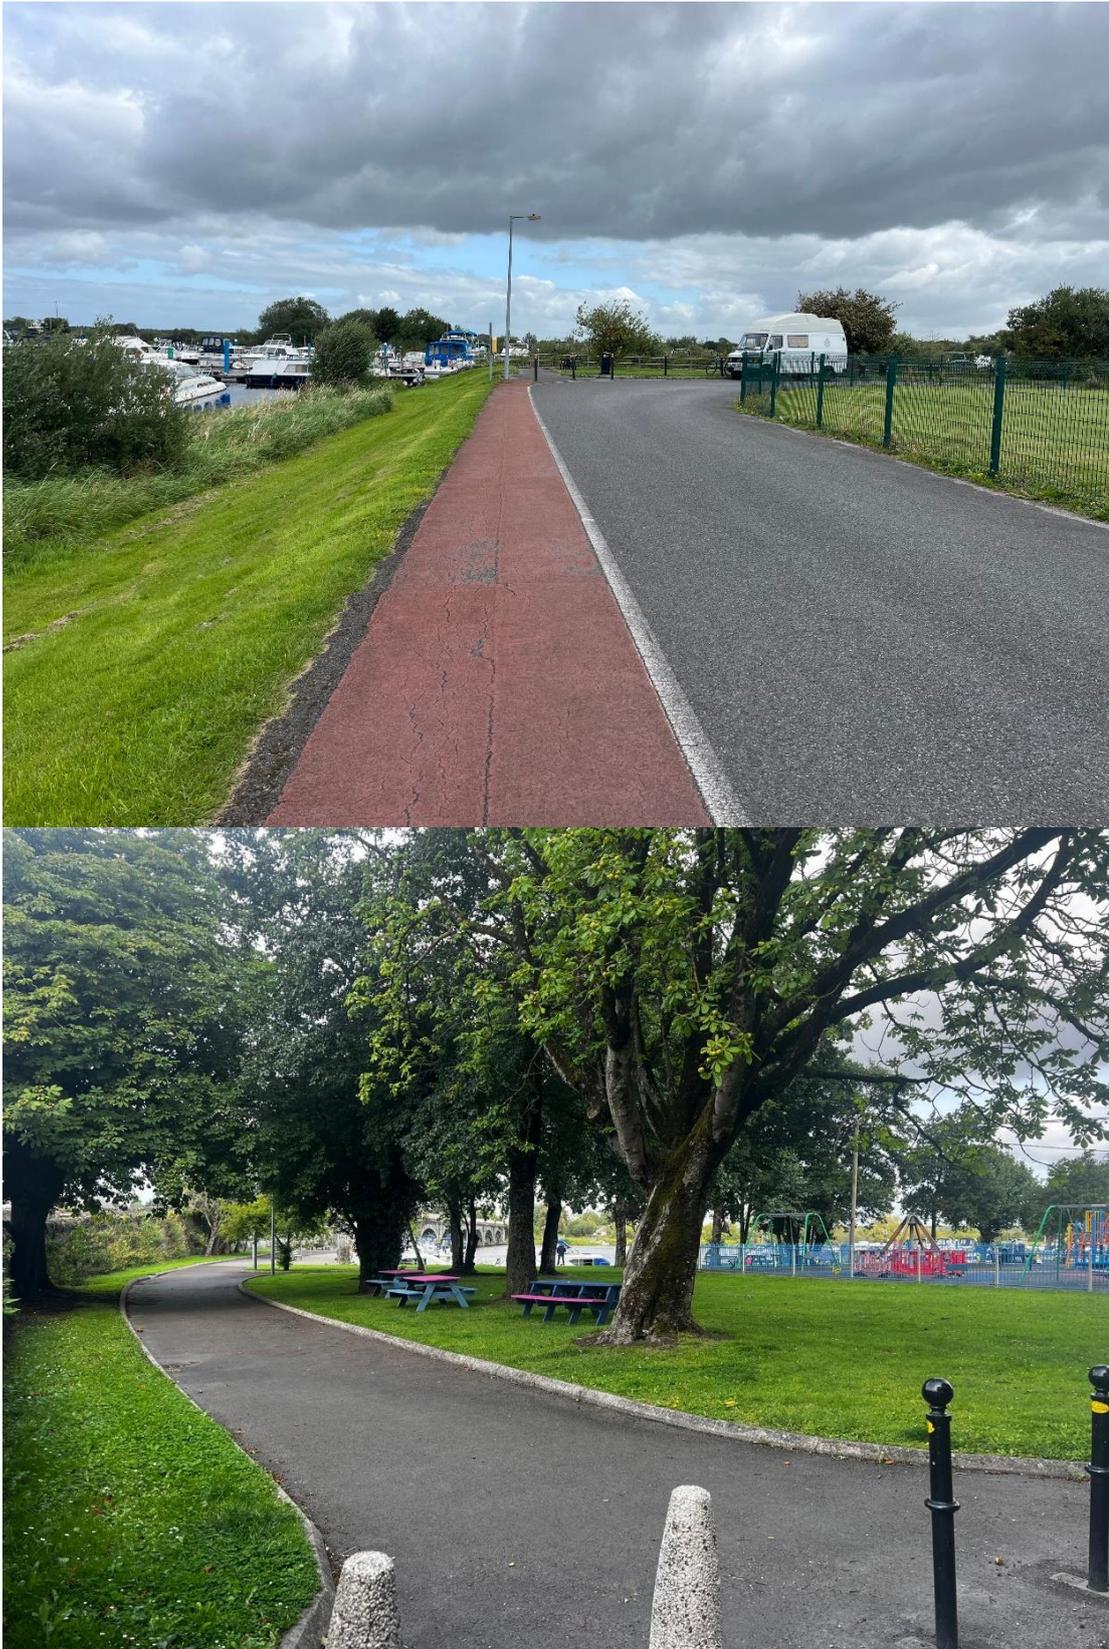
A paved road leads from the R356 towards the marina, looping around the various cruise business establishments. A pedestrian walkway is associated with the paved road along the marina, as displayed in Plate 3.6 below. Paved and gravel parking areas are located at the southeastern border of the site by the cruise business establishments. A paved path leads from the entrance of the marina towards the playground and towards Banagher Bridge and the marina area. It is also not considered necessary to map the paved areas along the marina, as it is associated with the general marina / jetty area. Examples of a paved road and pathway are presented in Plate 3.6 below.

Plate 3.6 Paved road with a pedestrian walkway (top) and paved path (bottom) at Banagher marina.

All of the pathways are in good condition, and are well-maintained. The pedestrian walking areas on the paved roads at the marina were at times used for vehicle parking – this is discussed further in Section 3.3.1 below.

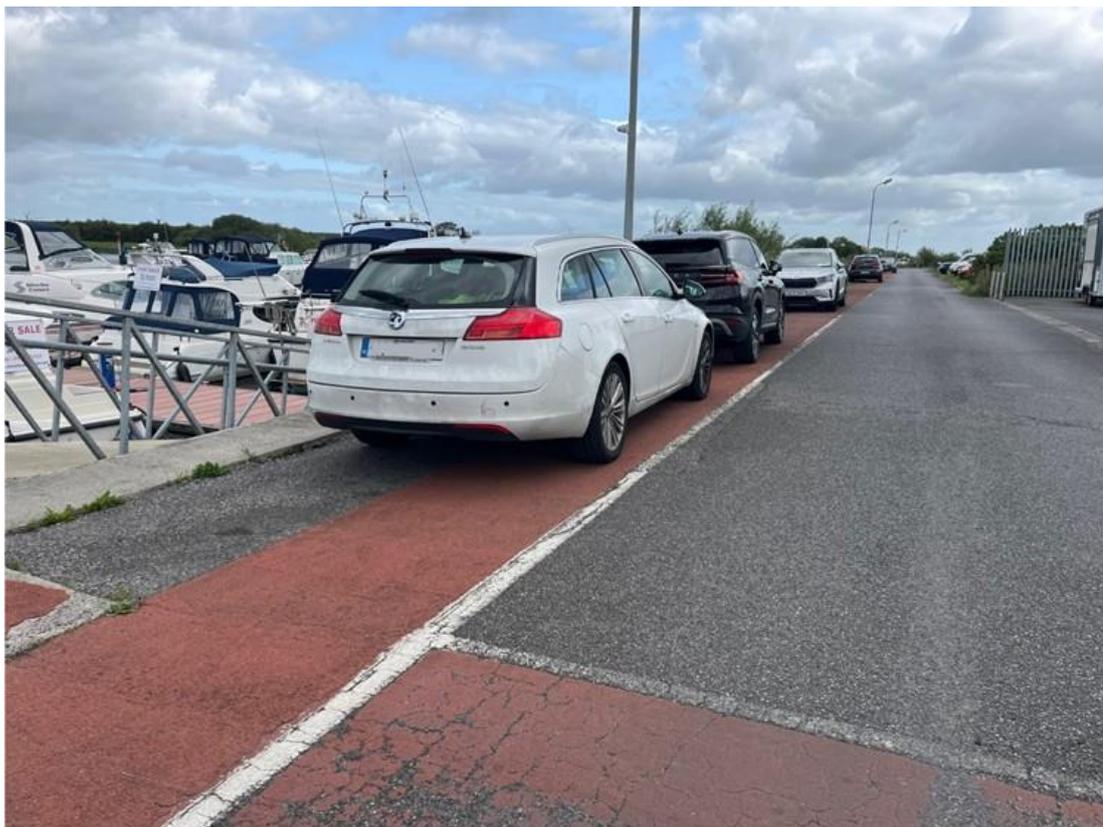
At the entrance to the marina off the R356, there is no pedestrian access. In order to gain access to the marina, pedestrians must walk on the roadway. There are pedestrian paths within the marina. Along main street, a section of the pedestrian path is painted onto the edge of the road. Cars were observed parked in this area during the survey. Cars parking on the pedestrian walkway is presented below in Plate 3.10.

Plate 3.10 Cars parking on the pedestrian walkway in Banagher marina.

- A number of cars were recorded parking on pedestrian walkways at the marina. The provision of additional parking at the marina should be considered to ensure adequate parking is available on the site during busy periods. This could be accompanied by bollards and signage to prevent and discourage parking on pedestrian walkways.

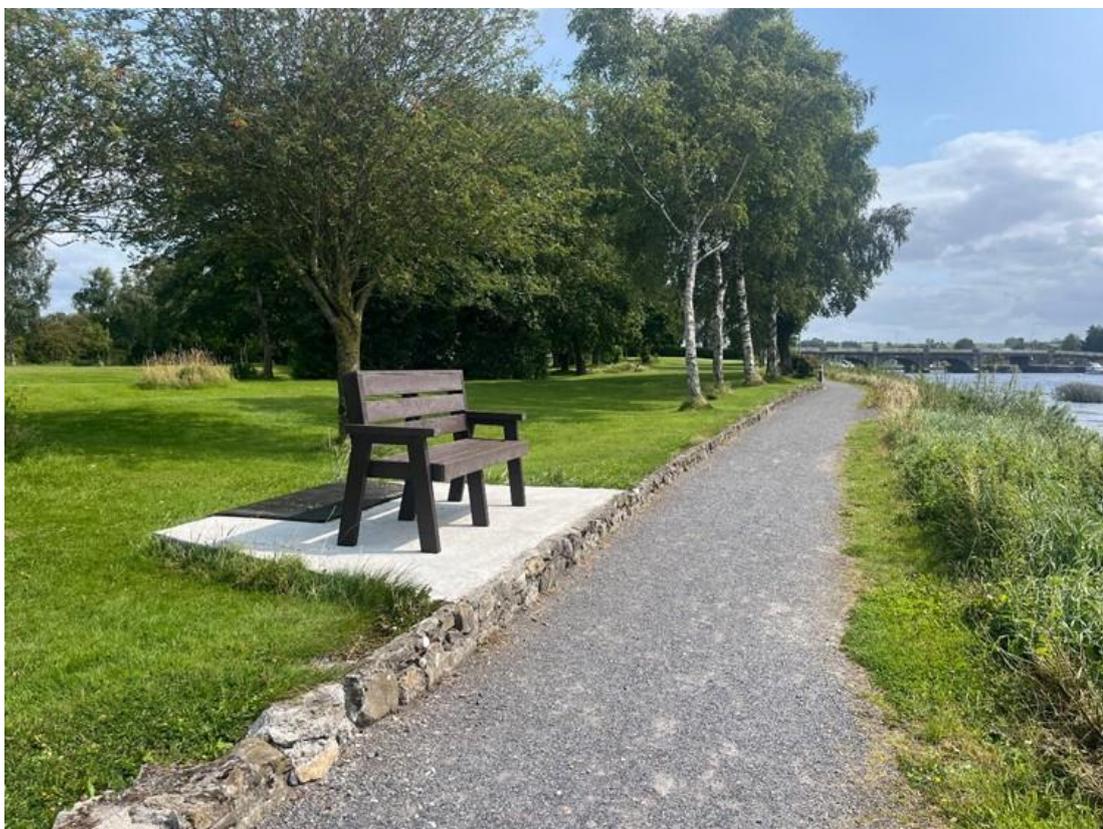
A number of benches are present throughout the site, however in the park, some benches adjacent to the path are on a raised concrete slab, with a stone kerb creating a trip-hazard for visitors, particularly people with disabilities, or the elderly . An example of this is presented below in Plate 3.11.

Plate 3.11 Bench and a high kerb in Banagher park.

- A number of benches in Banagher Park are located on high kerbs. The removal or adjustment of these kerbs should be considered to make this seating more accessible, particularly for less able-bodied visitors.
