# National Tourism and Environmental Monitoring Programme Hook Head 2024

# National Tourism and Environmental Monitoring Programme

## Report for Hook Head 2024

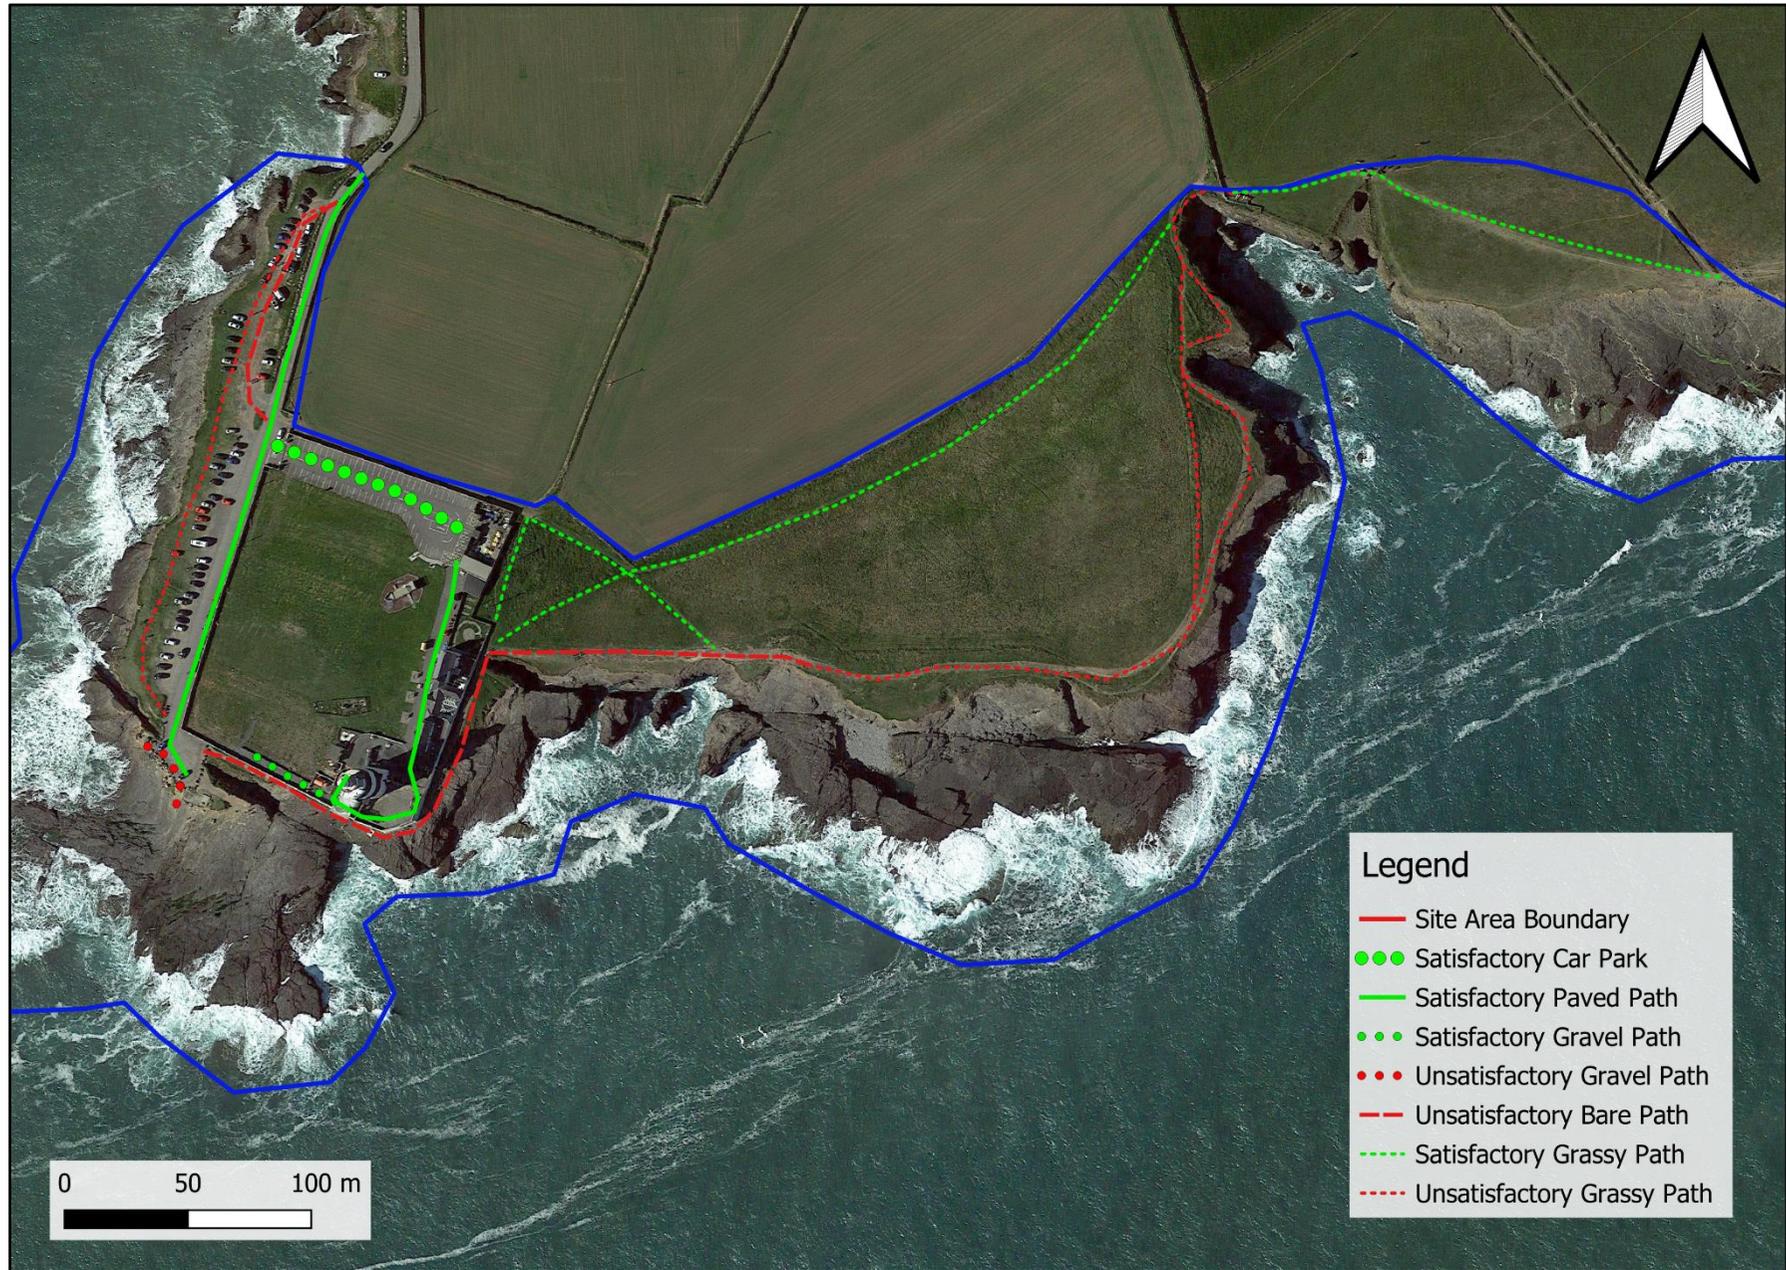
The grounds of Hook Lighthouse have paved surfaces including a car park, and also have a raised wooden platform which serves as a viewpoint for visitors. A short gravel path is present beside the amenity grassland, though the purpose of this is unclear. All of the pathways within the grounds of Hook Lighthouse are well-maintained and in good condition. The R734 is also in good condition. There is a bare path and a grassy path present directly west of the R734, both of which are in poor condition. Visitor movements along with vehicle parking has led to pathway braiding and vegetation regression on these pathways. Where the R734 leads south, two small gravel paths leading onto the cliffs are highly eroded and in poor condition. A bare pathway leads around the lighthouse over the rocks and into the agricultural field, where it turns into a grassy path. Both the bare and grassy portions of this pathways are in poor condition, with pathway braiding occurring at several points. An additional grassy path is present north of this pathway. Braiding occurs between the two pathways. Given its uniformity and lack of impacts on the surrounding habitat, the northernmost grassy path is considered satisfactory, though it was noted that having multiple pathways is unnecessary, as they lead to and from the same locations. A grassy path is present in the easternmost agricultural field. The pathways itself is in satisfactory condition, but as discussed in section 3.1, the surrounding habitat is heavily trampled as a result of both visitor and cattle movements. There are additional informal paths in this field, however it is unclear if these are a result of visitors or cattle. The most dominant and clear pathway in this field was mapped. Figure 3.4 presents a Strava heat map for the site. Strava aggregates data from users on its app who opt-in to share their activities and locations. The pathway condition assessment map is presented in Figure 3.5 below. Plate 3.1 displays some of the pathways found at Hook Head.

**Figure 3.5** Pathway types and conditions present on the site. Basemap provided by Google.

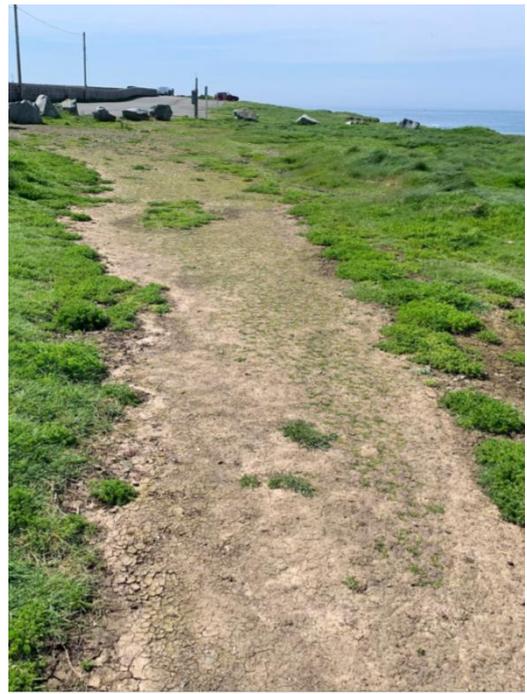
**Unsatisfactory Bare Path West of Lighthouse**

- The bare pathways to the cliffs are eroded and hazardous. Measures to restore and formalize some of these areas should be considered. The measures could include creating ramps or steps from the gravel parking area down onto the cliffs and towards the agricultural fields, which should be accompanied by barriers to ensure visitor safety.

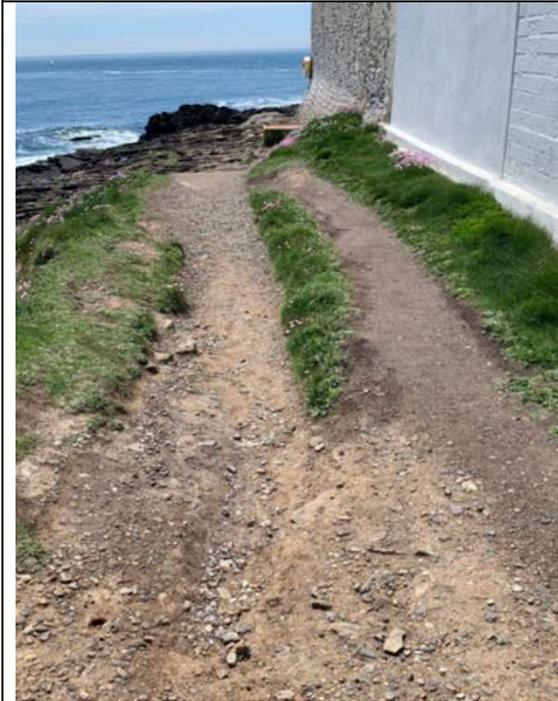
**Unsatisfactory Bare Path East of Lighthouse**

On the bare pathway at the eastern wall of the lighthouse, where the pathway enters the cliffs, erosion has led to uneven ground. In addition to this, there is a steel cable sticking out of the ground. Given this, and that the cliffs themselves are dangerous, this feature is hazardous to visitors. Signage is present to the south and east of the lighthouse grounds to warn visitors of the dangers of the cliffs, and life buoys are available throughout the site.

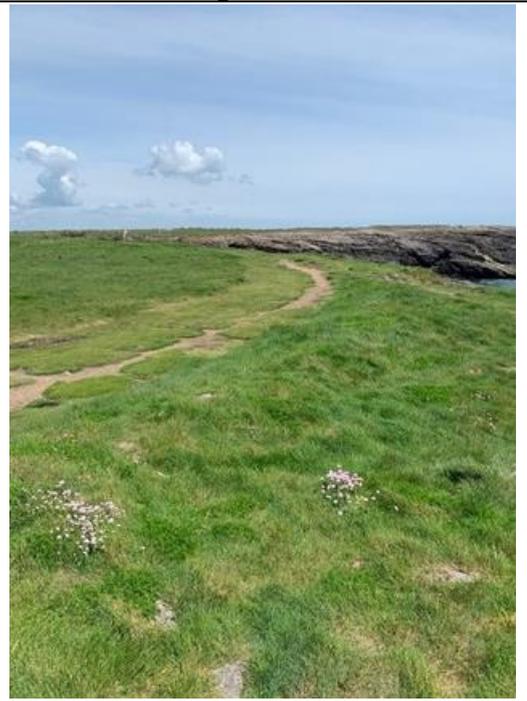
Two agricultural fields are present in the study area east of the lighthouse. The first field leading from the lighthouse has two main informal pathways running through it, both of which have smaller pathways and braiding between them as a result of visitor traffic. The vegetation here was roughly 30cm tall where visitors were not walking. Brambles and nettles were present at the northern boundary of this field. The second, easternmost field, was cut-off from the first with a stone wall. The stone wall was attached to a water trough and had barbed wire and a sign indicating it was private land which contained a bull. At the time of the survey, a bull was not present in the field, and visitors were observed climbing the wall and proceeding into the field. The field had areas of bare ground where the cattle congregated, such as at the water trough. It was unclear whether pathways were formed exclusively from visitors, or if cattle also created the informal pathways. Chough (*Pyrrhocorax pyrrhocorax*) were active in this field. White clover (*Trifolium repens*), red clover (*Trifolium pratense*), curled dock (*Rumex crispus*), kidney vetch (*Anthyllis vulneraria*), thistle (*Cirsium* spp.), along with grasses were recorded in both agricultural fields.

**Unsatisfactory Bare Path in Field**

- Part of the Slí Charman Coastal Trail, a 220km trail launched in the 1990's, and several informal pathways in the agricultural fields to the east of Hook Lighthouse are being used by visitors, and based on satellite imagery, lead to Slade village. Part of the Slí Charman Coastal Trail has fallen into disrepair and currently some sections are undergoing or are proposed for rehabilitation works. The construction of a formal path from the lighthouse to lead visitors along an already established coastal walking route should be considered as this would help reduce braiding and habitat degradation. This would require agreement with landowners along the route.

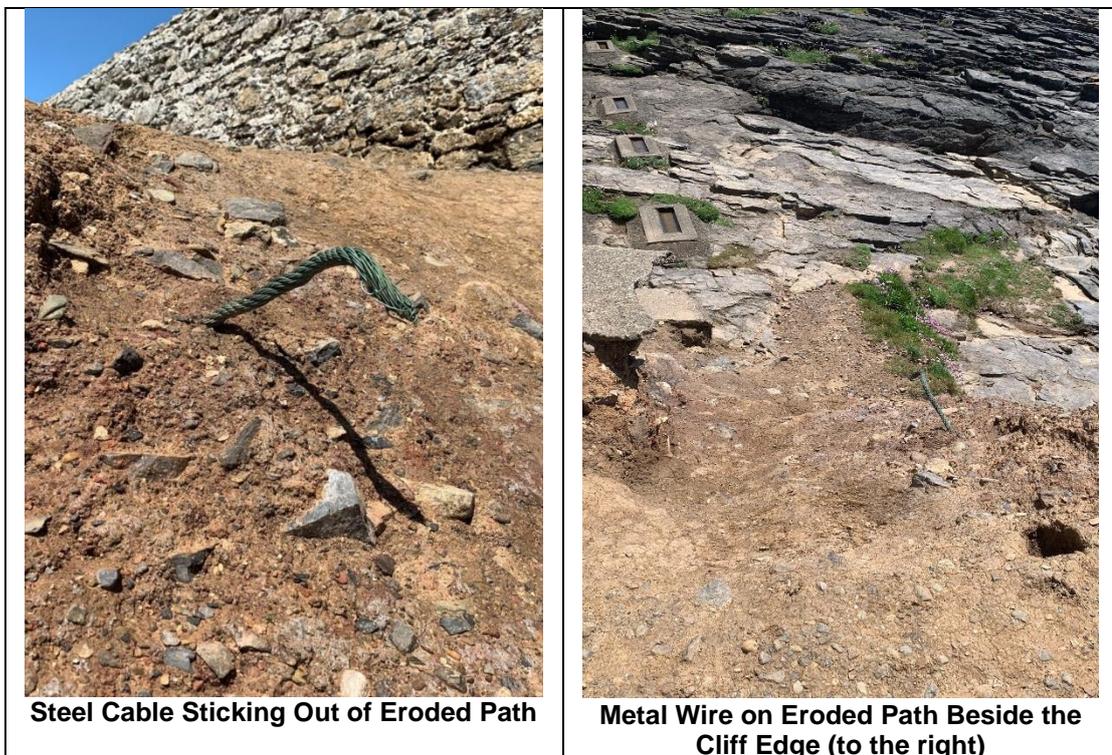
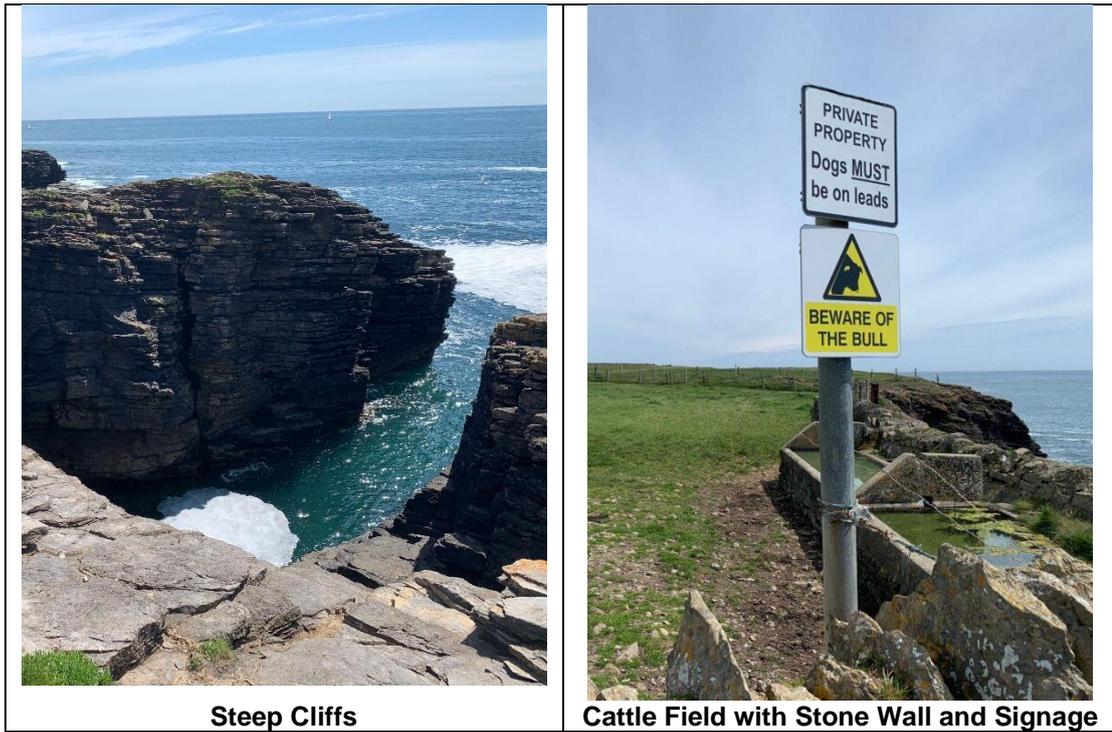
Plate 3.4 Hazards at Hook Head.

The cliffs at Hook Head are hazardous. The uneven footing, blow holes, sudden gaps in the rocks, and the general height of the cliffs create the risk of visitors falling. Furthermore, the unsatisfactory pathways, particularly those surrounding the lighthouse, were uneven and create the risk of visitors falling onto the dangerous rocky areas. It was noted on the surveys that in areas with little room between the pathway and the cliff edge, barriers such as wire fencing were in place.

The easternmost agricultural fields contained cattle at the time of the survey. These fields are contained by a stone wall with barbed wire, which must be climbed over to enter the field. This area poses the risk of visitors being injured both while trying to climb the wall, and by cattle. A sign informing visitors that they are entering private property and that a bull may be present, and also instructing them to keep their dogs on leads. A dog off the lead was recorded in this field. The hazards discussed here and signage relating to them are displayed below in Plate 3.4. The locations of the hazards on Hook Head are presented in Figure 3.5.
