# National Tourism and Environmental Monitoring Programme

## Sheep's Head 2024

## Report for Sheep's Head 2024

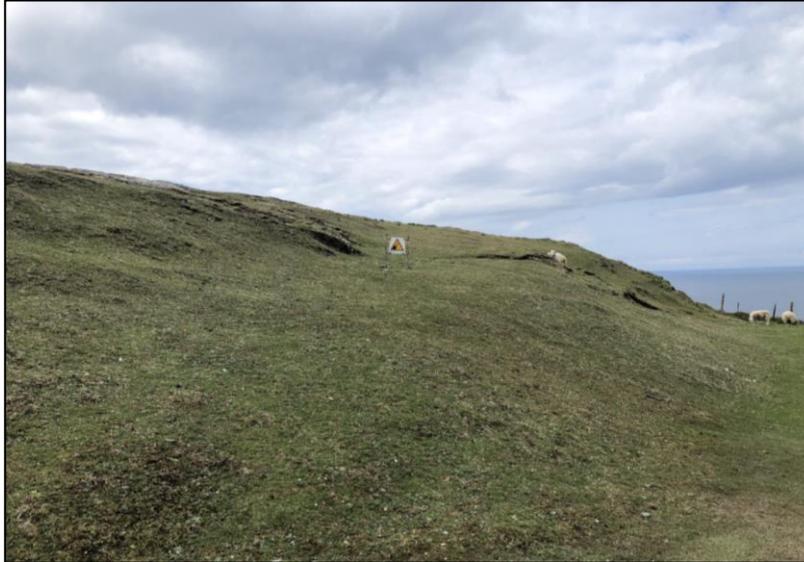
This habitat was recorded inland from the cliff edge southwest of Lough Akeen. Due to the presence of livestock and subsequent overgrazing, this habitat has become severely degraded (Plate 3.3). Plant species, which include daisy and thrift, are limited to the cliff edges due to this overgrazing.

**Plate 3.3 Overgrazed grassland habitat close to the southern cliff edge**

- Fáilte Ireland should support farmers and landowners and raise awareness on the benefits of sustainable grazing which would allow the habitat to recover.

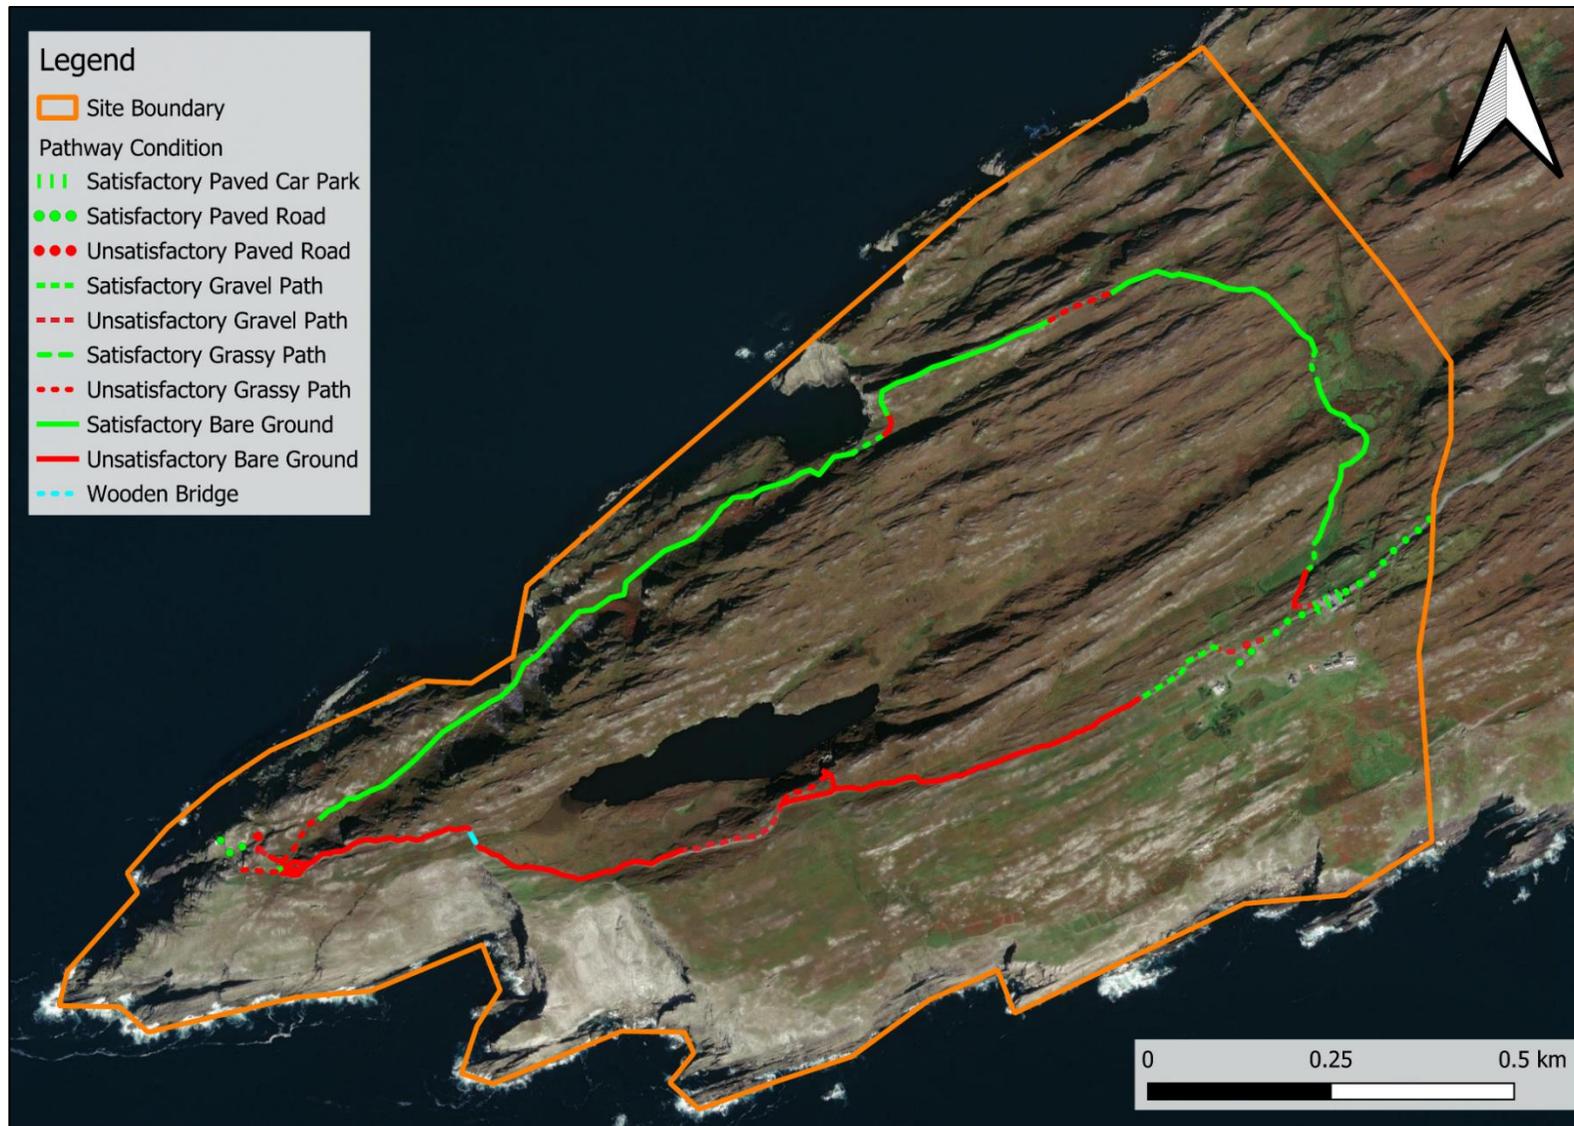
There is a tarmacadam carpark adjacent to Bernie's Café on the Sheep's Head, which marks the start of the Lighthouse Loop walk. There is a gravel road running through the carpark in a westerly direction which leads to a cul-de-sac for private access only. This gravel road is also used as the entry point to the main walking track, which veers off the private road approximately 80 m west of the carpark. This walking track develops into a bare ground track, which comprises much of the walking loop track. The bare ground track is generally a mosaic of bare ground with loose rocks/stones. Overall, this track is in unsatisfactory condition, particularly along the southern part of the loop, due to erosion, widening and braiding. This is due to the natural topography and the nature of the rock outcropping. It is also understood that the rough terrain is part of the appeal of the trail. In this instance, the unsatisfactory condition of the path is primarily due to the off-trail activities of the visitors degrading the existing path

There are areas of the pathway in slightly better condition, notably along the northern part of the loop, which are considered satisfactory relative to the foot traffic. This is likely due to physical limitations of the terrain (e.g. large rocky outcrops in proximity to the cliff edge) preventing visitors from widening the path or creating diversions in these areas. A 15 m-long raised wooden bridge allows visitors to safely to cross wet grassland habitat west of Lough Akeen, where the lake drains towards the sea.

Overgrazed areas of short-sward grassland habitat have likely caused visitors to widen the track between the lighthouse and the Eire 31 sign, likely as a viewpoint to the southern coastline. Other areas of grassy paths are exposed to soil erosion and high foot traffic and have started to degrade into bare ground.

Potentially hazardous areas along the walking loop include areas of the path which are loose rock scree or uneven, rocky surfaces on sloping surfaces, creating a hazard for slips, trips and falls. The pathway condition assessment map is presented in Figure 3.4 below.

Figure 3.4 Pathway types and conditions present on the site. World Imagery Basemap provided by Esri, DigitalGlobe, GeoEye, i-cubed, USDA FSA, USGS, AEX, Getmapping, Aerogrid, IGN, IGP, swisstopo, and the GIS User Community.

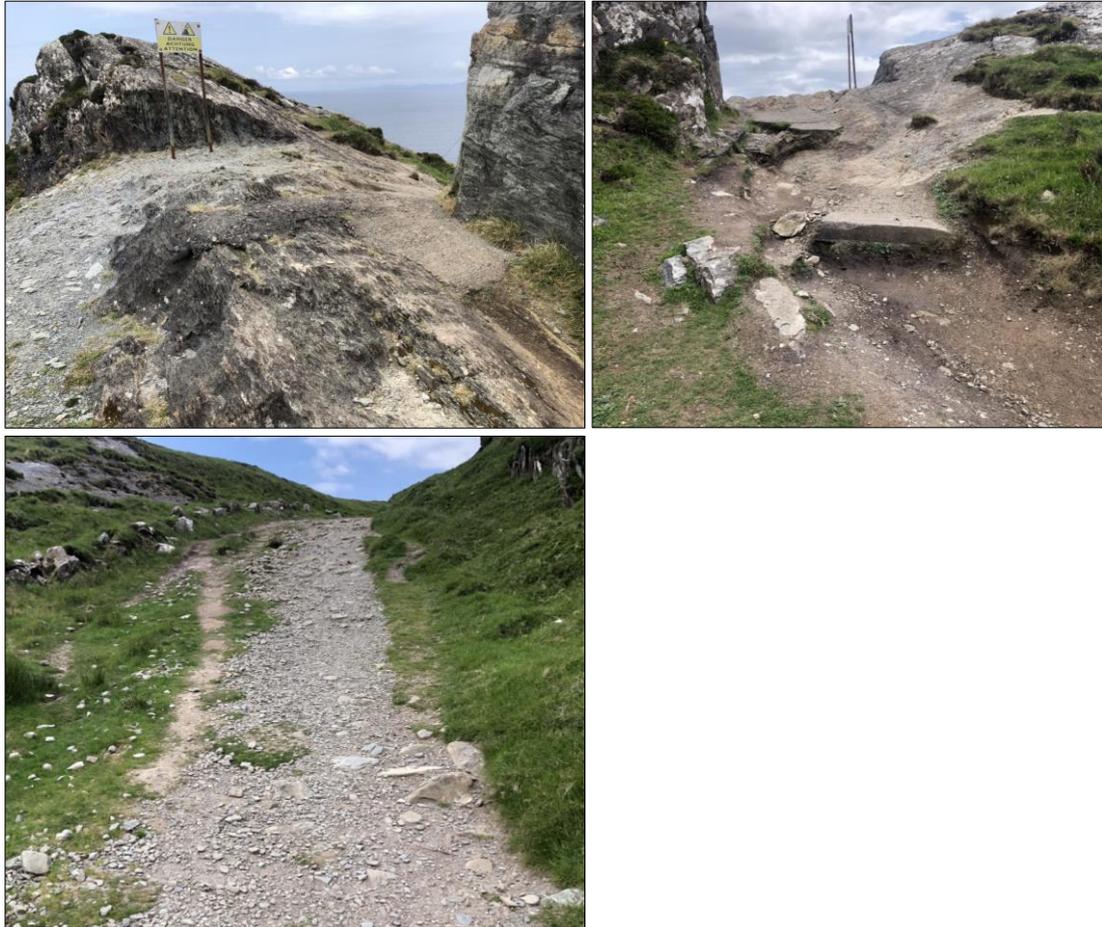
Two areas of the track were identified as potential trip hazards. One area, adjacent to the lighthouse steps contains exposed rock on a rise followed by a steep decline and larger rocks. This area is particularly important as it is located between the helicopter landing area and the lighthouse and would require unimpeded access in an emergency. A 'sudden drop' warning sign is present in this area (Plate 3.8).

The other area was an incline of the track covered in loose scree south of Lough Akeen, which is a slipping hazard and has led visitors to make their own paths through the grass on either side for a safer ascend/descend. There is no signage at this location to indicate this track is potentially hazardous. Both areas are documented in Plate 3.8 below.

**Plate 3.8 Hazardous parts of the track by the lighthouse (above) and on a scree-coated incline south of Lough Akeen (below).**

- Railings should be considered in areas of slight inclines where there is loose scree. Additional tracks through the grass are being formed to avoid slipping on the scree. Railings should have a natural, rustic aesthetic in keeping with the landscape.

- Fáilte Ireland should liaise with the Commissioners of Irish Lights to improve and formalise the path between the helicopter landing and the lighthouse steps to reduce the risk of injury.

- Fáilte Ireland should consider adding signage indicating that the terrain is uneven and potentially hazardous at the steep track south of Lough Akeen.

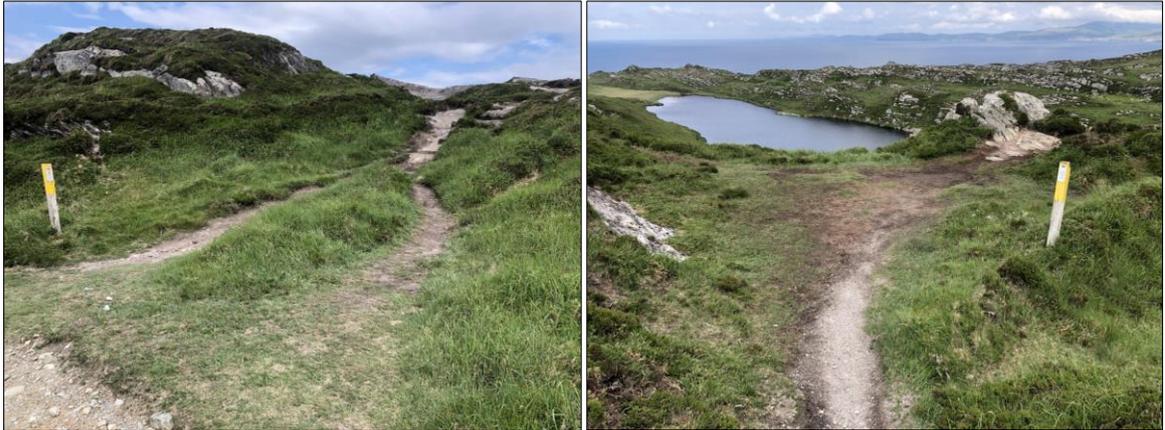
The pathway leading to the Lough Akeen viewpoint is in unsatisfactory condition due to braiding and erosion along the pathway and trampling and erosion at the viewpoint. However, it is acknowledged that by creating a dedicated viewpoint, it lessens the likelihood of visitors creating new viewpoints, potentially resulting in further, more widespread damage. Therefore, this degradation is considered acceptable considering it is very localised (Plate 3.9).

**Plate 3.9** Pathway leading to the Lough Akeen viewpoint (L) and the Lough Akeen viewpoint (R)

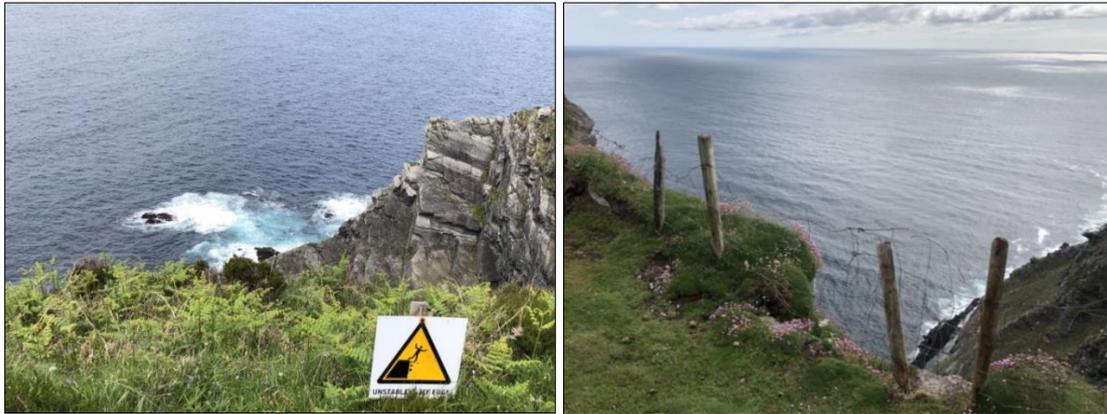
The steep sea cliffs surrounding the Lighthouse Loop of Sheep's Head are a hazard. As there are exposed edges, loose gravel/scree on the tracks and wet ground underfoot in some areas (e.g. wet heath habitat), trips and falls are a safety issue. Along areas close to steep edges, cautionary signage and fencing is used, as seen in Plate 3.13. All features, signage and hazards recorded on site during the survey are mapped below in Figure 3.5.

**Plate 3.13** Cautionary signage (L) and fencing in areas (R) at steep edge

- Existing fencing and barriers should continue to be maintained and improved along areas where the path get close to the cliff face.
- Consideration should be given to improving areas of the path that are in poor condition.

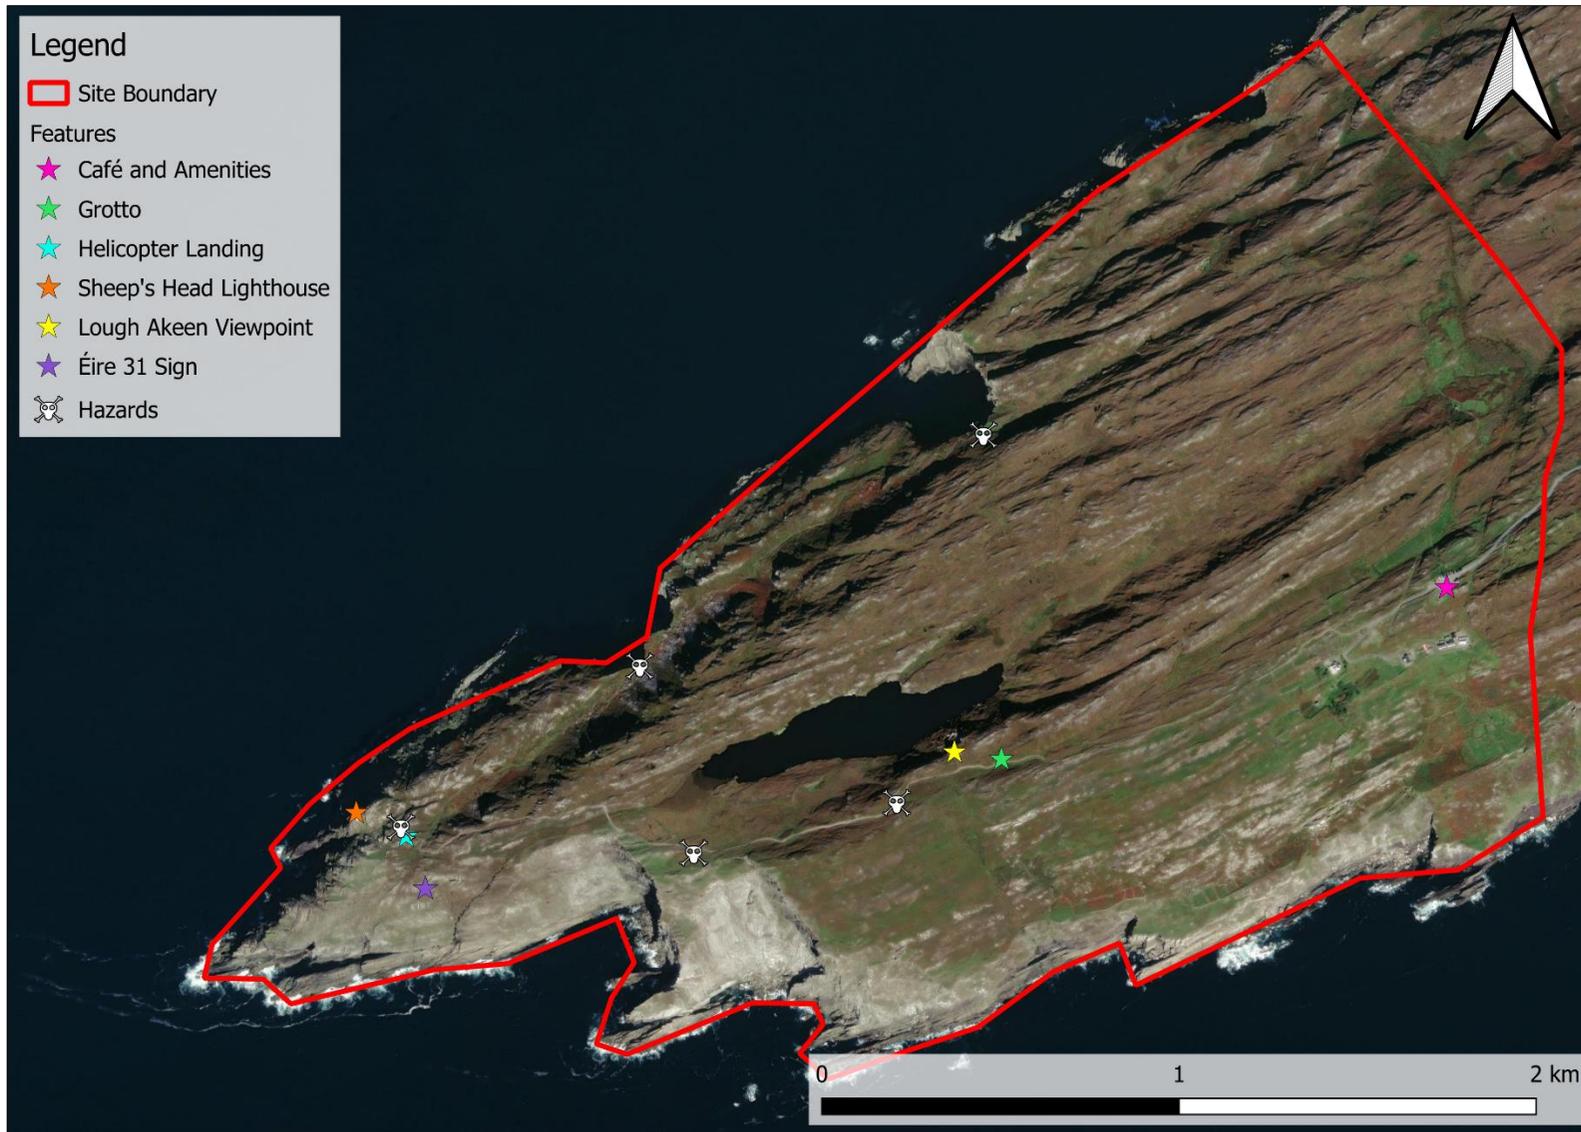
Figure 3.5 Hazards and Features present on the site. World Imagery Basemap provided by Esri, DigitalGlobe, GeoEye, i-cubed, USDA FSA, USGS, AEX, Getmapping, Aerogrid, IGN, IGP, swisstopo, and the GIS User Community.
