2017 Further Monitoring Report

Wild Atlantic Way Monitoring

A Report prepared for Fáilte Ireland

November 2017

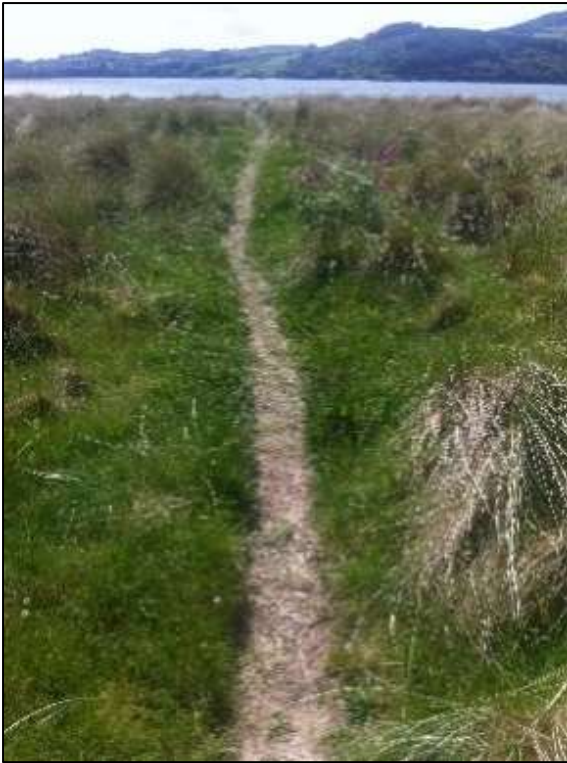
Figure 3.3 Well demarcated track in the dune slacks at the south of the Lisfannon beach

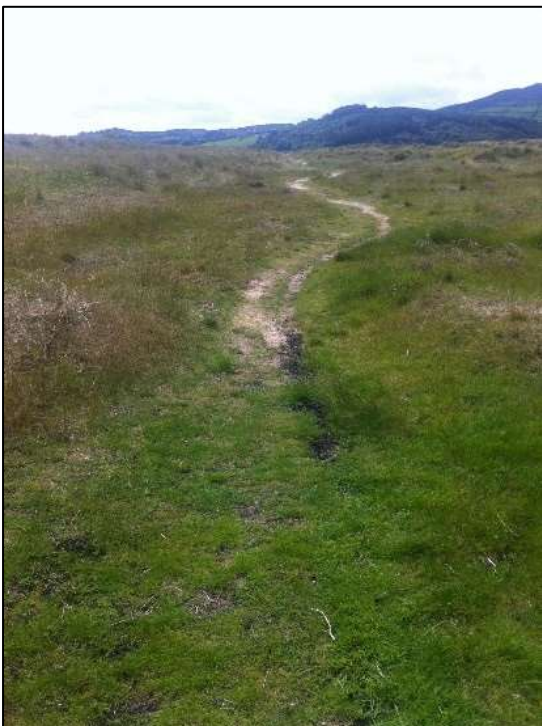
It should be noted that some of the erosion caused in the dunes may be the result of storm surges leading to an inundation of the dune slack area with seawater. There is evidence for this in the accumulation of dried seaweed and other debris in parts of the habitats to the rear of the dunes. In these sites fast-flowing water has cut erosion channels in the vegetation and sandy soil.

Figure 3.4 Eroding vegetation and exposed sand in the dune slack area, Lisfannon; Some of this erosion may be caused by seawater incursions at high tides or in storm surges

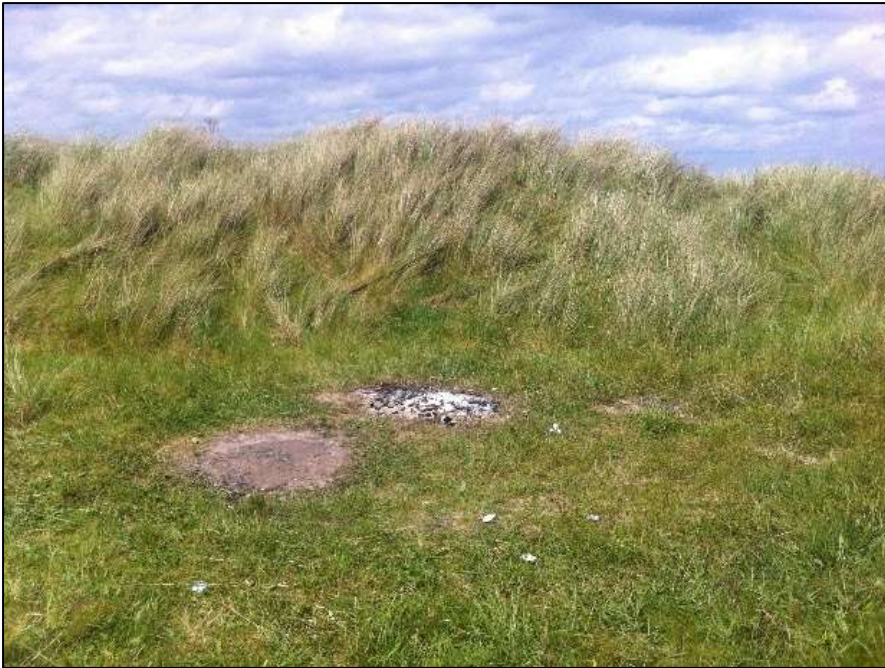
Figure 3.5 Site of fires adjacent to dune vegetation, Lisfannon

Lisfannon beach, Co Donegal	Fire damage adjacent to dunes	Fire is primarily a threat in prolonged dry conditions. Information on threat of fire could be provided. In some areas barbeques could be provided.

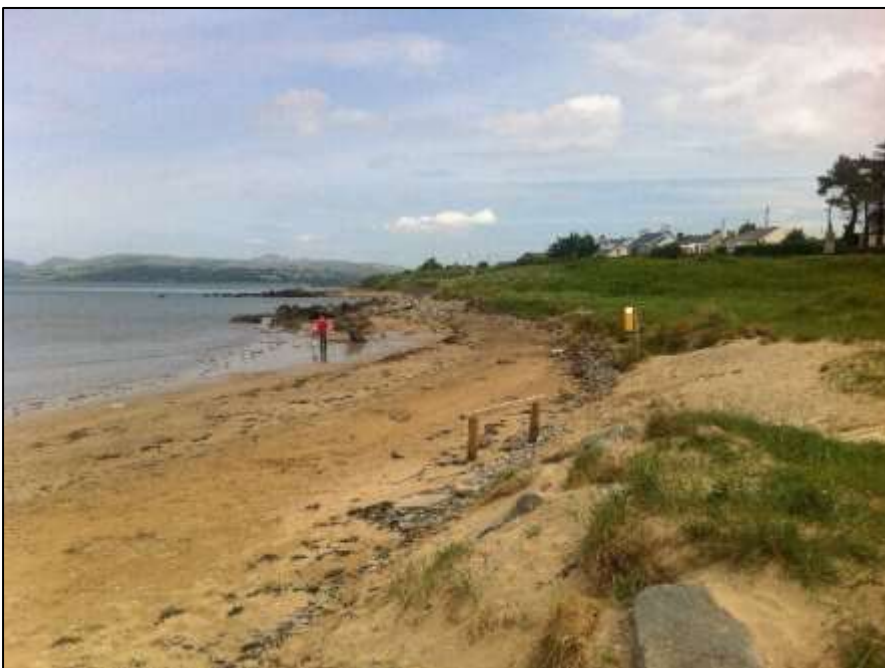
Figure 3.6 Erosion of dune vegetation at access to Lisfannon beach from car park.

Example 1 Lisfannon beach, Co Donegal			
Survey Photo	Site	Impact	Comment
 	Lisfannon beach, Co Donegal	Vegetation loss at access point to the beach Impact is caused by long established patterns of visitor activity. No other cause was evident	Use of wooden tracks at such access points would help guide visitors avoid development of secondary access tracks
 	Lisfannon beach, Co Donegal	Vegetation loss in area behind dunes at Lisfannon. Impact is caused by long established patterns of visitor activity. No other cause was evident	The track is limited in extent. In time such desire lines could become the site of walkways

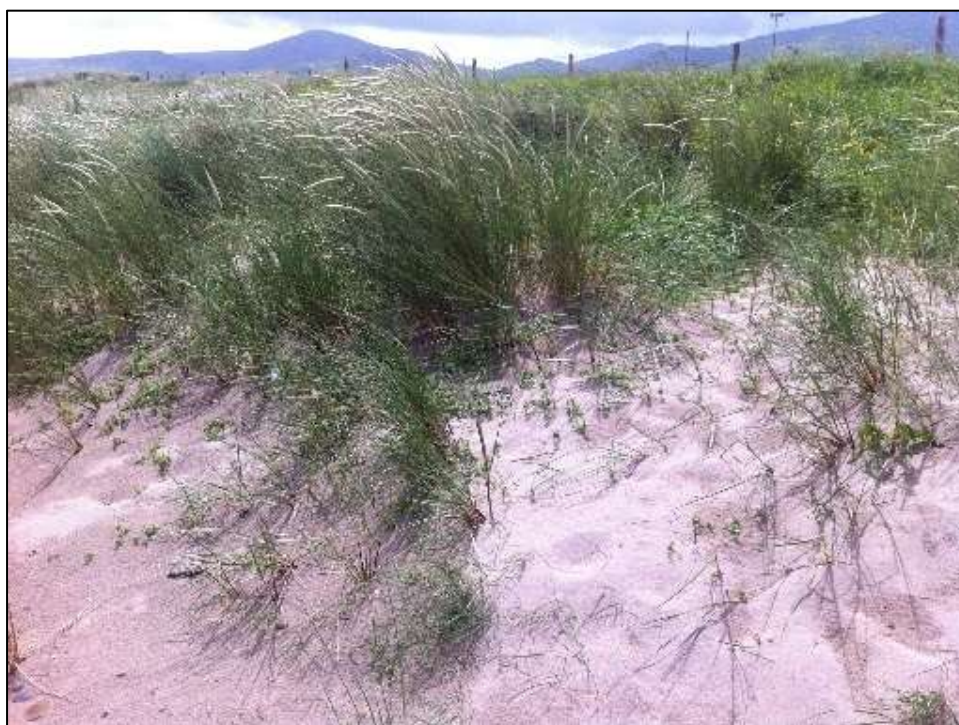
Figure 3.11 Vegetation growing on developing dunes to the east of the car park at Castlegregory beach

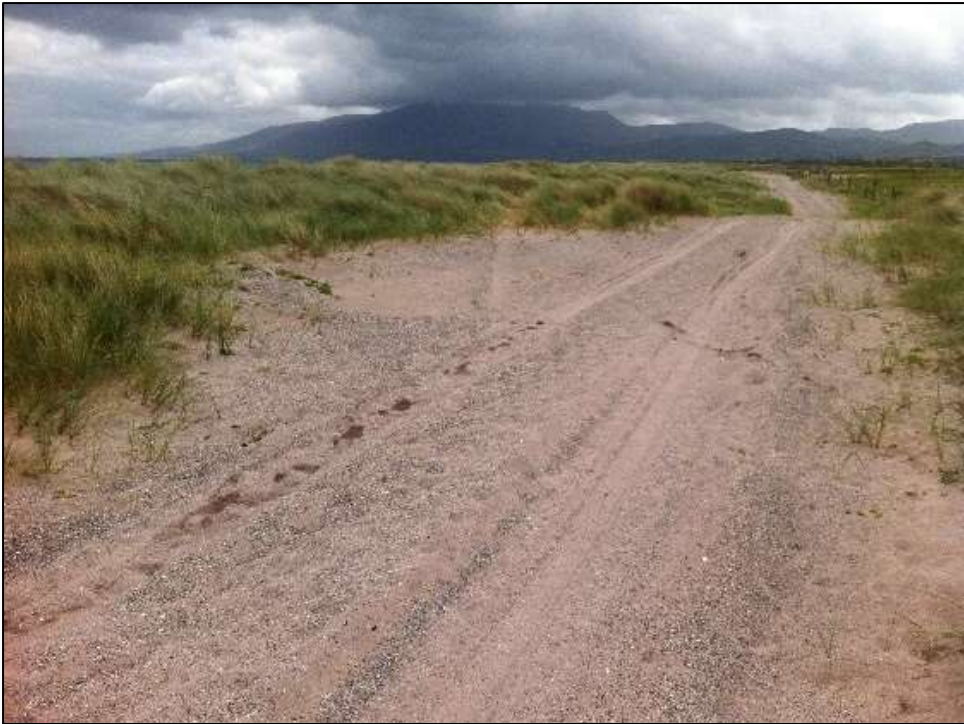
Figure 3.12 The sandy track to the rear of the dunes and east of the car park at Castlegregory beach

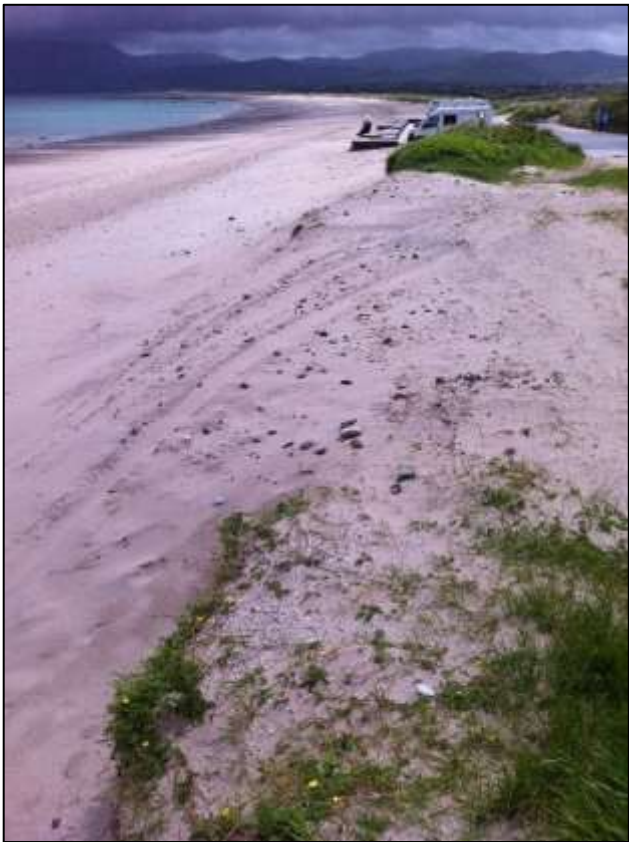
Figure 3.13 Retaining wall at car park and access track to beach on western side of the car park on Castlegregory beach. Tyre tracks are evident in the foreground. This access is to farmland along the beach.

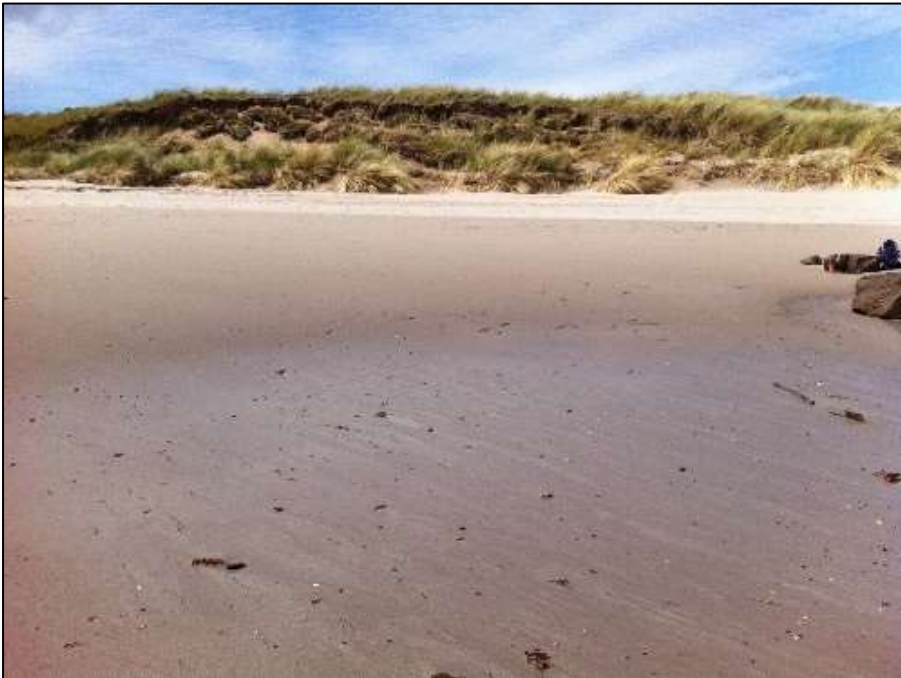
Figure 3.14 Dune erosion on Castlegregory beach

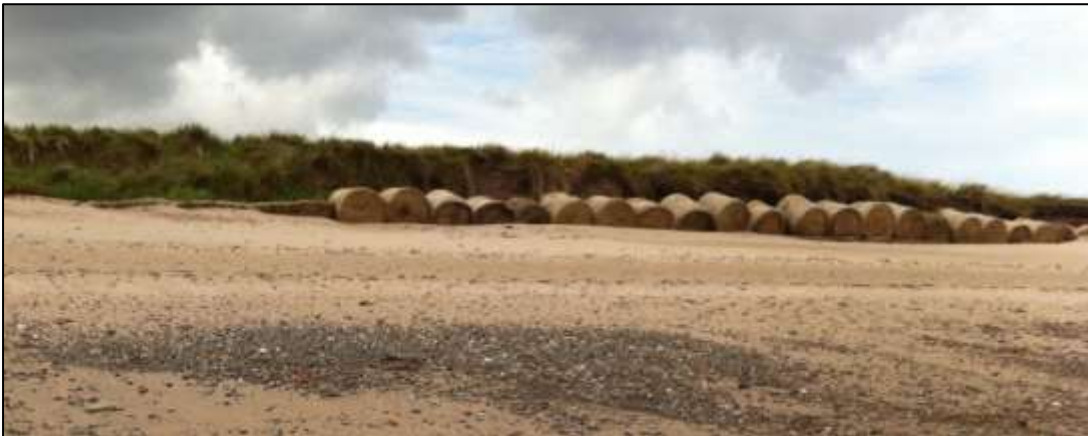
Figure 3.15 Bales being used to manage erosion of dunes on Castlegregory beach

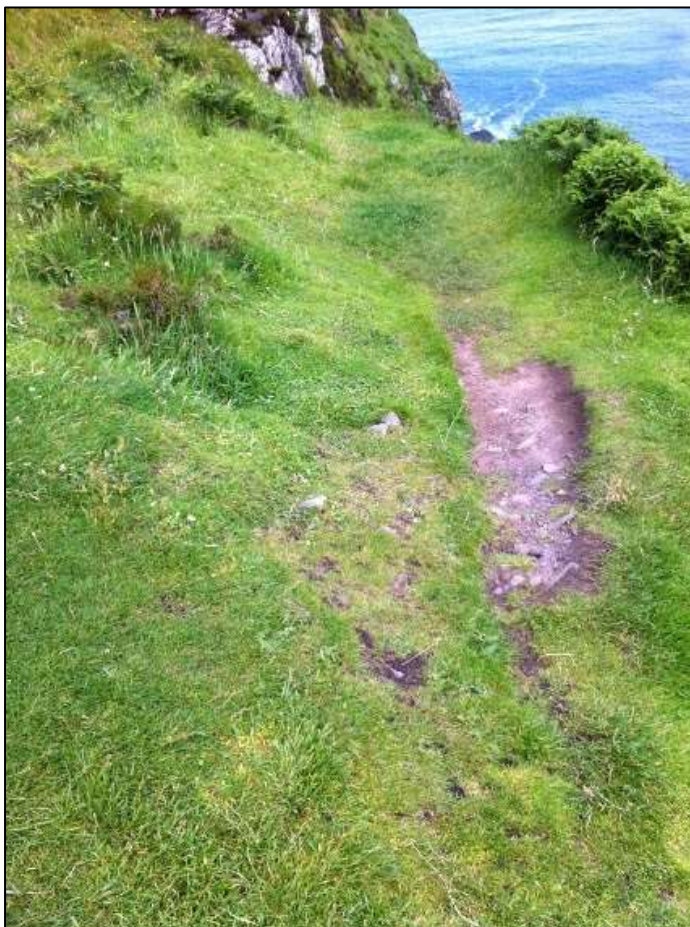
There is marked erosion of vegetation and soils in a few places along the cliff ledges adjacent to the car park. This damage is limited in extent.

Figure 3.18 Vegetation loss and soil erosion on cliff ledges at Brandon point, adjacent to the car park

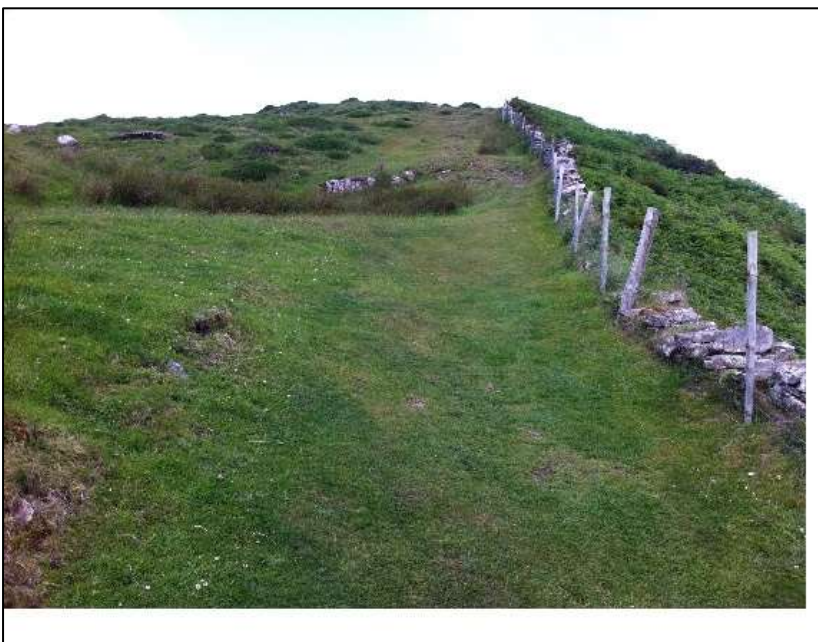
Figure 3.20 Track running uphill from car park at Brandon Point. As the track narrows soil is exposed

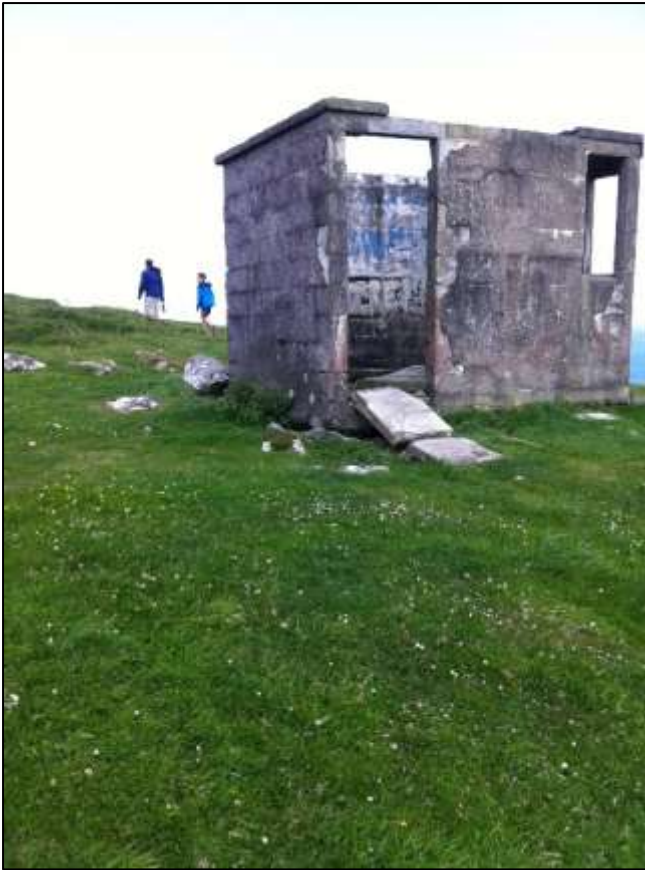
The observation tower is in poor condition; a slab of the roofing material has collapsed onto the floor of the building.

Figure 3.21 Observation building at Brandon point, the roof has collapsed in and the structure is in poor condition

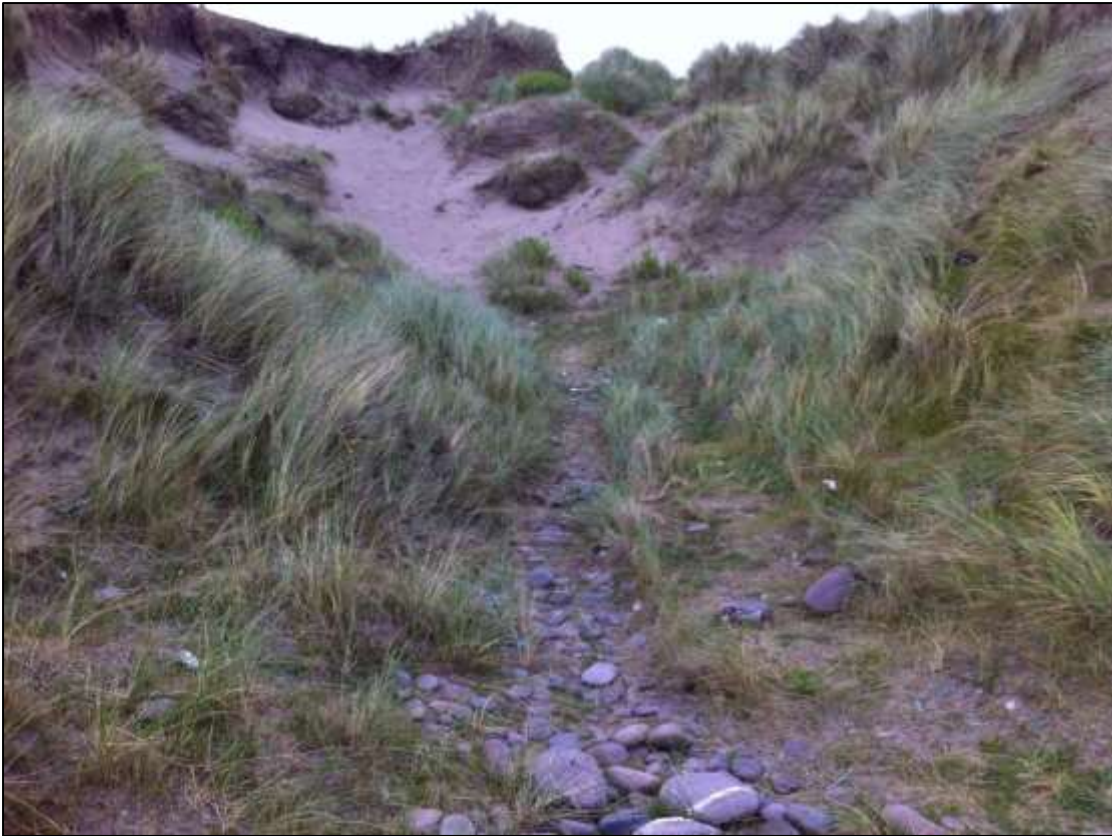
Figure 3.24 Blowout fronting beach at Rossbeigh

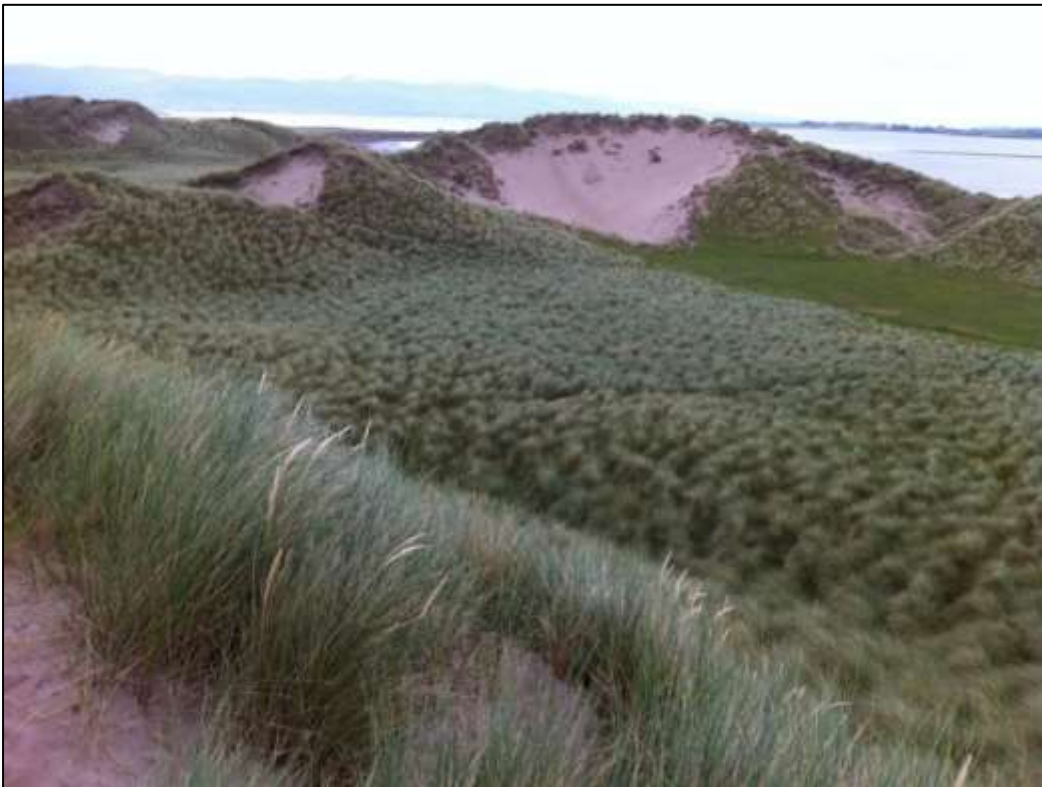
Figure 3.25 Blowouts in the dune system at Rossbeigh, these could derive from eroded dune ridges

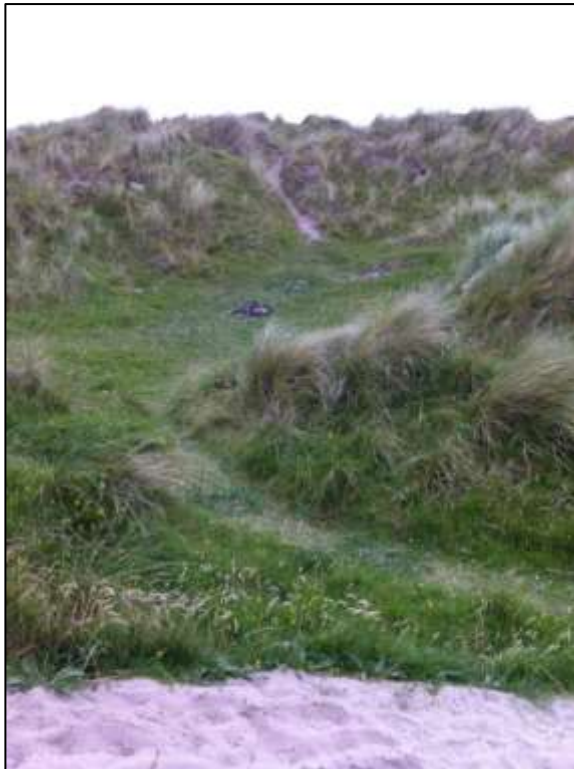
Figure 3.26 Three fire sites in the dunes

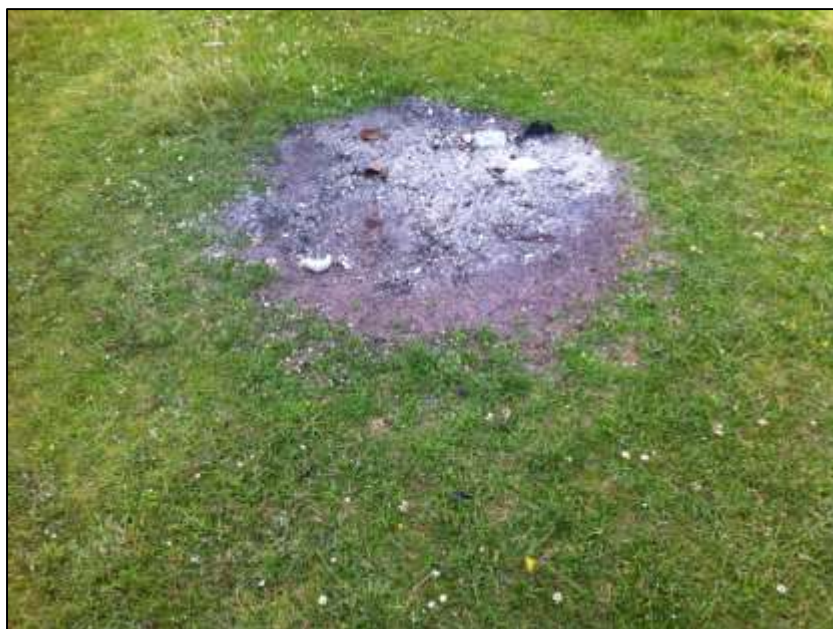
Figure 3.27 Fire in grassland within dunes

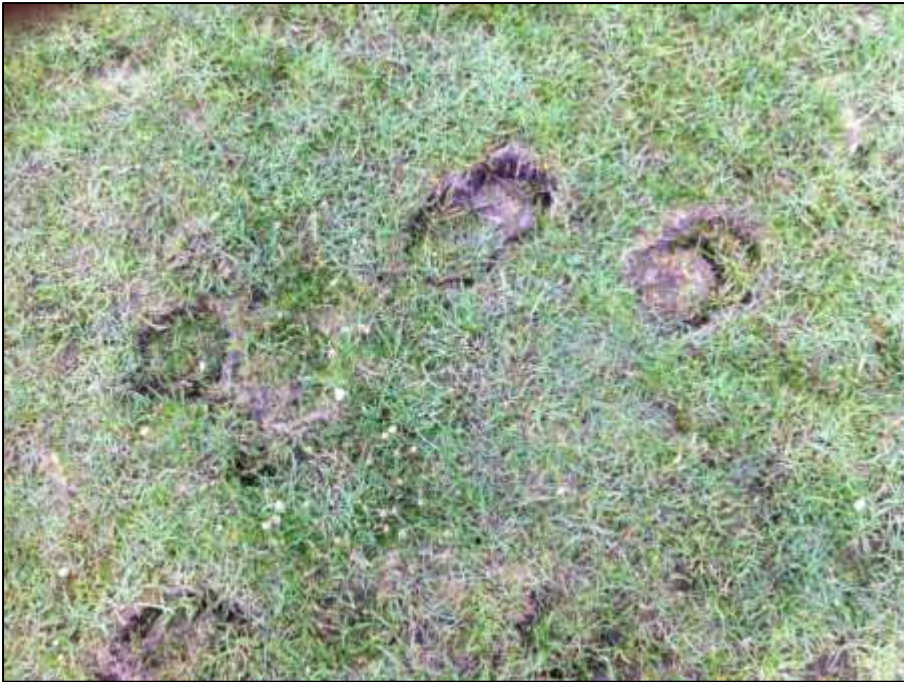
Figure 3.28 Shoe marks from pony trekking in salt marsh

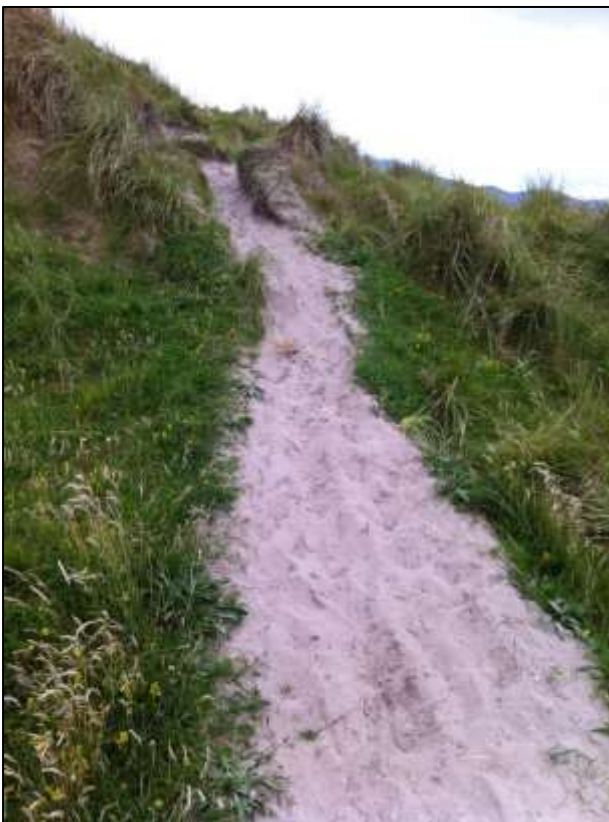
Figure 3.29 Exposed sand along flank of dune ridge

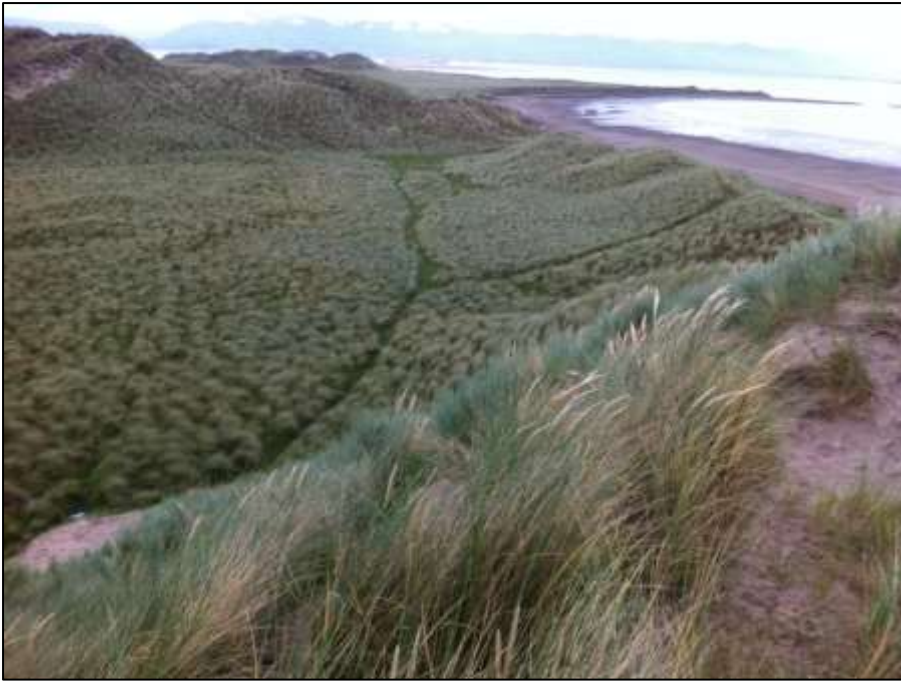
Figure 3.30 Network of trails through dunes and on to beach at Rossbeigh

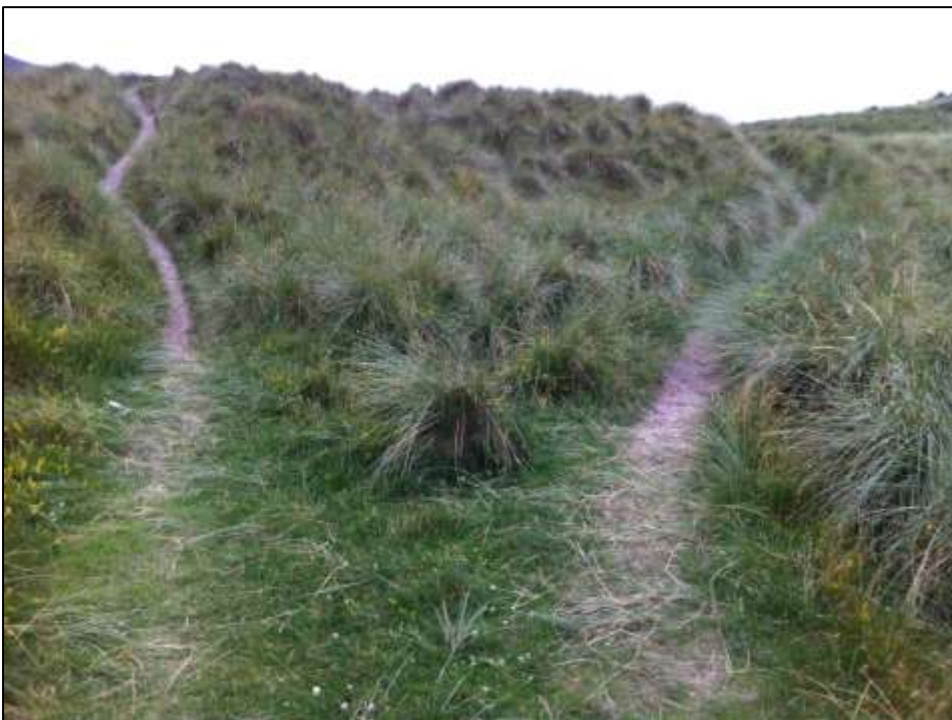
Figure 3.31 Details of trails through dunes at Rossbeigh, grass eroding and giving way to exposed sand particularly on sloping ground

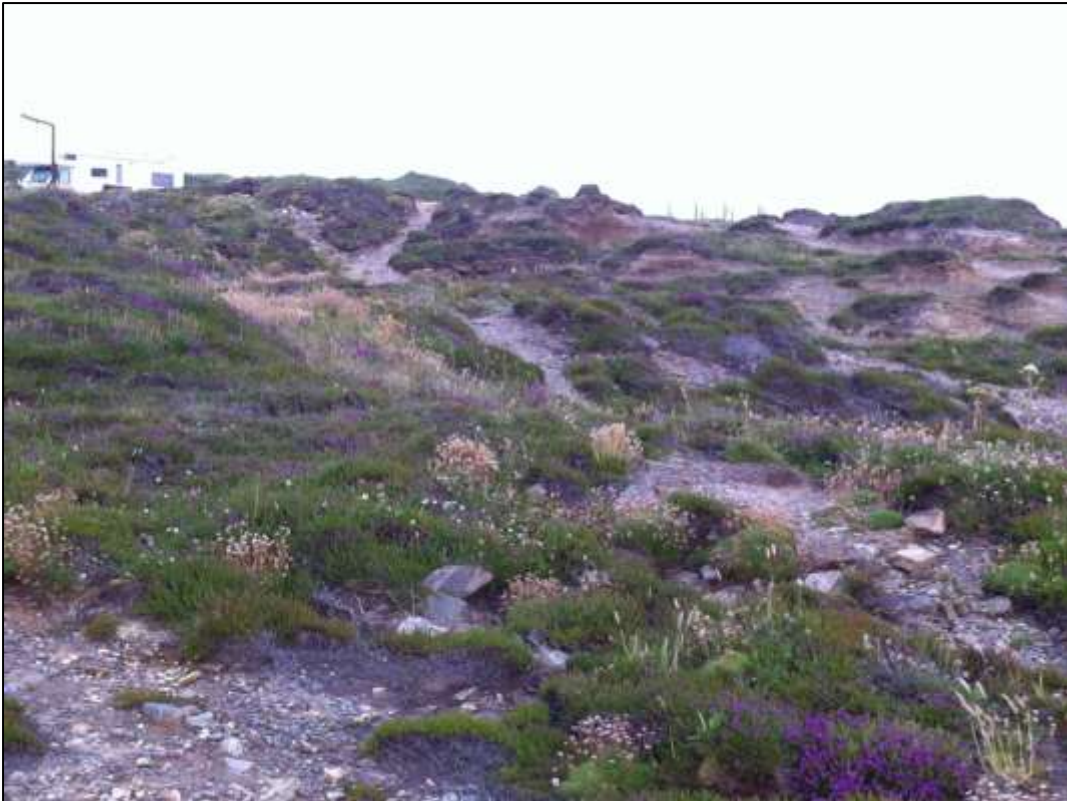
Figure 3.35 Network of tracks, exposed spoil and vegetation at Dooneen

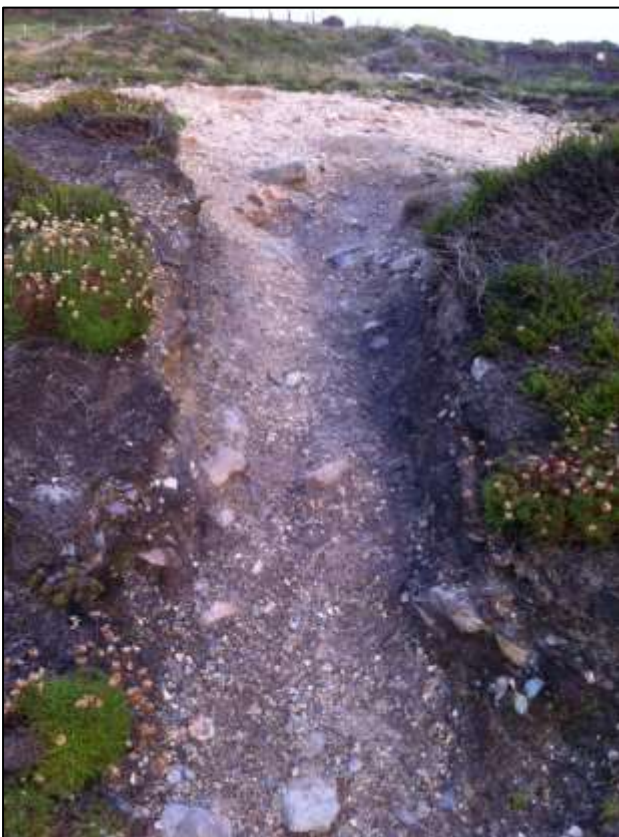
Figure 3.36 Deeply eroded gully at Dooneen, rain, running water and trampling

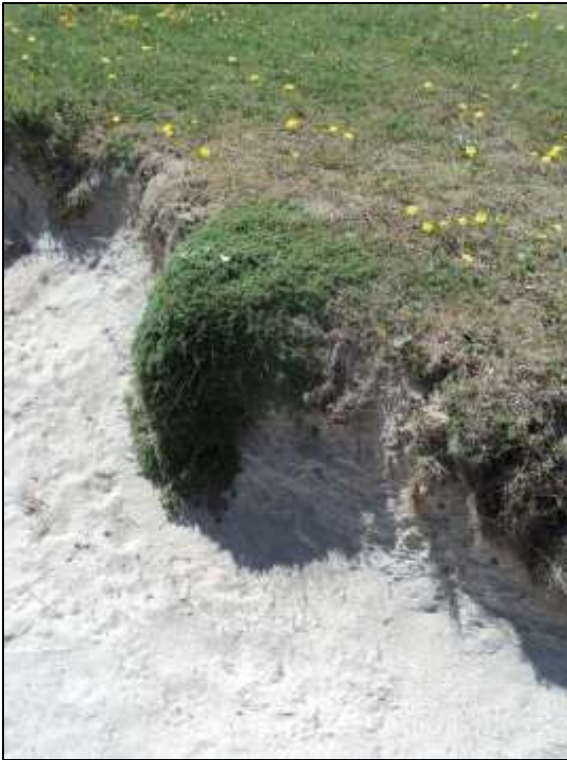
Figure 3.40 Erosion at edges of walkway, may have been happening prior to installation of walkway at Barley Cove

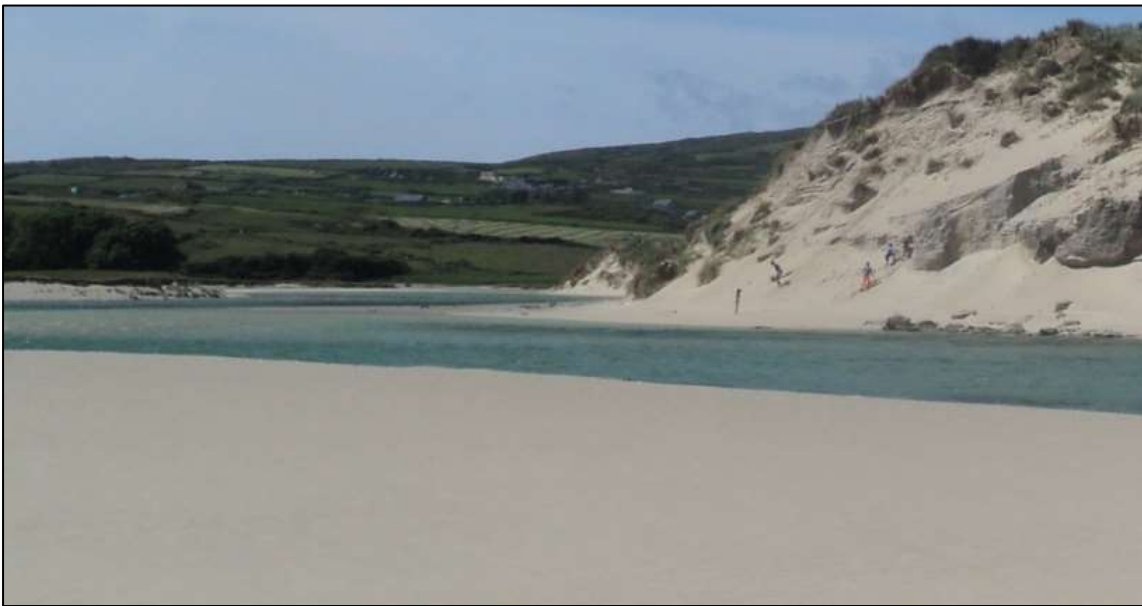
Figure 3.43 'Play' on the face of a dune, erosion from tidal action and play may be causing vegetation loss

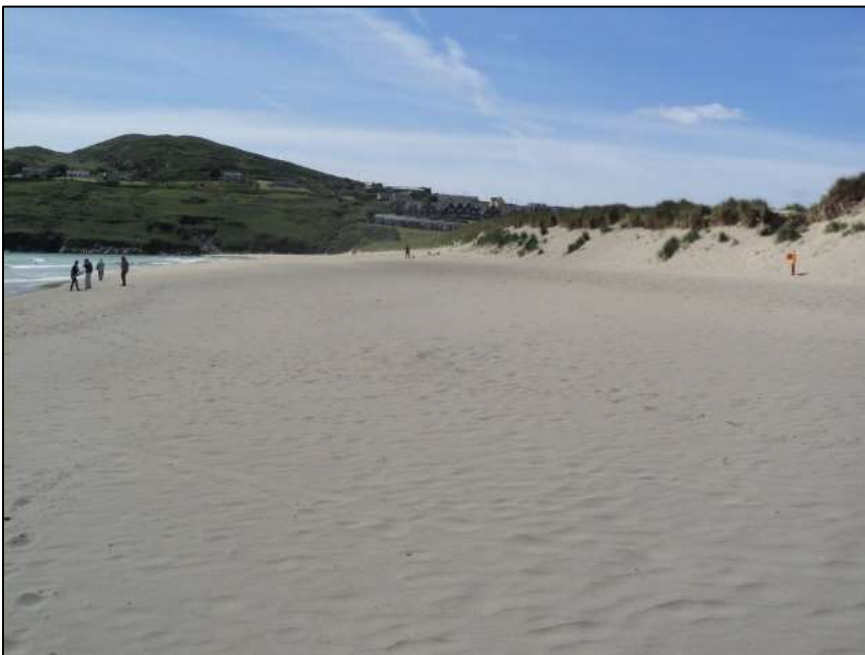
Figure 3.45 The beach at Barley Cove with evidence of vegetation loss on faces of fore dunes.

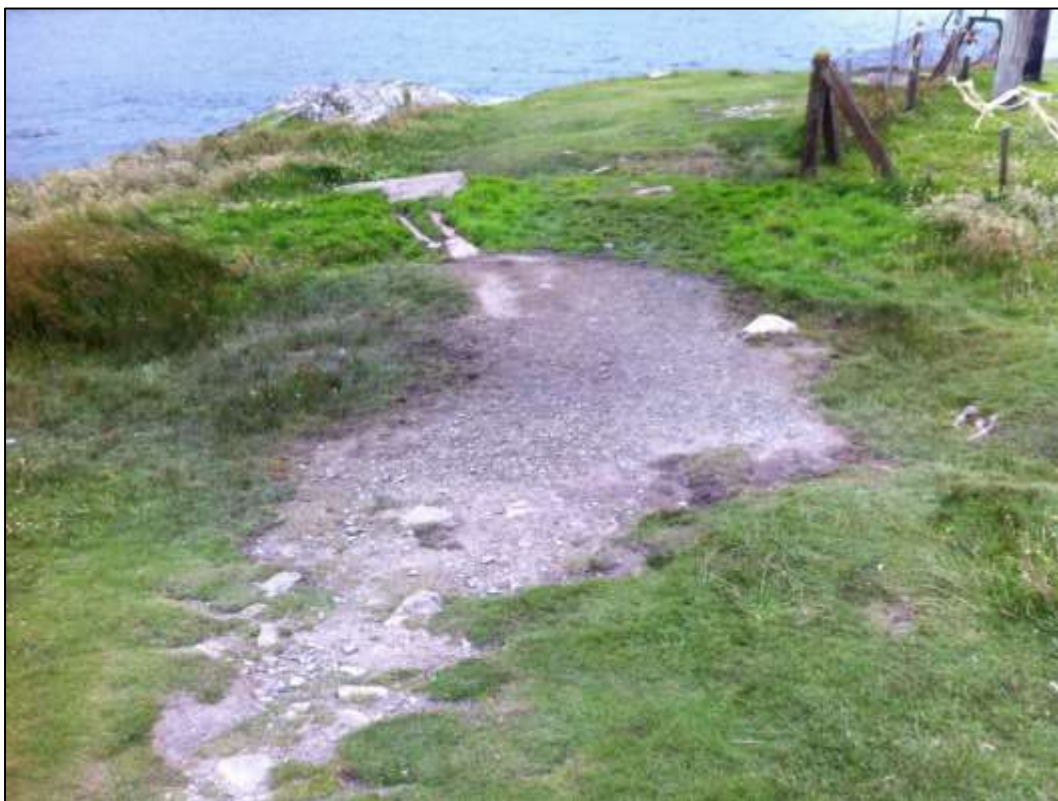
Figure 3.48 Erosion of grass cover and exposure of underlying soil at Garnish

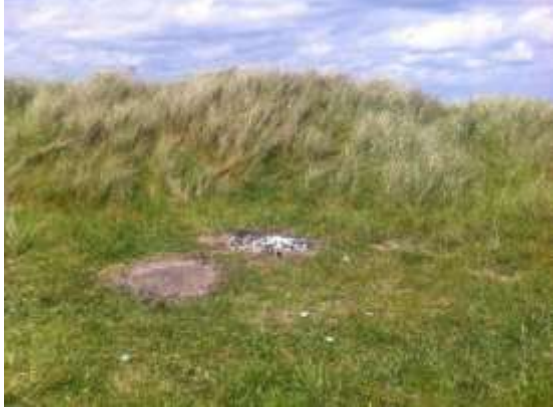
<p>Rossbeigh, Co Kerry</p>	<p>Soil erosion, natural slippage/movement of soil and erosion of vegetation and soil on track. Impact is caused by long established patterns of visitor activity. No other cause was evident.</p>	<p>This site is part of a secondary Zone and is not at the location of the signage.</p>
 	<p>Rossbeigh, Co Kerry</p>	<p>Exposed sand and trails through dunes at Roissbeigh, Co Kerry. Fire sites in the grassy area between dunes</p>	<p>Visitor information could warn users of threats to vegetation from fires</p>
 	<p>Rossbeigh, Co Kerry</p>	<p>Blowouts in dune complex.</p>	<p>These blowouts could have developed from tracks along dune ridges that exposed sand to wind action</p>

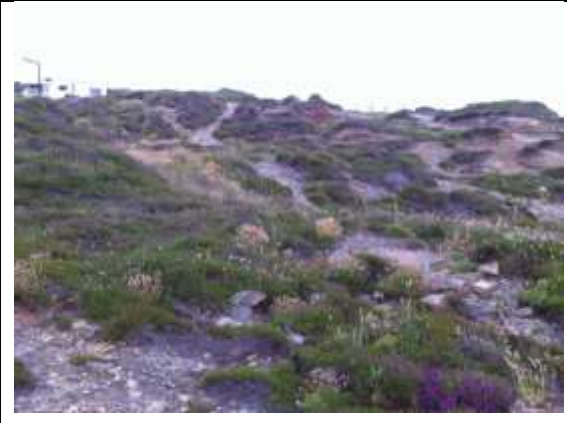
<p>Dooneen, Co Cork</p>	<p>Tracks through vegetation at Dooneen expose underlying spoil. The vegetation is growing on a poorly developed soil and mine spoil and so vulnerable to trampling from visitors accessing cliff edge</p>	<p>The tracks are relatively robust. Runoff following rain may be deepening some tracks.</p>

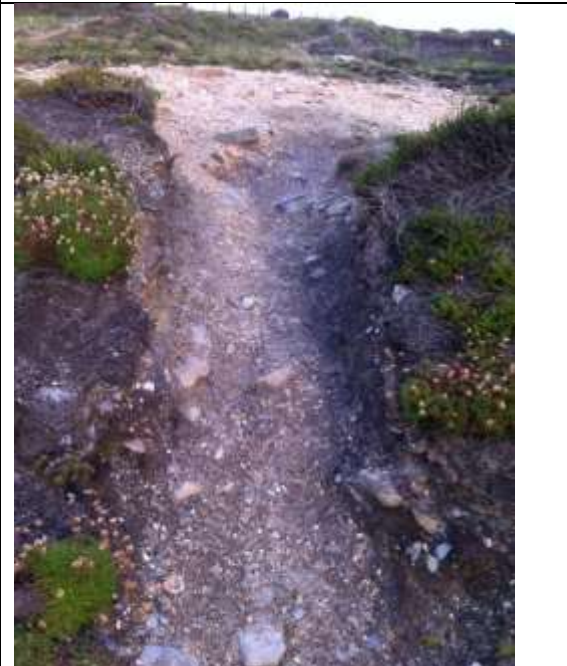
<p>Dooneen, Co Cork</p>	<p>Path evolution, vegetation change, loss, exposure of underlying soil, widening of track. Impact is mainly caused by visitor activity to a plant community on a poorly develop soil</p>	<p>Visitors could be guided through this site with one key track to a viewing platform at the cliff.</p>
