NATIONAL TOURISM MONITORING PROGRAMME 2021-2025

ANNUAL RESULTS FOR 2021

ACRES LAKE FLOATING BOARDWALK

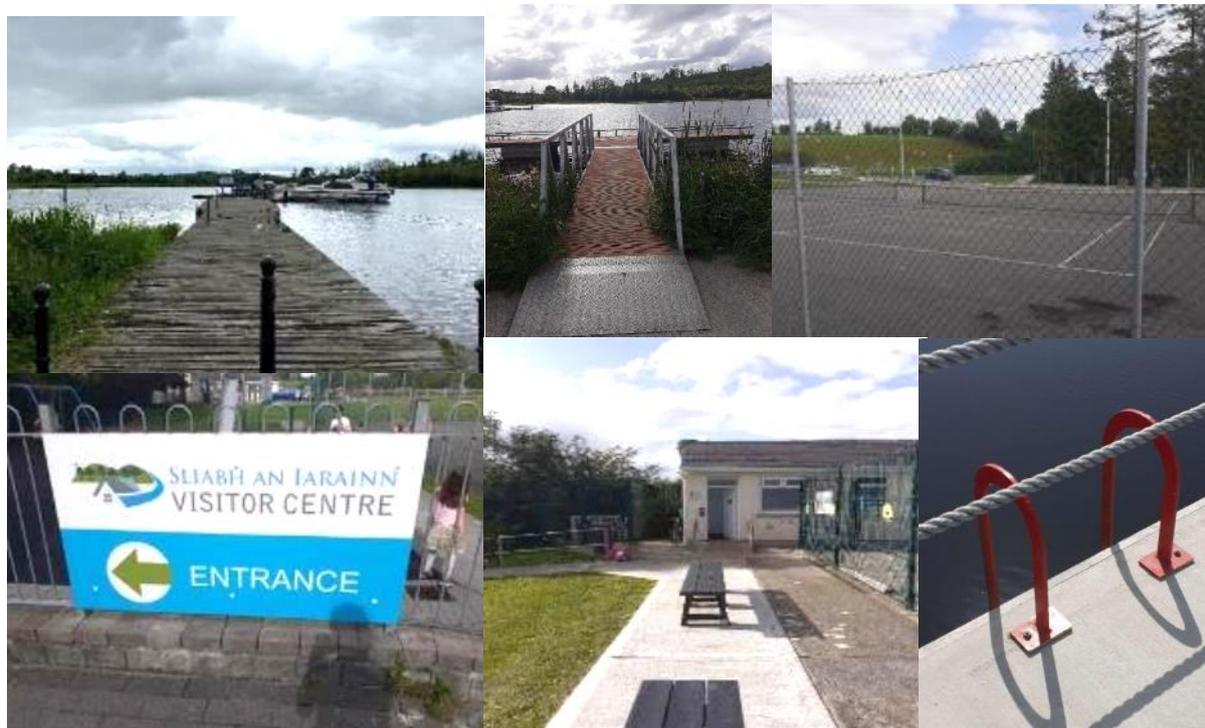
Figure 1.1 Montage of some of the features at Acres Lake Floating Boardwalk

The site is host to leisure facilities such as tennis courts, a visitor centre and an outdoor pool. There are a number of jetties and mooring features on the site.

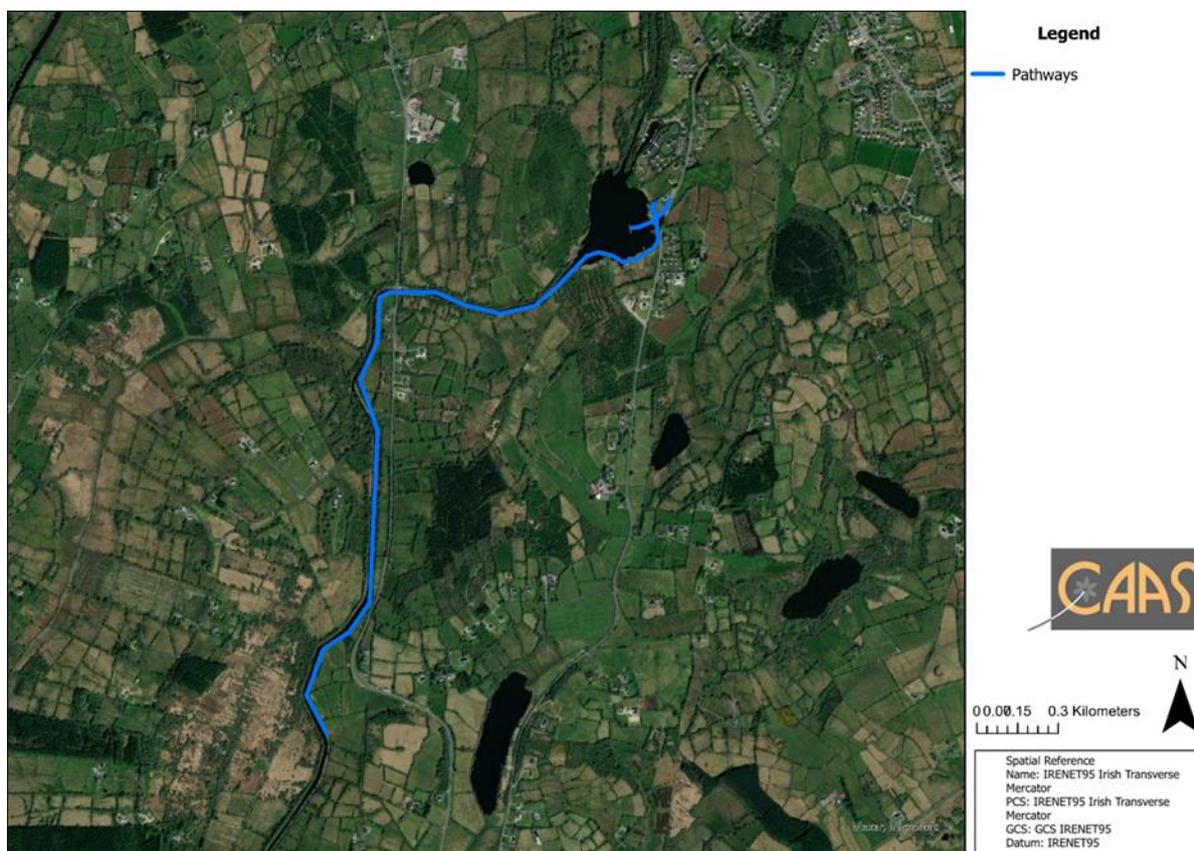
Figure 1.2 Pathways identified at Acres Lake Floating Boardwalk

The path is perfectly maintained – the full site is a guarded boardwalk which is all hard infrastructure. The material and dimensions are consistent throughout (Figure 1.2 & Figure 1.3).

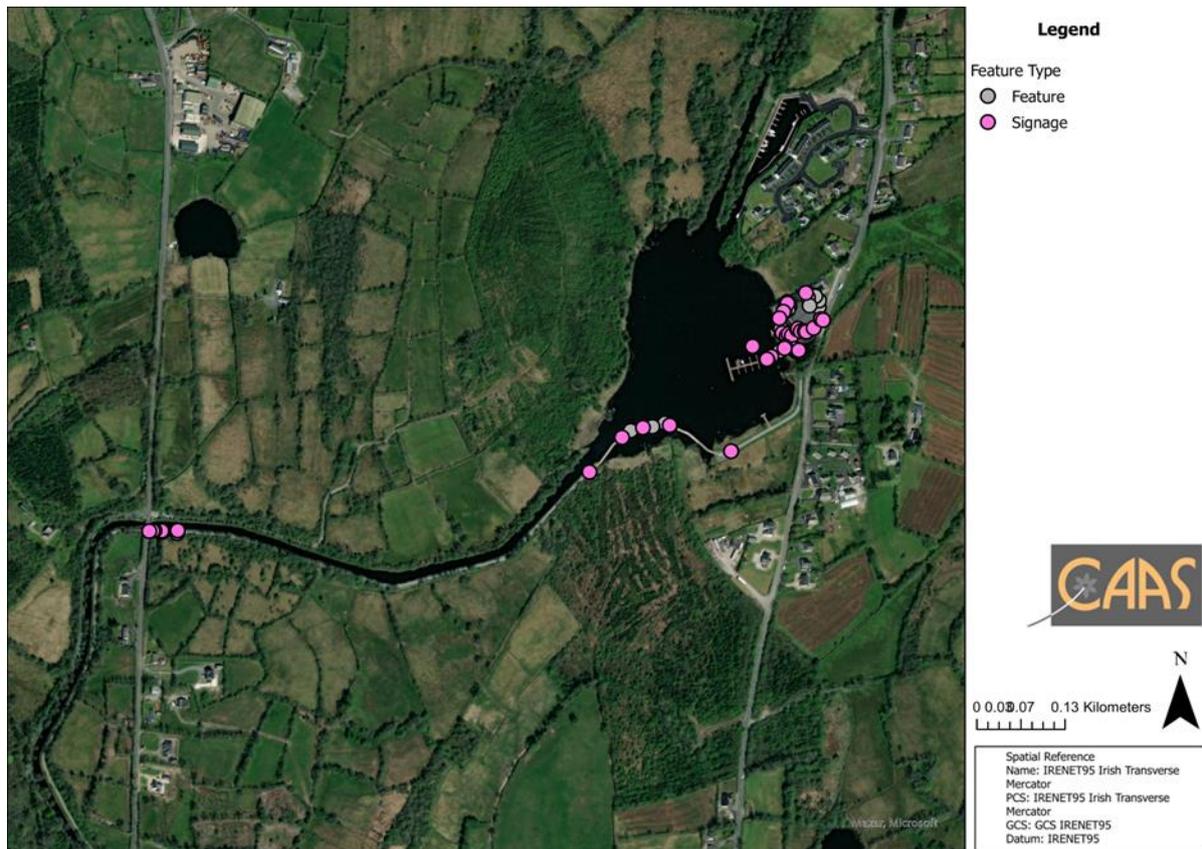
Figure 1.4 Features recorded at Acres Lake

There are many signs and tourism features on site (Figure 1.4). There is an on-site visitor centre and playground with an associated outdoor swimming pool and toilet facilities. The main attractions are the jetty pier and the boardwalk itself. The signage mainly related to safety warnings, but there are signs identifying features of the Shannon Blueway, as well as a sign detailing information about Drumshambo and a wider trail map (Figure 1.5). There is minimal information about the wildlife or biodiversity of the area – mainly focusing on common duck species.

The site has a carpark capacity issue as it has very few spaces available to ensure accessibility. Efforts should be made to explore options for increasing the capacity. Additionally, engaging interpretive material should be provided across the site to activate an interactive and educational experience.

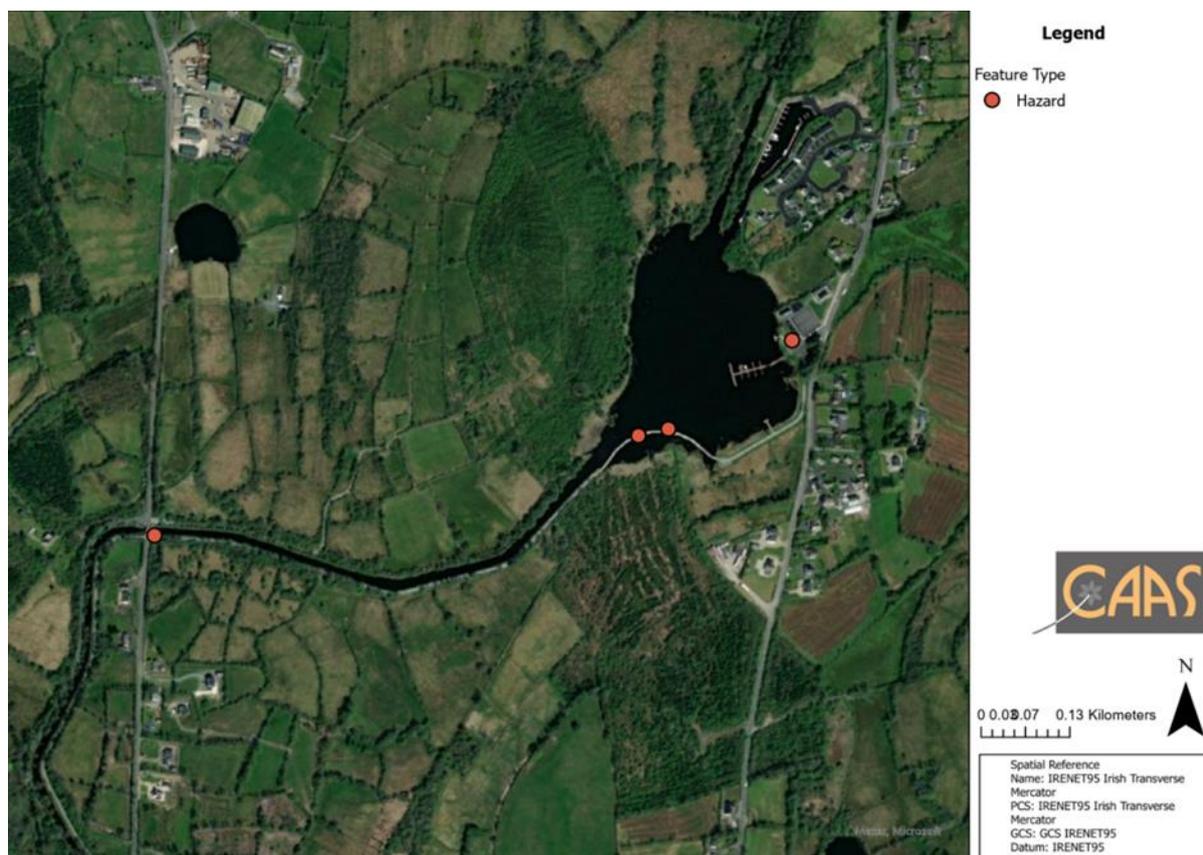
Figure 1.6 Hazards recorded at Acres Lake

The hazards identified on site (Figure 1.6) relate to slippery surfaces which are accompanied throughout the site with signs alerting visitors to the potential for hazards such as slippery surfaces.

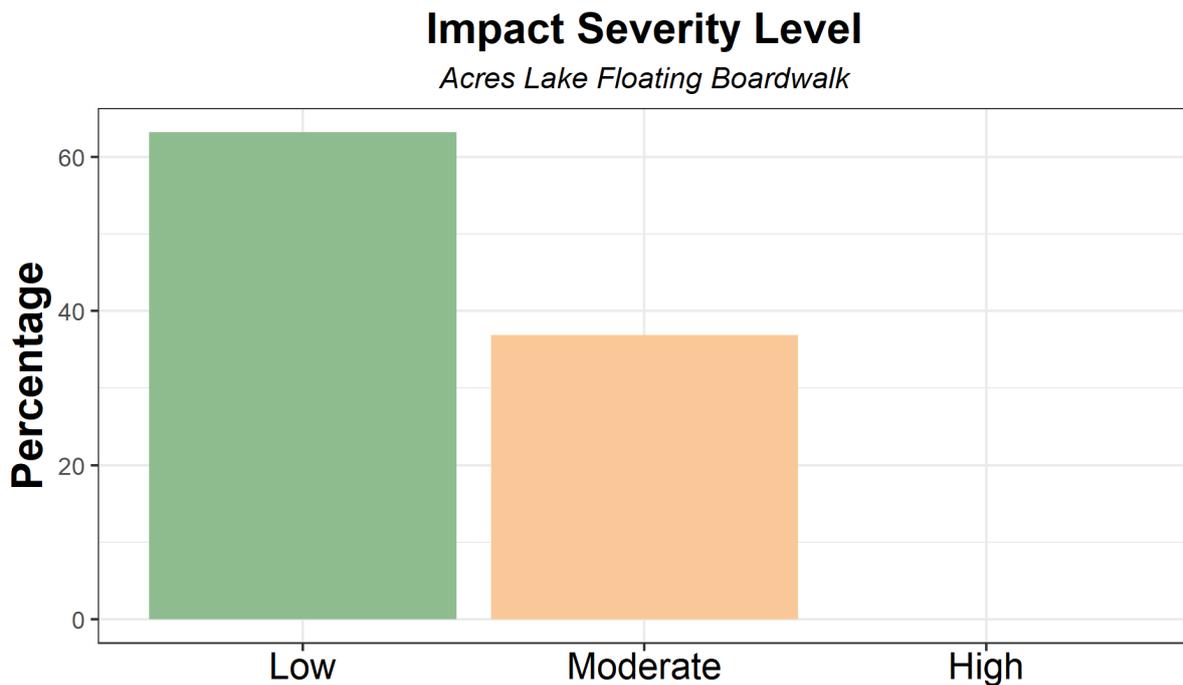
Figure 1.14 Categories of Environmental Impact Levels Observed at Acres Lake Floating Boardwalk as a result of Visitor Activities³

³ Impact severity was measured as a categorical variable which has a range of impact factors that are pre-determined; such as injuring, killing or taking wildlife as a severe impact (high) and temporary disturbance of wildlife being a low impact. These are explained fully in the method section above.

Of the 82 sample groups recorded on site 67% of them undertook activities other than walking. These activities (identified above) resulted in 19 impacts being observed on site during the survey. Thus, 33% of activities on site resulted in impacts on the environment. The impact severity levels varied with 63% of the impacts being low, 37% of impacts being moderate, and 0% of impacts being high severity. The impacts identified for the site were:
