NATIONAL TOURISM MONITORING PROGRAMME 2021-2025

ANNUAL RESULTS FOR 2021

FANAD

CAAS Ltd.

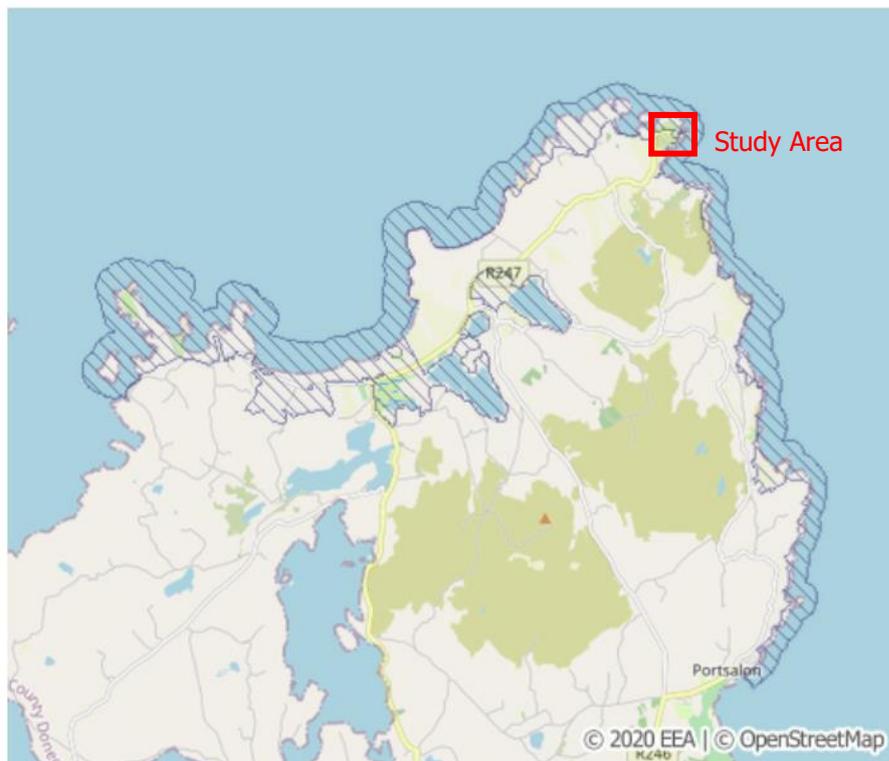
Figure 1.2 Study Area within Ballyhoorisky Point to Fanad Head SAC

Centred on Fanad Lighthouse, this Discovery Point also directs visitors to views and trails along the rocky Atlantic shore. The site is contained within both the Ballyhoorisky Point to Fanad Head SAC along with the Horn Head to Fanad Head SPA and contains large areas of dry siliceous heath.

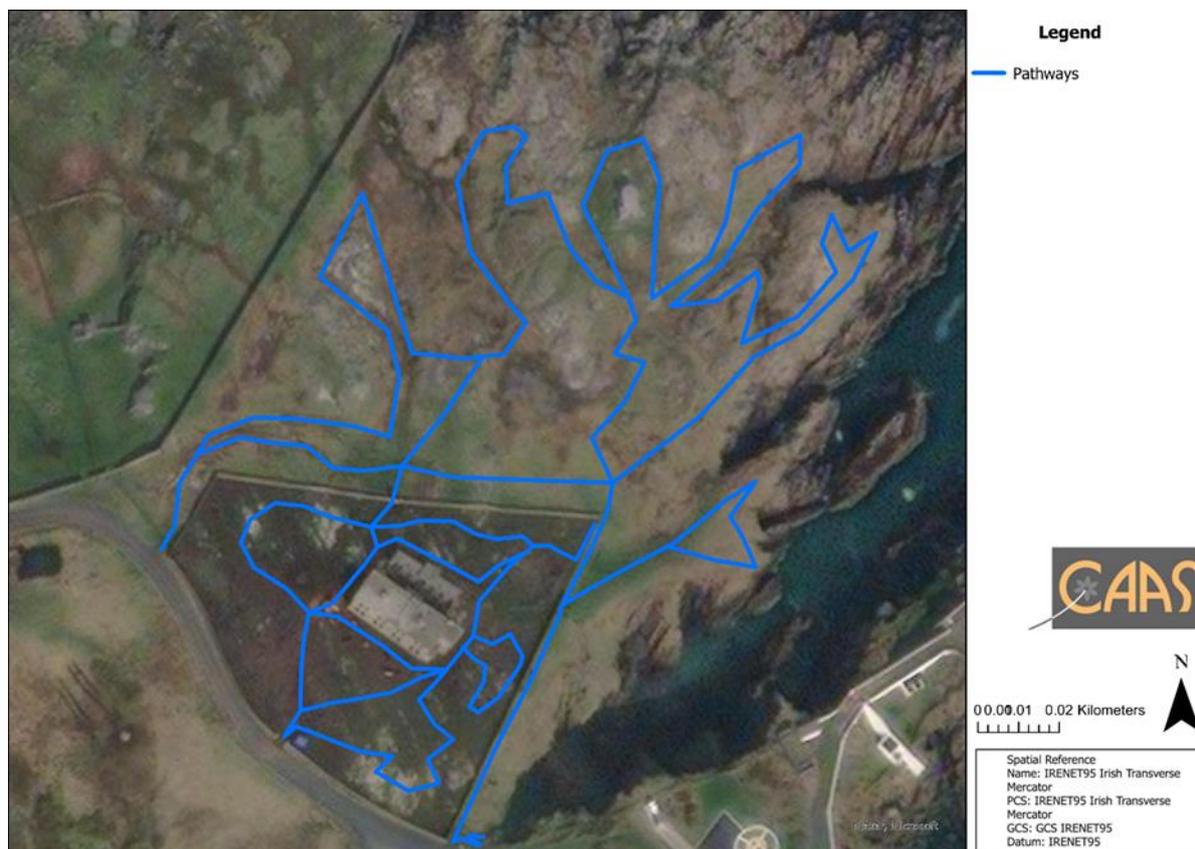
Figure 1.3 Pathways identified at Fanad

Due to the small size and complex surfaces at this site there are not many designated pathways. There is a road (Figure 1.4) at the site along with highly varied soft infrastructure pathways and desire lines, which have seen compaction to the soil due to use of vehicles and a large number of walkers in the area.

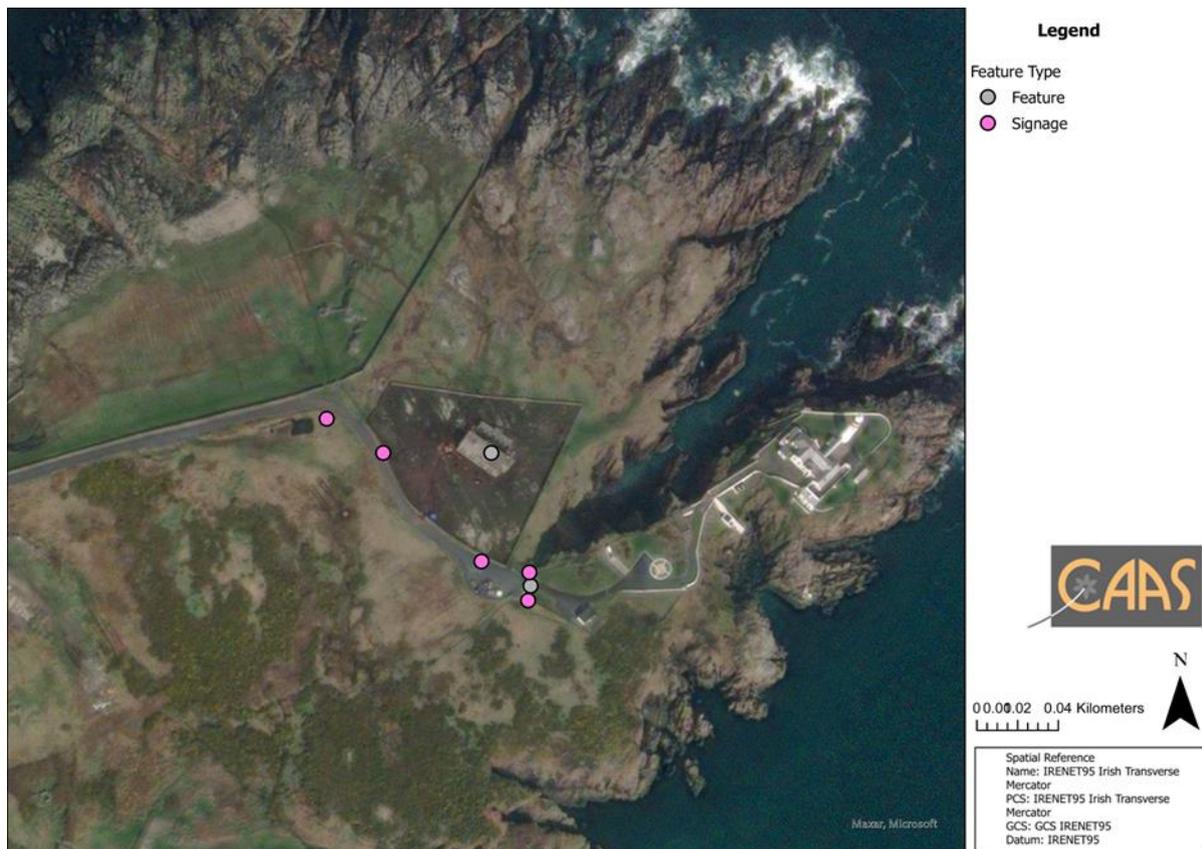
Figure 1.5 Features recorded at Fanad

At Fanad, there are various tourism signage, including information signs giving information on the surrounding area and trails as well as road signs and a sign designating Fanad as part of the Wild Atlantic Way (Figure 1.6). Along with the noted lighthouse, there are also abandoned buildings in the area. In terms of amenities, there is a Visitor Centre, car park, toilets and cafe.

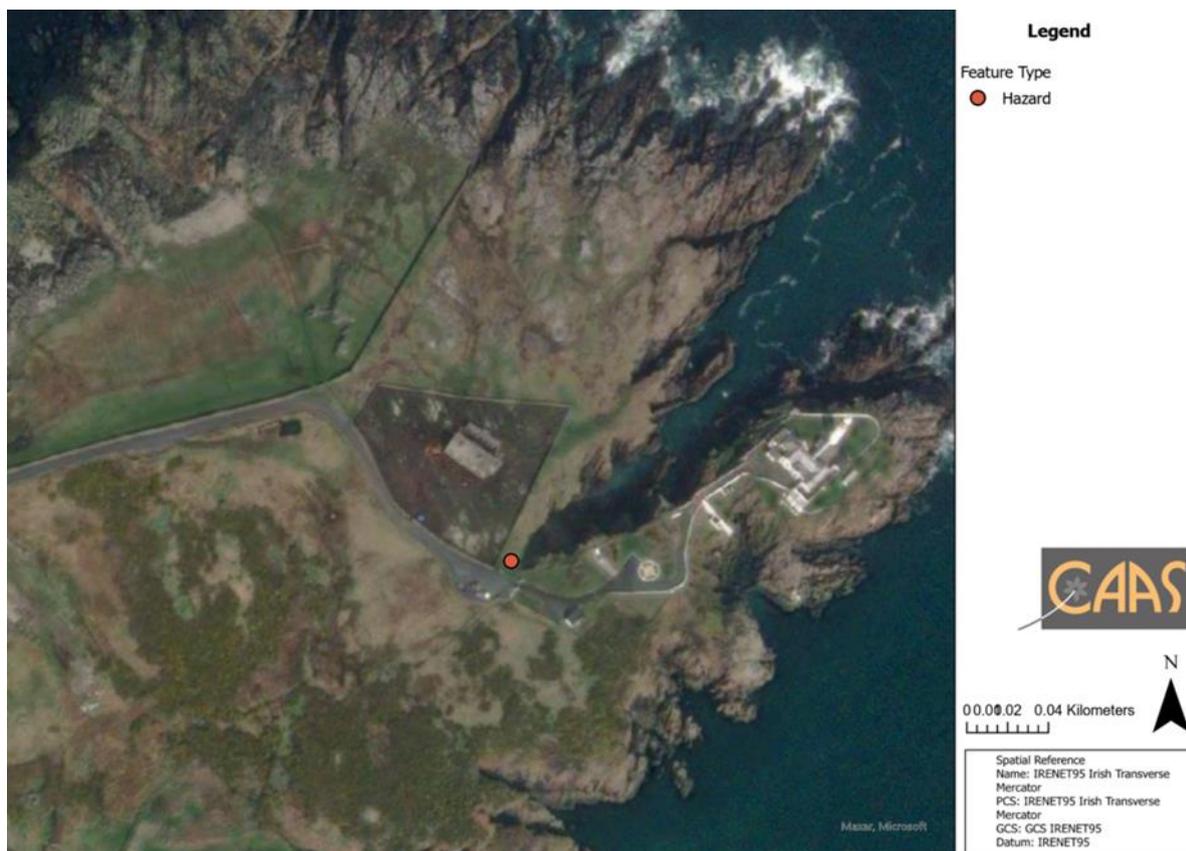
Figure 1.7 Hazards recorded at Fanad

In terms of hazards, it was noted that a broken fence led to an unprotected cliff edge (Figure 1.8) that showed signs of regular activity. This was the only hazard that was recorded during habitat mapping.

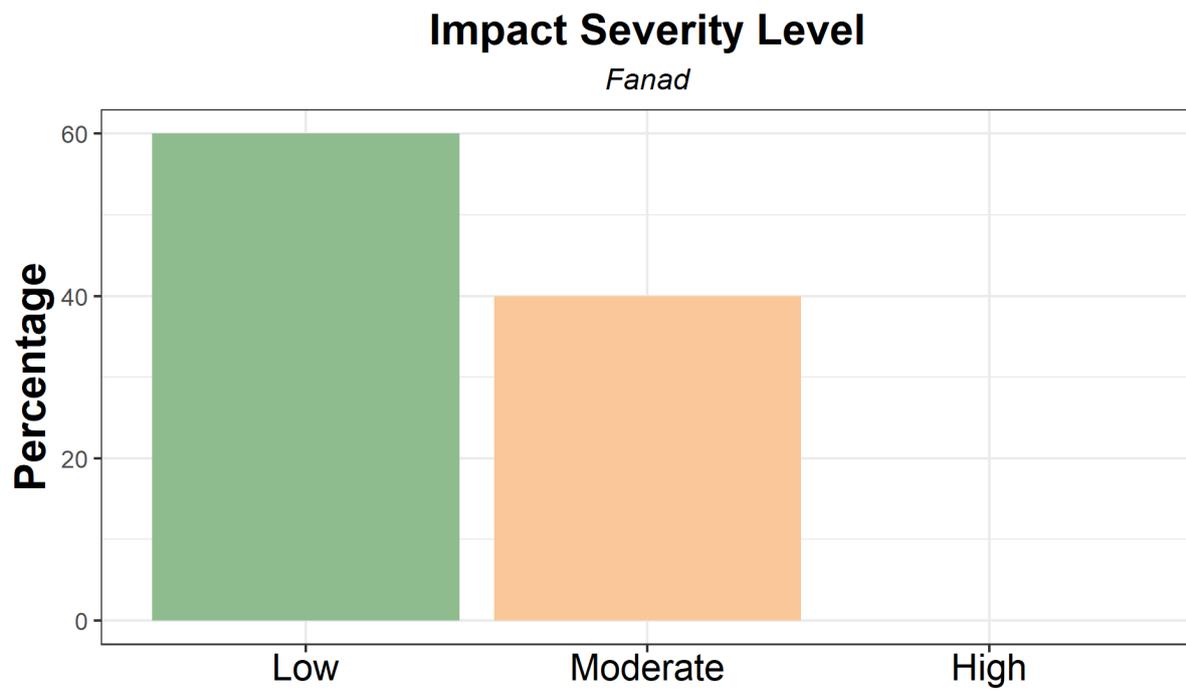
Figure 1.16 Categories of Environmental Impact Levels Observed at Fanad as a result of Visitor Activities

Of the 86 groups recorded on site 45% of them undertook activities other than walking. These activities (identified above) resulted in 5 impacts being observed on site during the survey. Thus, 13% of activities on site resulted in impacts on the environment. The impact severity levels varied with 60% of the impacts being low, 40% of impacts being moderate, and 0% of impacts being high severity. The impacts identified for the site were:

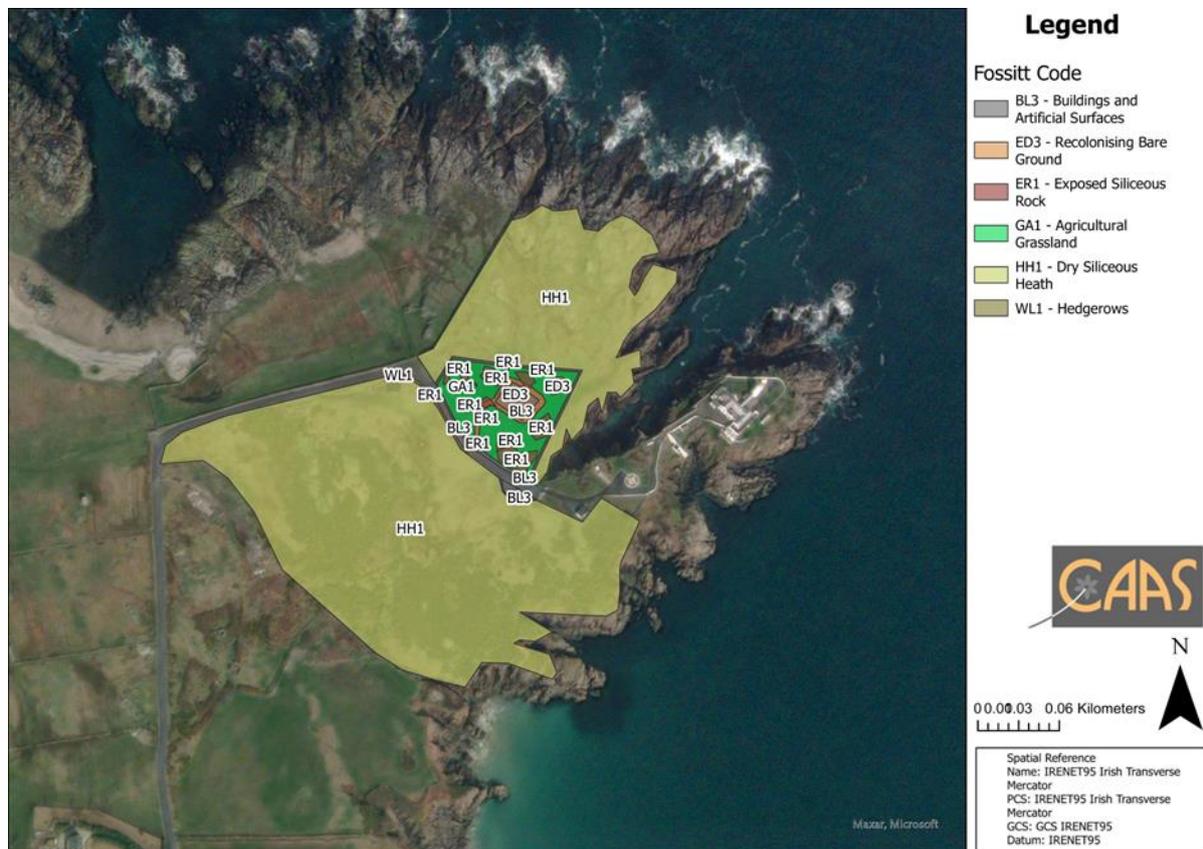
Figure 1.19 Habitats present at Fanad

The habitats of Fanad are mainly made up of areas of dry siliceous heath (Fossitt Code HH1), which align with the special conservation interests for which the SPA, Horn Head to Fanad, is designated as it is suitable foraging habitat for these species. The more managed part of Fanad, the lighthouse and the immediate surrounding area contains more managed habitats such as agricultural grassland (Fossitt Code GA1).

There is a network of desire lines through the heathland to the north of the roadway where there is visitor access. The area to the south is fenced off with no authorised access to visitors. The desire lines to the north have mild compaction and show indications of low visitor numbers.
