NATIONAL TOURISM MONITORING PROGRAMME 2021-2025

ANNUAL RESULTS FOR 2021

STREEDAGH BEACH

CAAS Ltd.

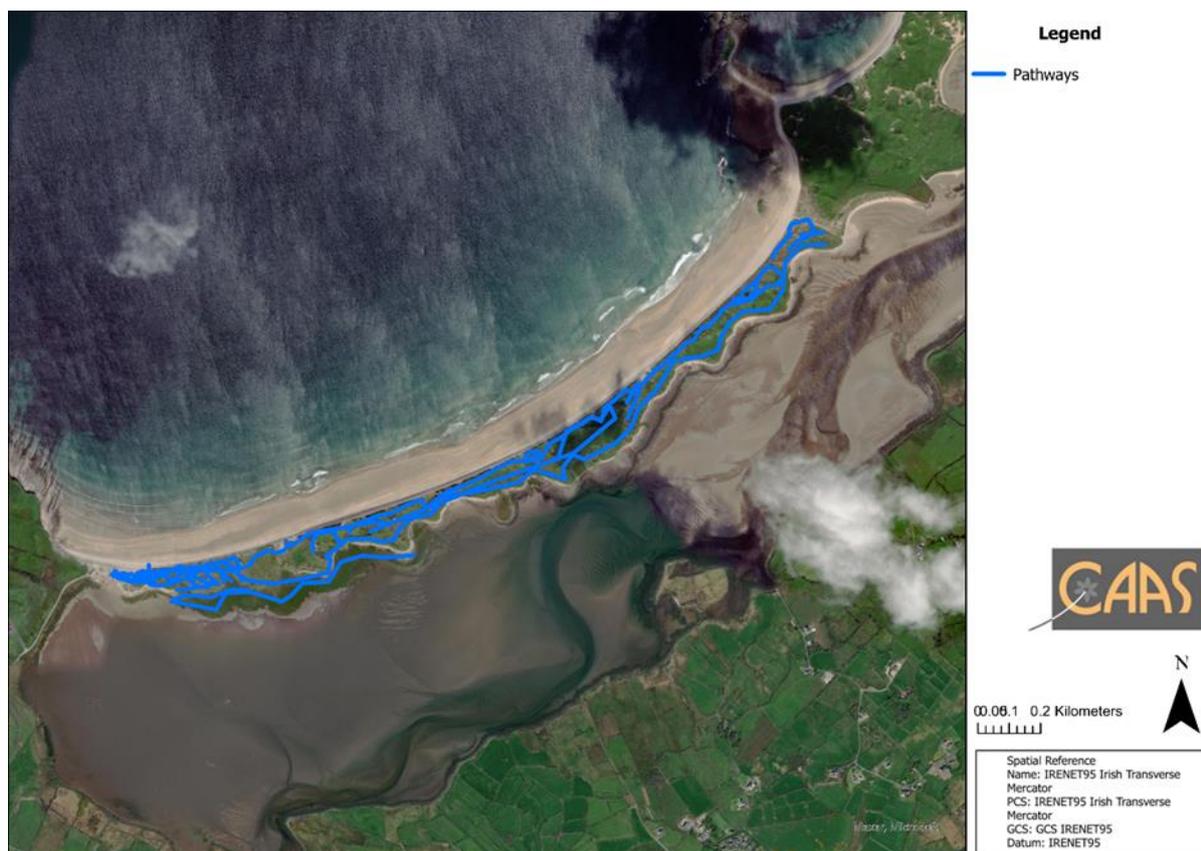
Figure 1.3 Pathways identified at Streedagh Beach

Most of the main paths at Streedagh Beach are confined to an area within 250m of the paved road access point and the loosely organised – but unedged parking area that intrudes at busy times onto muddy sand and saltmarsh areas. There is occasional and slight evidence of paths or trails for remaining 2km of the beach length.

There are various degrees of pathways formation which show various levels of compaction and damage caused by walkers and vehicles in this restricted area.

- The density of trails is extremely high, if very localised, but all other habitats off-trail are relatively undisturbed. Efforts should be made to consolidate the trails on site.
- A dynamic path management system could alleviate the pressures which are occurring along with a habitat restoration plan for closed trails in highly affected areas.
- There should be an examination of how to improve the existing parking management system which appears to be ineffective due to movable barriers.
- Engaging interpretive material is required to increase visitor awareness of the importance of dunes and the damage to habitats caused by extensive trail networks.

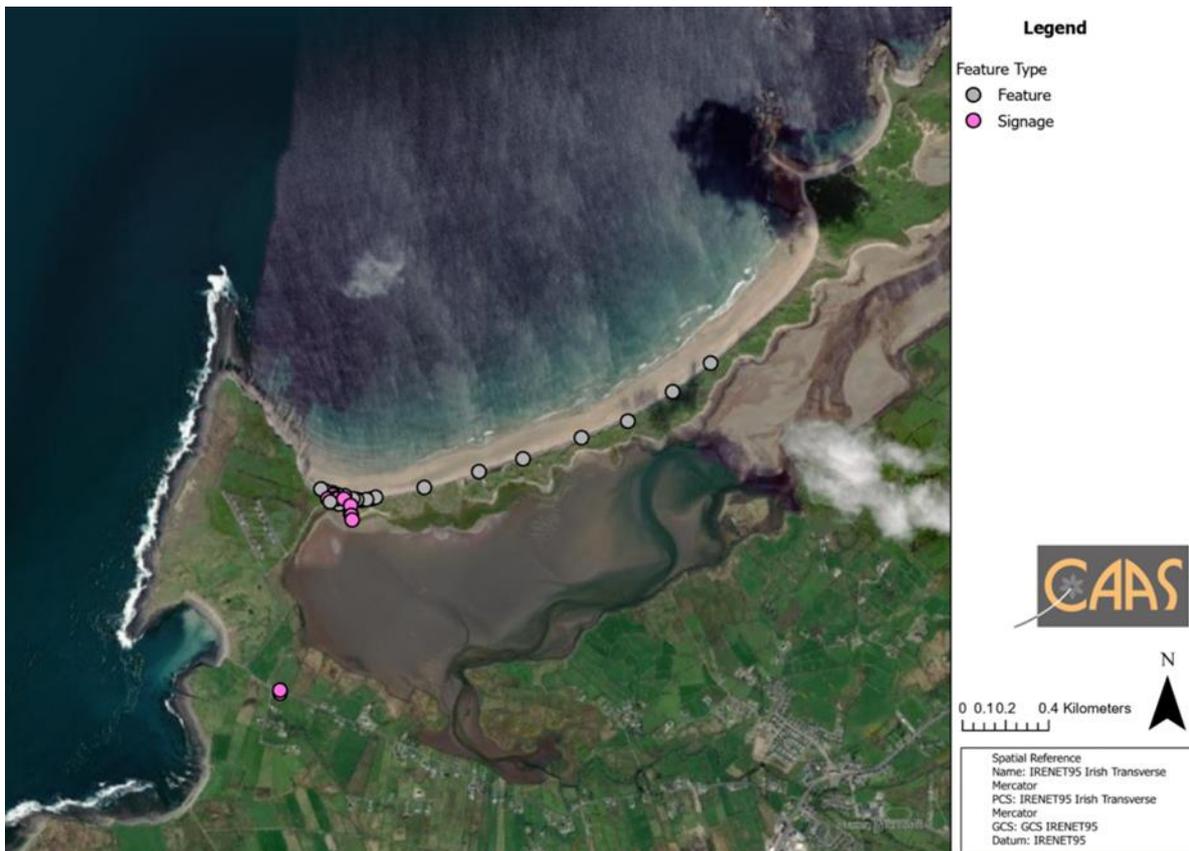
Figure 1.5 Features recorded at Streedagh Beach

Streedagh Beach contains features that would be expected of a coastal visitor area such as a lifeguard hut along with toilets and carpark surfaced with unbound material. The beach also has signage related to beach safety and warnings of strong currents. Along with these, it also has information signage such as historical information and a general information board as well as signage that designates the area as a Special Area of Conservation, with barriers that prevent cars from entering dunes, and as part of the Wild Atlantic Way (Figure 1.6).

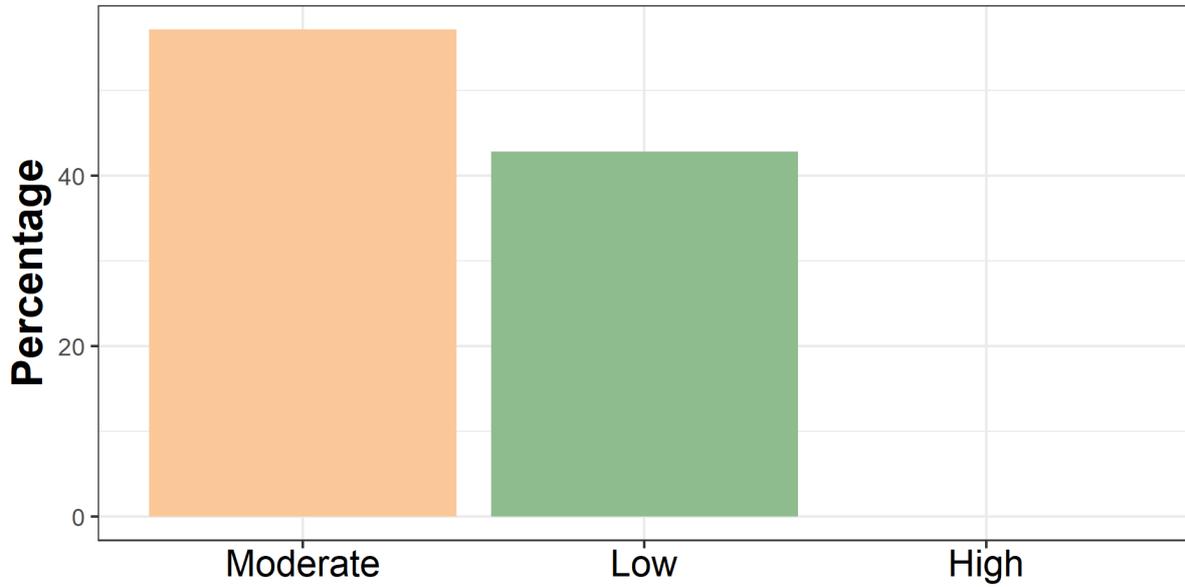
Figure 1.14 Categories of Environmental Impact Levels Observed at Streedagh Beach as a result of Visitor Activities

Of the 65 groups recorded on site 85% of them undertook activities other than walking. These activities resulted in 7 impacts being observed on site during the survey. Thus, 13% of activities on site resulted in impacts on the environment. The impact severity levels varied with 43% of the impacts being low, 57% of impacts being moderate, and 0% of impacts being high severity. The impacts identified for the site were:

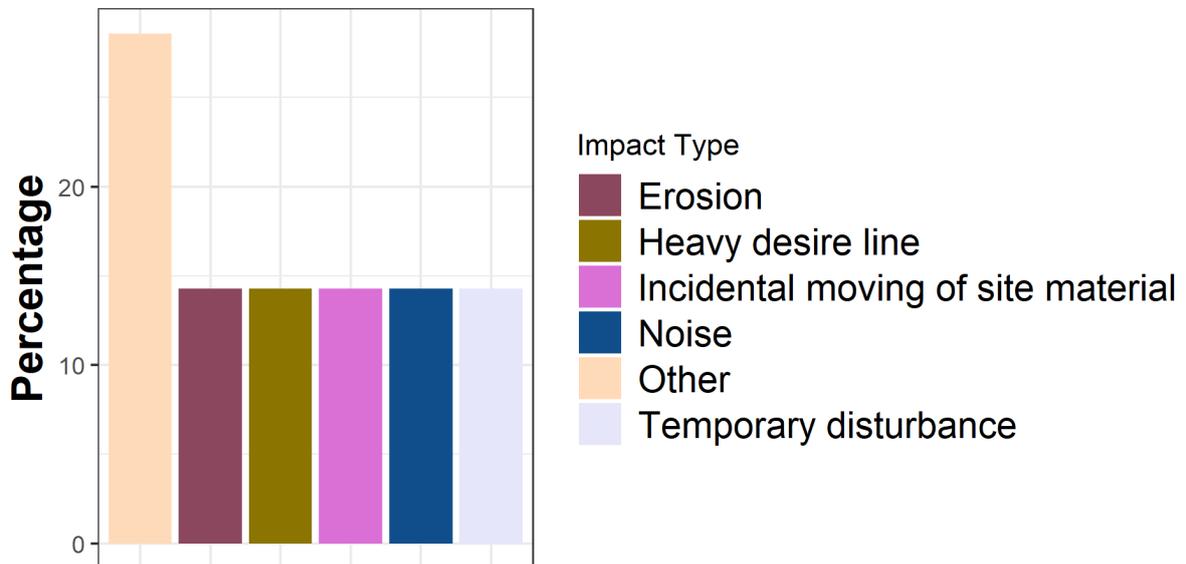
Figure 1.15 Range of Environmental Impacts Observed at Streedagh Beach

Impact Type	Count
Erosion	1
Heavy desire line	1
Incidental moving of site material	1
Noise	1
Other	2
Temporary disturbance	1

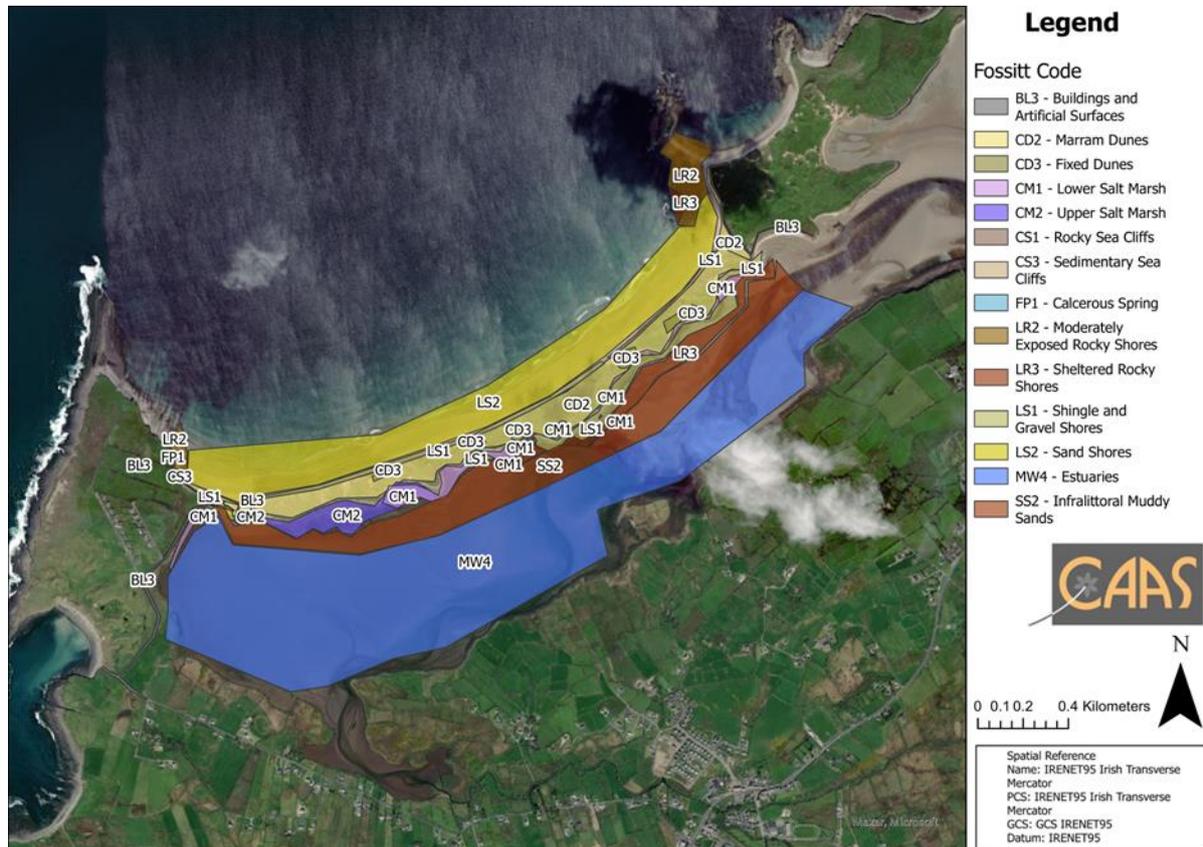
Figure 1.17 Habitats present at Streedagh Beach

The majority of the habitats at this site consist of sand shores (Fossitt Code LS2) and infralittoral muddy sands (Fossitt Code SS2). Streedagh Beach also contains marram dunes (Fossitt Code CD2) and fixed dunes (Fossitt Code CD3) which align with the Annex I habitat for which the SAC, Streedagh Point Dunes, is designated (Fixed coastal dunes with herbaceous vegetation – grey dunes [2130]).

There is an extensive network of trails through the dunes which have locally exhibit erosion and exposed sand. The density of trails is extremely high but localised – but all habitats off-trail are relatively undisturbed.
