NATIONAL TOURISM MONITORING PROGRAMME 2021-2025

ANNUAL RESULTS FOR 2022

BRAY HEAD

CAAS Ltd.

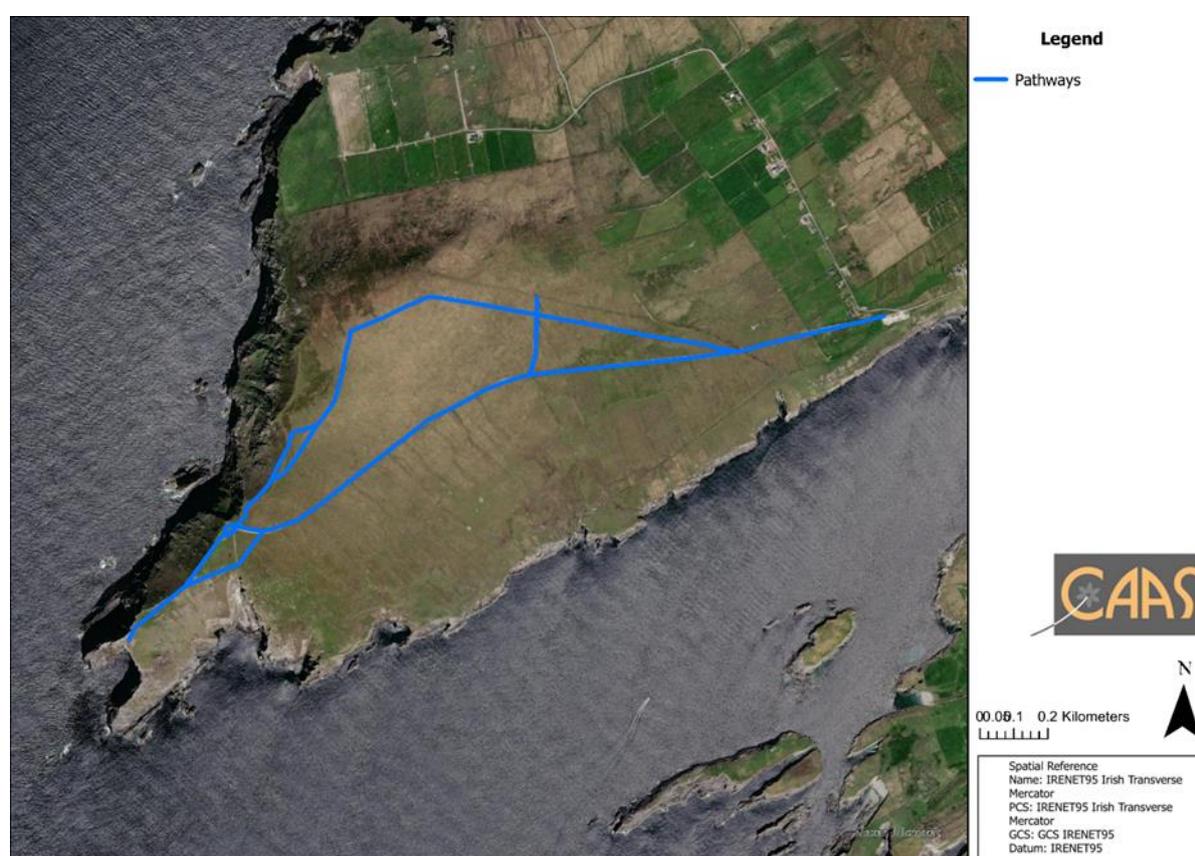
Figure 1.4 Pathways identified at Bray Head

The path is a mix of hard and soft trails which lead from the carpark to the main viewing point which is the tower (Figure 1.5). At and around the tower there are a number of desire lines and compaction areas – there are early signs of site overuse with some bare soil areas. The most used trail from the carpark to the tower is largely confined by two deep ditches which confine activity.

The northern trail to up to the highest point is a waymarked trail. This trail is through heathland habitat and there is evident signs of damage to the habitat within the locality of the path itself. In areas of steep topography there are higher rates of erosion and bare peat sub-strata. On the downward track leading back towards the carpark the trail is highly variable up to almost 8 meters at its widest part. This shows signs of extensive dispersion.

The vegetated paths show clear signs of compaction and impact from excess visitor numbers. Interventions should be considered to ensure that future loadings of the site can be facilitated by the trail network on site.

The site as a whole is well managed in regards to tourism, however, as is stated in the 2021 report it was recommended that a boardwalk or stone pathway should be developed if visitor numbers were to increase. Visitor numbers did increase in 2022, however, while this did not lead to an increase in impacts a boardwalk or stone pathway should still be explored as options in order to safeguard the habitats at Bray Head from visitor impacts.

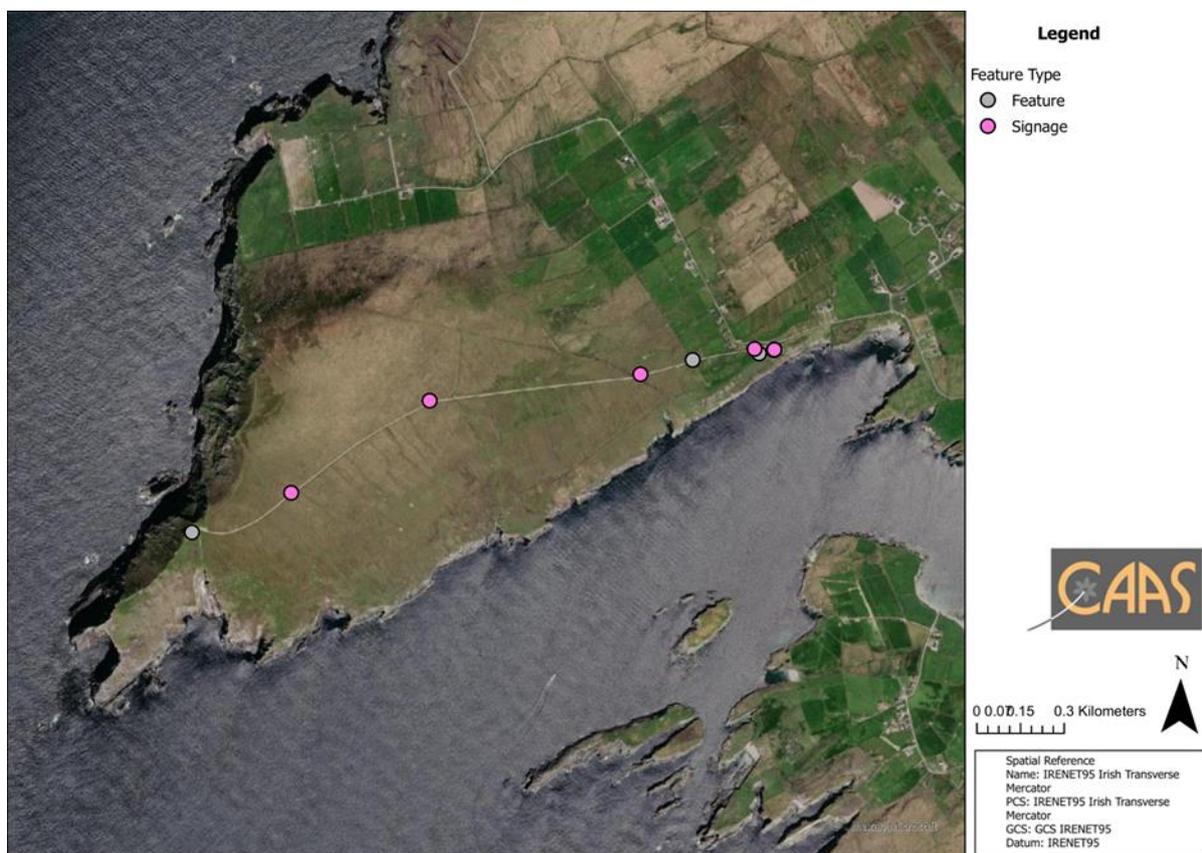
Figure 1.6 Features recorded at Bray Head – these features are way mark signs and information signage

The site has a number of trail markings and some facilities on site - however, there is a lack of signage related to the ecological value of the biodiversity at the site. This is seen to be a missed opportunity for environmental awareness. There area however signs and information boards which provide information on the heritage of Bray Head along with a sign designating Bray Head as part of the Wild Atlantic Way (Figure 1.7).

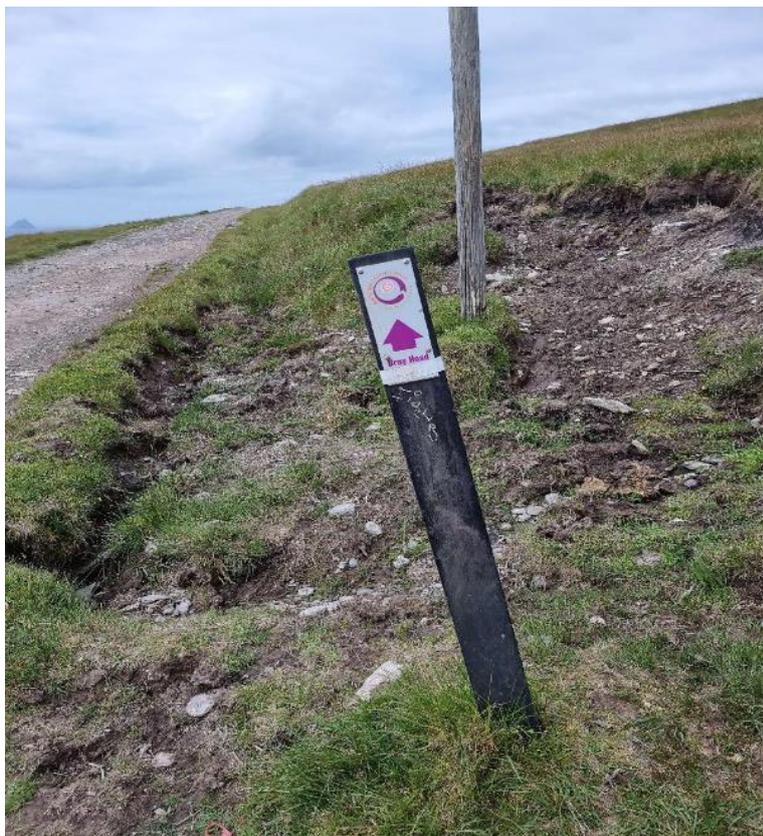
Figure 1.8 Example of erosion at Bray Head

There is erosion on some pathways along Bray Head (Figure 1.8) however, the hazard mapping identified no obvious safety issues or hazards for the site.

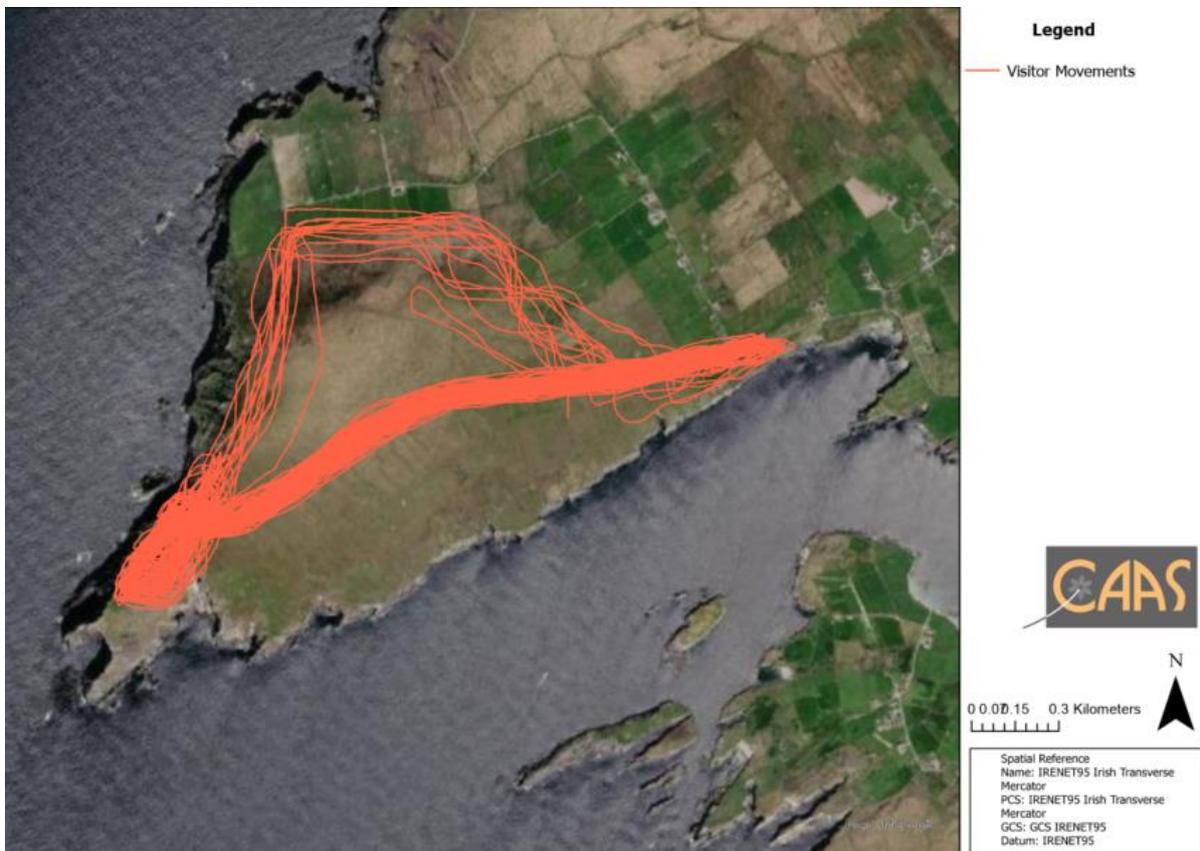
Figure 1.18 Visitor movement patterns at Bray Head

Of the 103 sample groups recorded on site 36% of them undertook activities other than walking, which is a large decrease of 29% from the 2021 survey. These activities (identified above) resulted in 2 impacts, 17 lower than 2021, being observed on site during the survey. Thus, 4% of activities on site resulted in impacts on the environment when compared to 23% in 2021. The impact severity levels did not vary with 100% of the impacts being low, 0% of impacts being moderate, and 0% of impacts being high severity. The impacts identified for the site were:

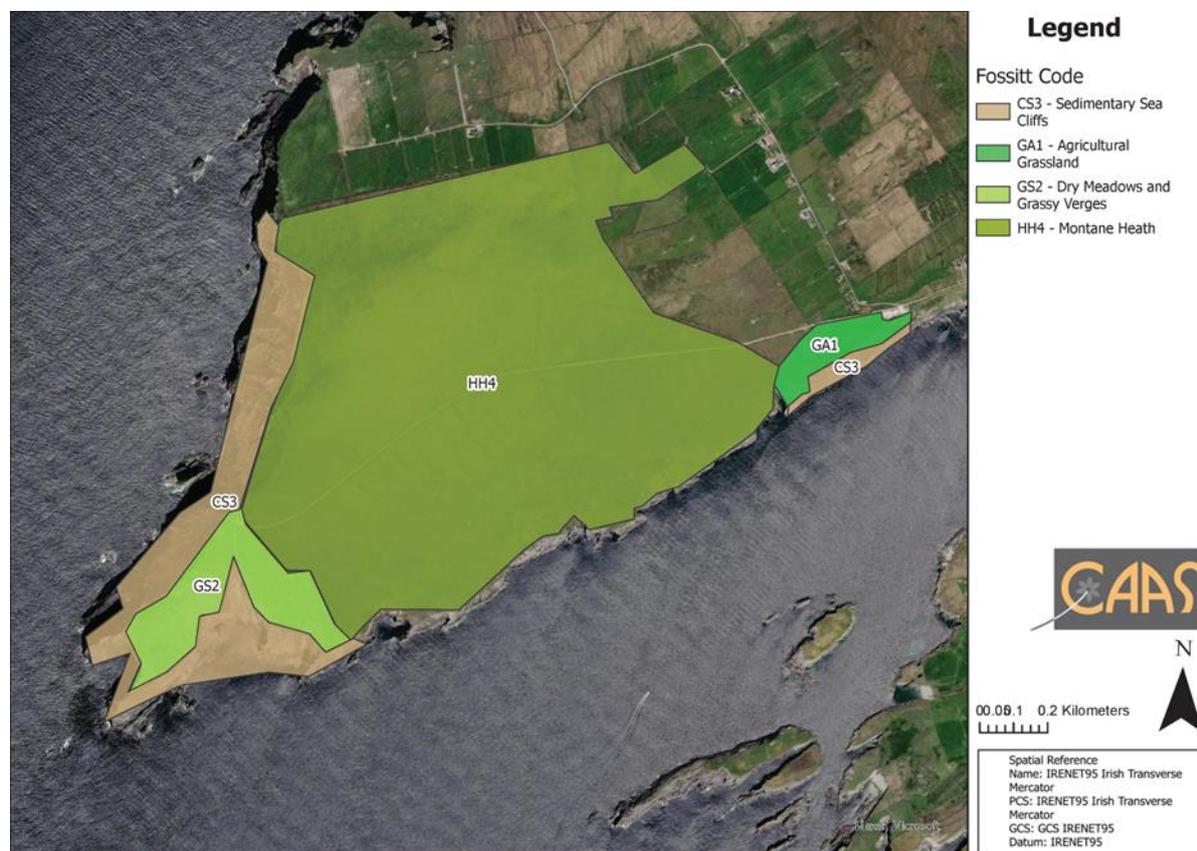
Figure 1.27 Habitats present at Bray Head

The main habitat at Bray head is mountain heath which dominates most of the landscape (Figure 1.27). The area has low intensity cattle graze present and it was recorded that a number of Chough use the site regularly. The area surrounding the castle at the top of the walkway is characterised by a very short grass sward – this is a low diversity mix which has higher intensity sheep graze which is resulting in a very short sward.

The site is well managed with the majority of the visitors staying along the soft infrastructure path. The main area of visitor activity which is off path – has incidences of exposed soils from trampling – however these are localised. The loop walk has less footfall but there is more damage to the habitats as a result – with the steep incline areas of the heath having high rates of exposed substrate and damage. The carpark side of the main peak on site has a widely dispersed network of trails showing dispersed damage – likely to be due to the topography and wet conditions of the site.

As is also stated in the 2021 report, chough are known to frequent the site and thus a managed grazing regime is recommended in order to both support the requirements for chough but also increase the floral diversity on site.
