# National Tourism and Environmental Monitoring Programme

## Ards Forest Park 2025

## Report for Ards Forest Park 2025

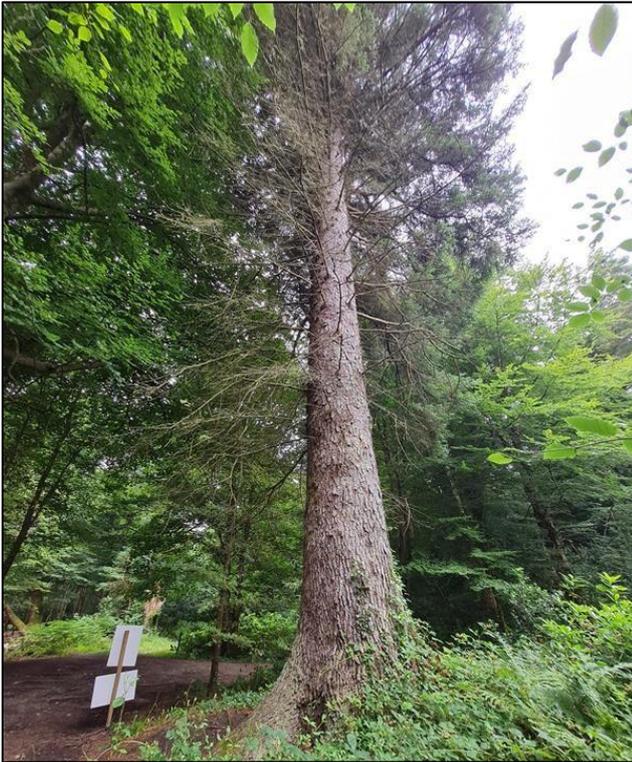
The oldest and largest Sitka Spruce in the forest, 'the Old Cashellilly Tree', was planted in the forest in the 1940s. It was saved from felling in 2005 and is dedicated to those who planted the first trees at the site after the estate was taken over by the Irish Land Commission in 1927.

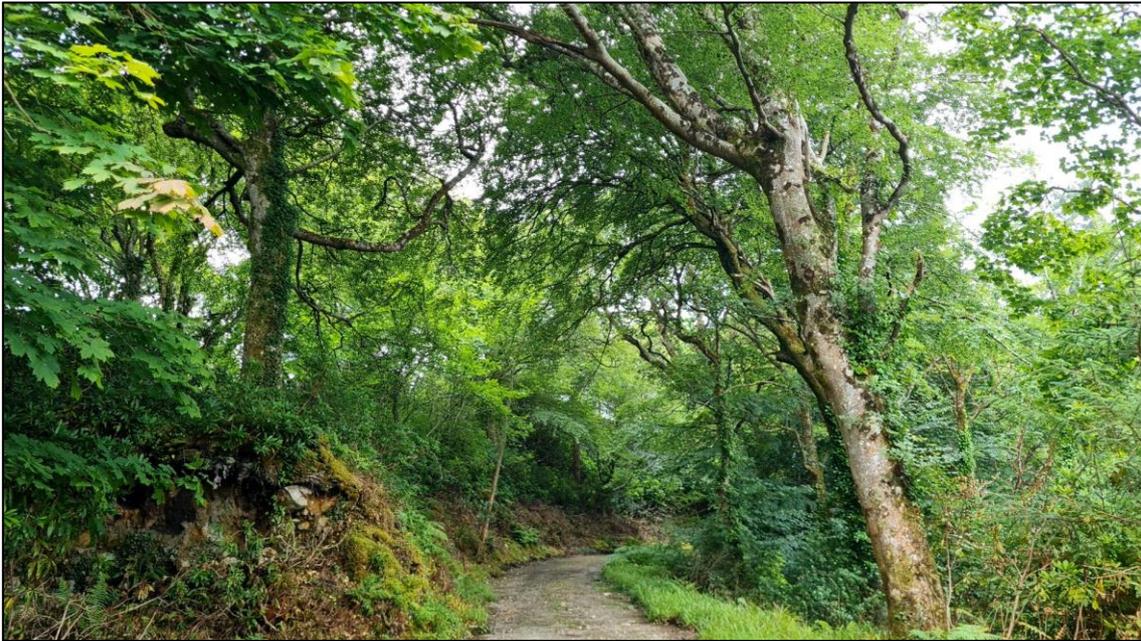
To the west of the main car park, areas of WD1 are largely populated by pedunculate oak (*Quercus robur*) and downy birch (*Betula pubescens*), with hazel, ash, holly and sitka spruce recorded alongside them.

**Plate 3.1** (Mixed) broadleaf woodland (WD1) and a gravel pathway.

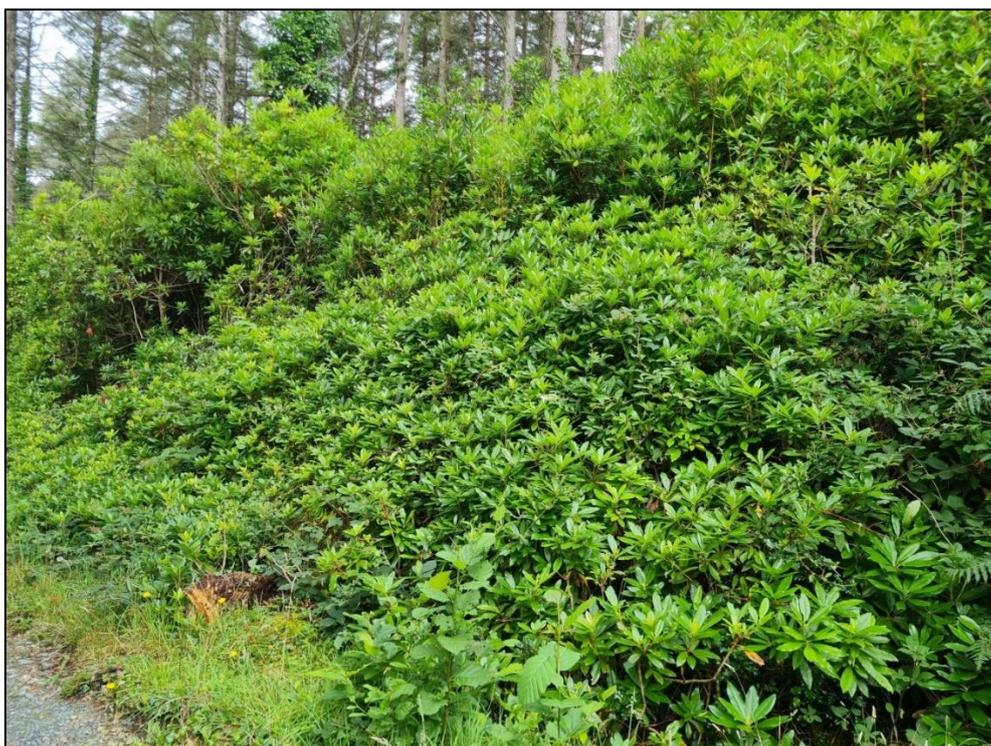
Dense stands of rhododendron (*Rhododendron ponticum*) were recorded lining most of the woodland pathways and in some areas, it extends into the woodland. Small patches of rhododendron are being treated in four areas of this habitat. Where these invasive species are present, they shade out the understorey and prevent the regeneration of trees.

**Plate 3.2** Dense Rhododendron growth in the woodland adjacent to the pathway to the east of Lough Lilly

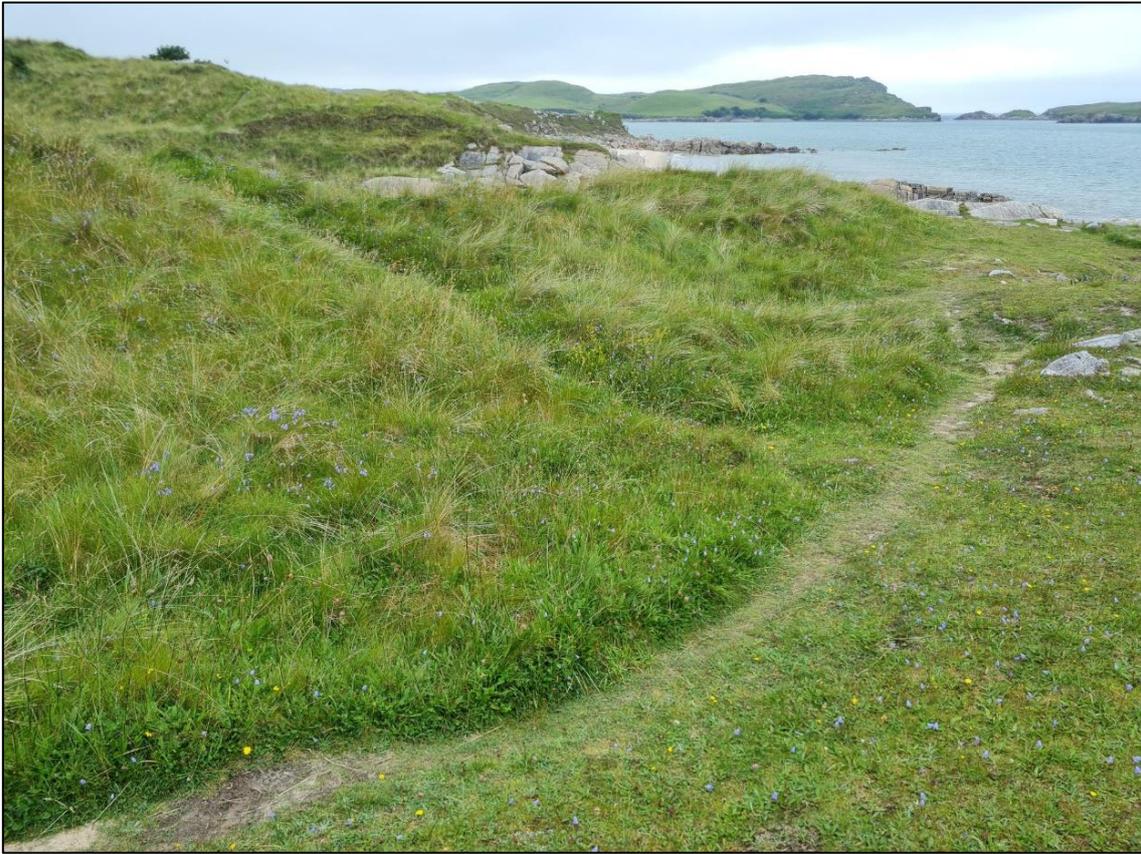
Numerous informal paths are present in the dunes, particularly leading to and from the beaches, resulting in erosion and habitat loss. This is discussed further in section 3.2 below.

**Plate 3.3**            **Fixed dune habitat (CD3) with informal pathways recorded in the north of the site**

- Numerous informal pathways are present in the dunes. A formal pathway and a boardwalk are already present, however, there is no formal path connecting them. An extension of the boardwalk to discourage visitors from using the informal paths through the dunes, which is causing the dunes to collapse onto the beach, is recommended. The potential use of way markers and signage to keep visitors on track should be considered to reduce the number of informal trails in the dunes.

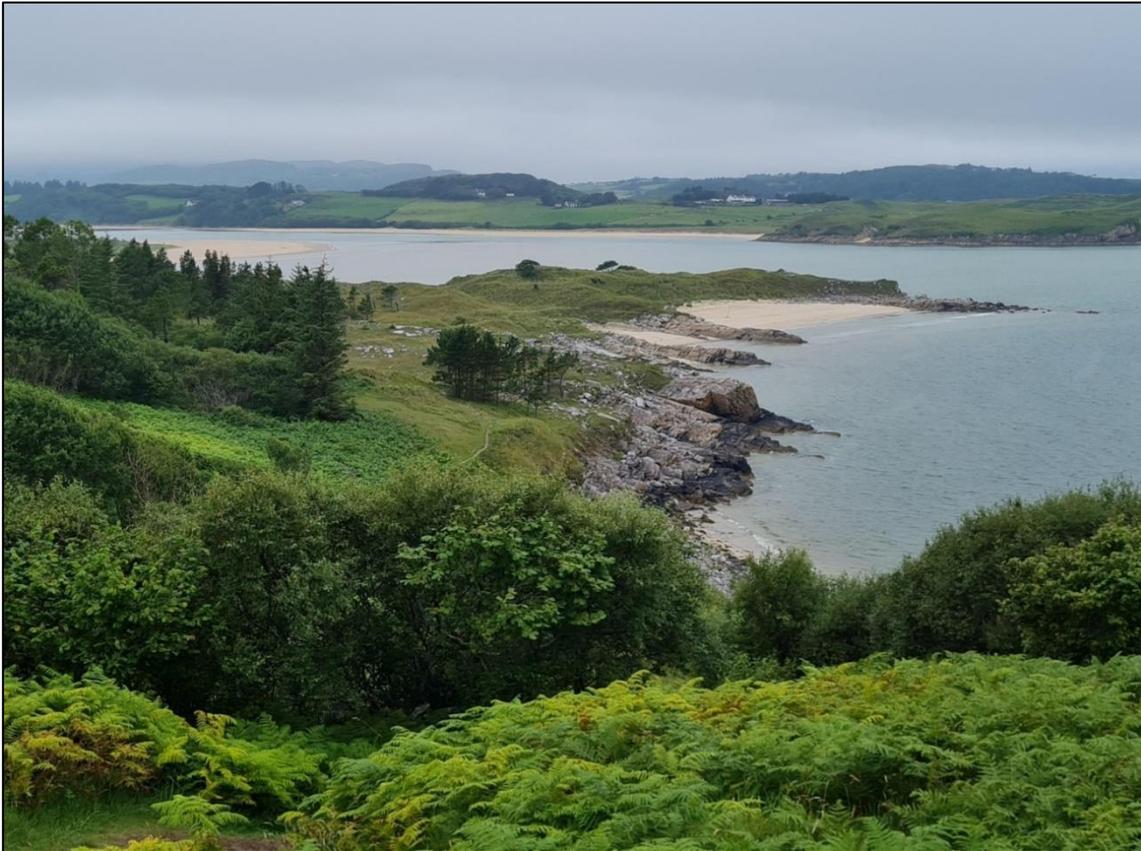
This habitat is present in some areas of the study area, acting as a transitional habitat between the dunes and the beach. No visitor impacts were noted on the rocks, likely due to them being difficult to traverse. Lichens, limpets and barnacles were recorded throughout this habitat. This habitat is shown above in 3.4.

**Plate 3.4** View of the site, showcasing Dense bracken (HD1) and (Mixed) broadleaved woodland (WD1) in the foreground. Fixed dunes (CD3), Moderately exposed rocky shores (LR1), Sandy shores (LS2) and Conifer woodland (WD3).

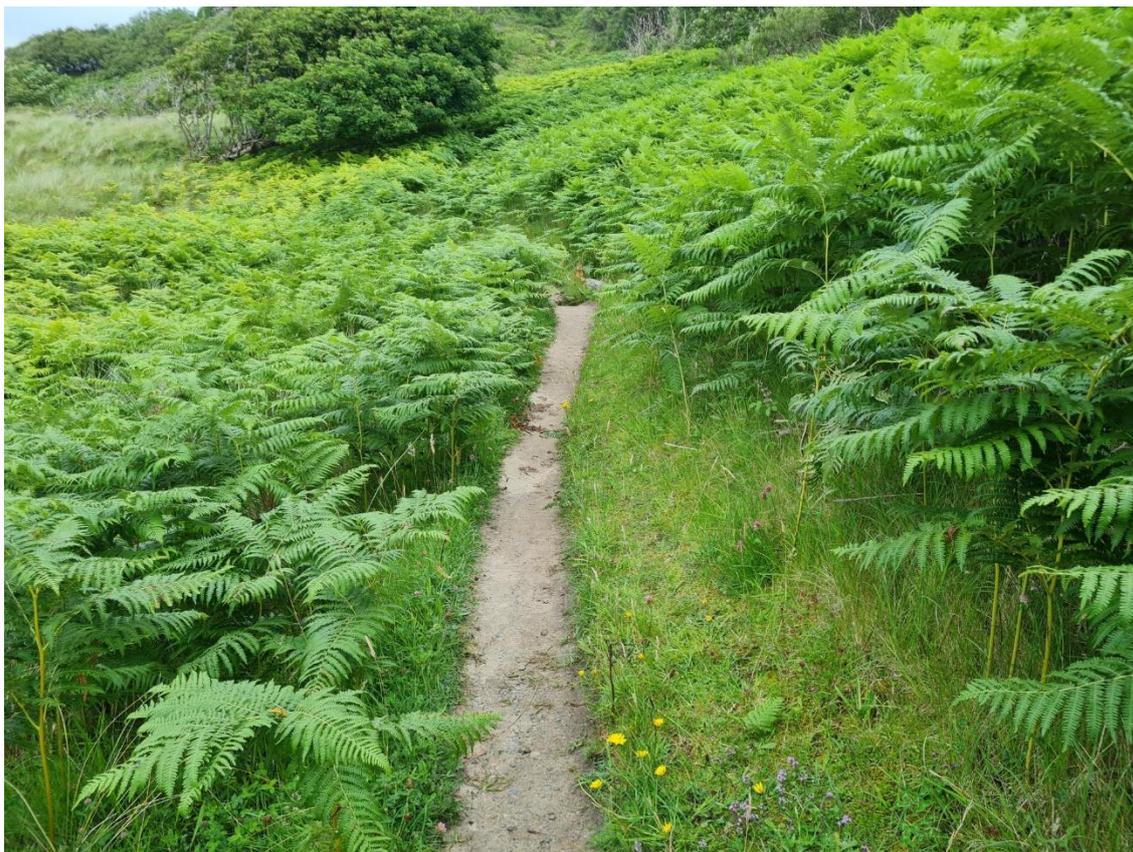
This habitat is present on the northeast side of the site between the dunes and woodland habitats, and was also found at the north side of the playground, separating it from the marram dune. The habitat was dominated by bracken (*Pteridium aquilinum*) and does not correspond to any Annex I habitats. A photo of dense bracken at Ards Forest is presented in Plate 3.5 below.

**Plate 3.5** Dense bracken habitat in the north of the site

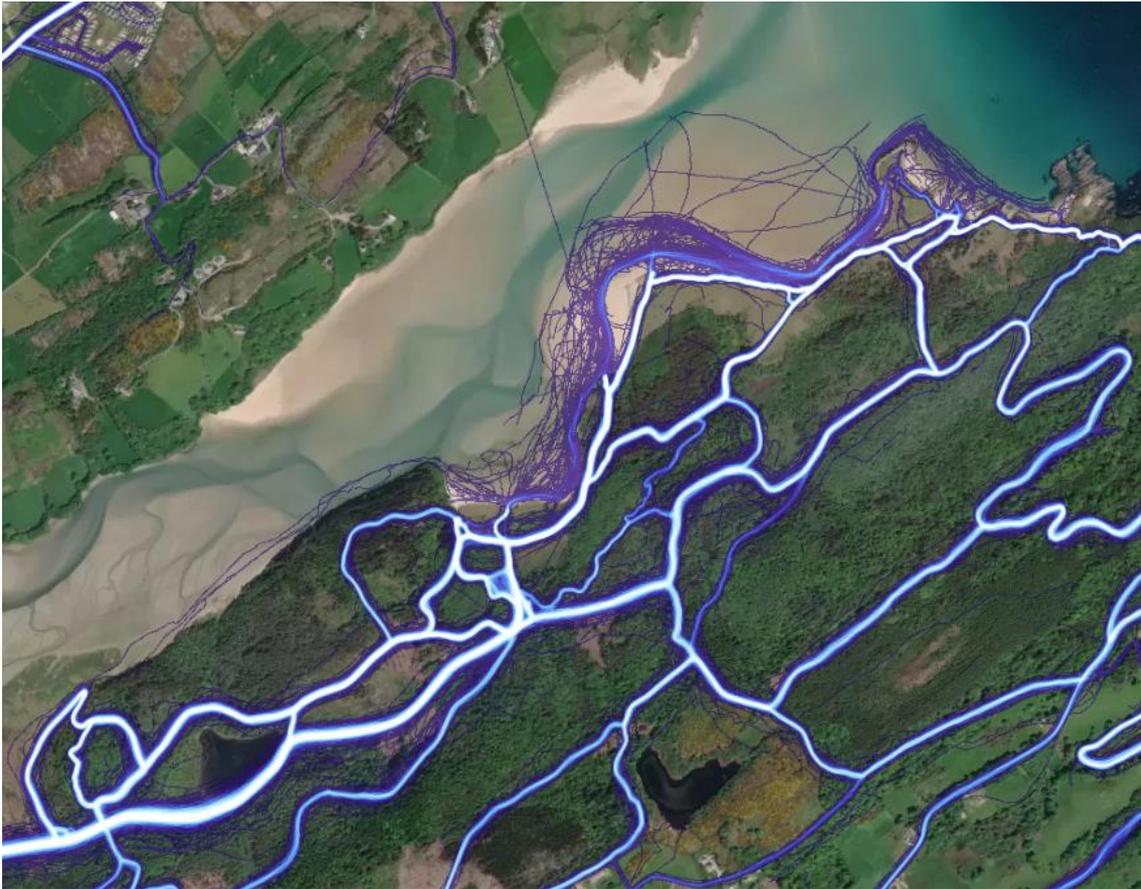
Figure 3.2 presents a Strava heat map for the site. Strava aggregates data from users on its app who opt-in to share their activities and locations. The pathway condition assessment map for the site east of the main car park is presented in Figure 3.3 below and the map for the site west of the main car park is presented in Figure 3.4 below.

Figure 3.2 Heat map of visitor movements in Ards Forest Park (Strava, 2025)

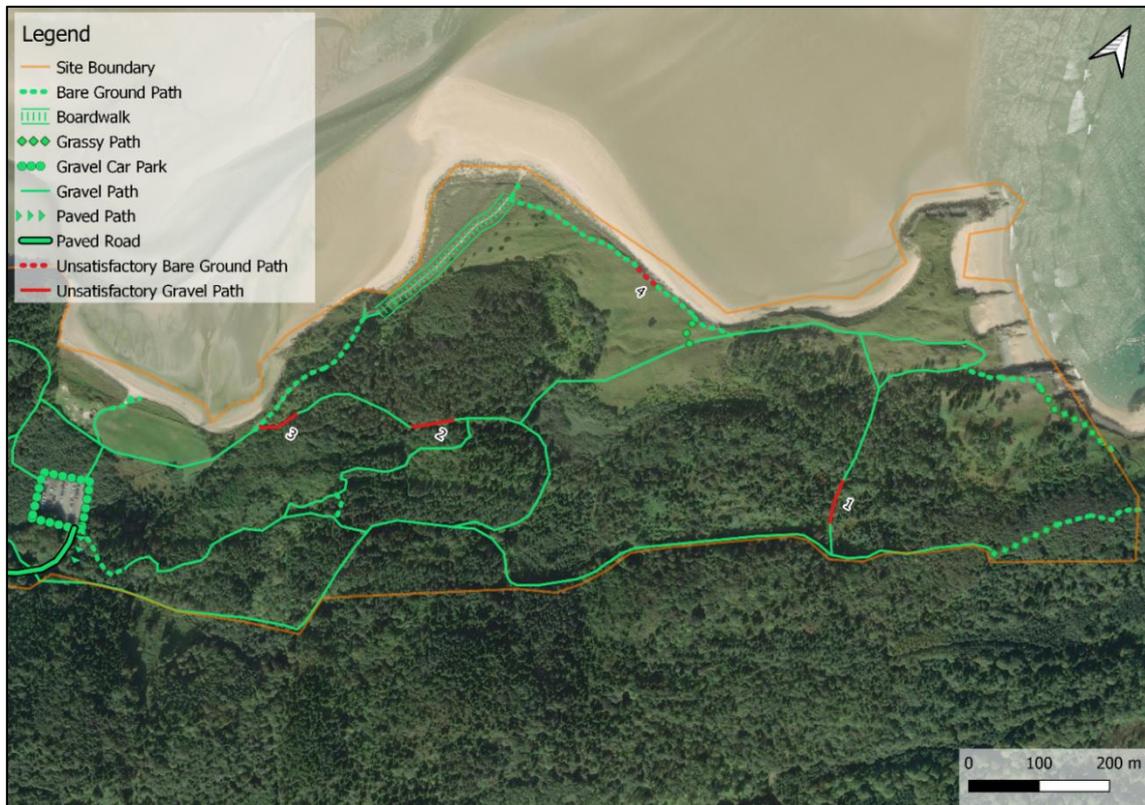
Figure 3.3 Pathway types and conditions presented in the eastern section of Ards Forest Park, with unsatisfactory pathways numbers 1-4.

Most pathways in Ards Forest Park were gravel pathways and were generally in good condition. Three small stretches of the gravel pathways were in unsatisfactory condition due to erosion (Figure 3.3, Areas 1, 2 & 3), as described below. Other pathways present within the site include two gravel car parks, a paved road, several bare ground paths in the woodland and dunes on the east half of the site and a wooden boardwalk along the coast to the north-east of the main car park. These pathways were in satisfactory condition, with the exception of a stretch of the bare ground pathway connecting the boardwalk to a gravel path to its east (Figure 3.3, Area 4), as described below.

- It is recommended that trail improvement and repair works are carried out on the unsatisfactory pathways to the east of the car park, where erosion has damaged the paths.

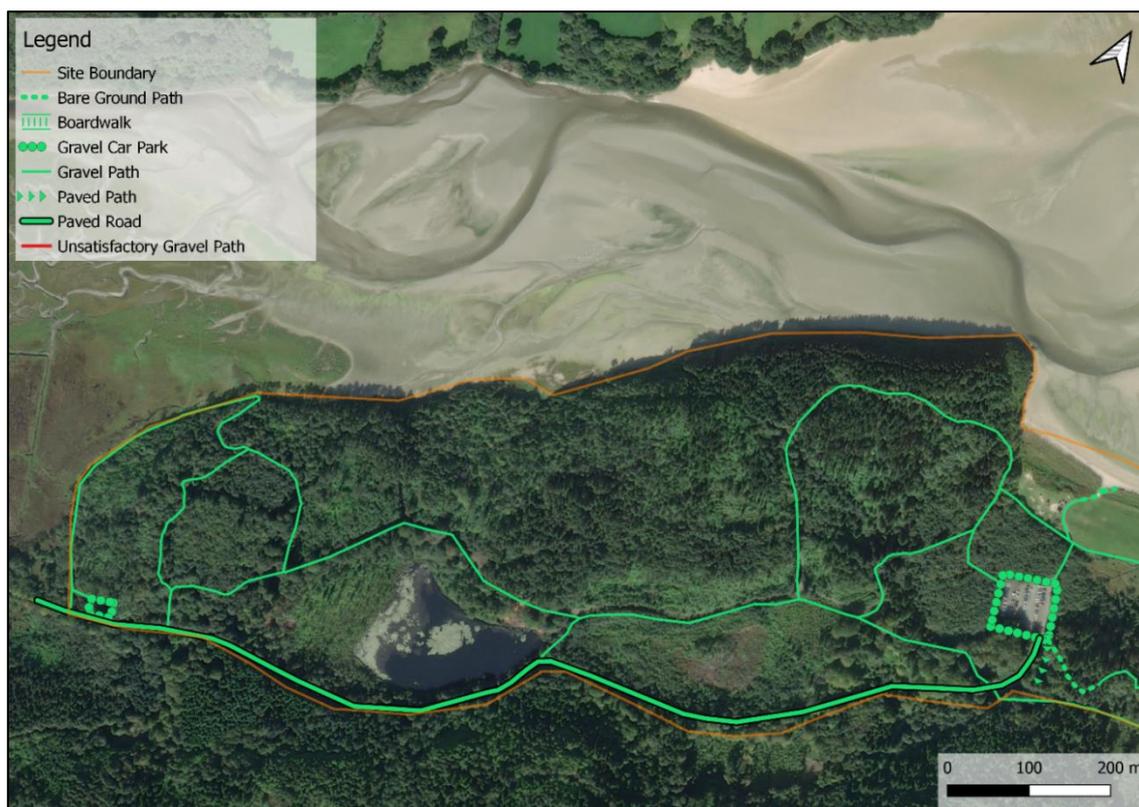
**Figure 3.4** Pathway types and conditions presented in the western section of Ards Forest Park

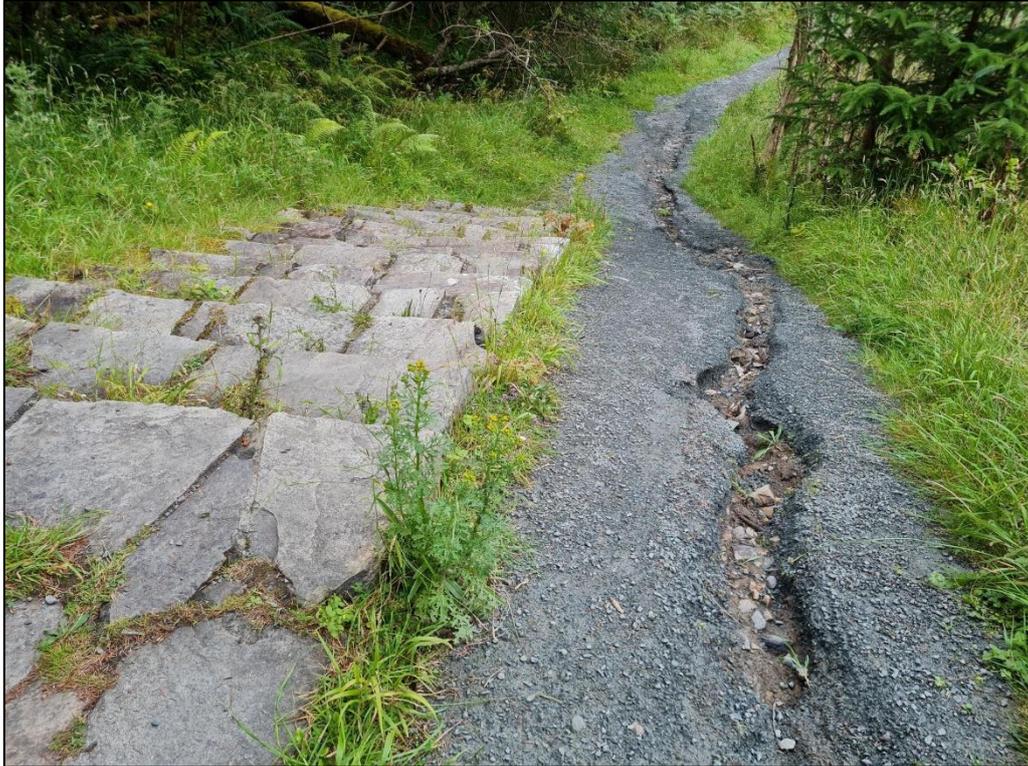
A gravel path follows the southern border of the study area from the main car park in an eastern direction and loops back towards the playground and car park through the dunes. This pathway is in satisfactory condition, however, one gravel pathways connecting the north and south of this loop is in unsatisfactory condition due to erosion (labelled '1' in Figure 3.3 above). Erosion has formed a series of holes along another section of this gravel path (labelled '2' in Figure 3.3 above) which poses a trip hazard. The gravel in this section of path has been compacted into the ground. Another section of this gravel path, located approximately 170m east, is in unsatisfactory condition due to erosion (labelled '3' in Figure 3.3 above).

**Plate 3.5** Unsatisfactory gravel pathway adjacent to stone steps recorded in Ards Forest Park (labelled 1 in Figure 3.3 above).

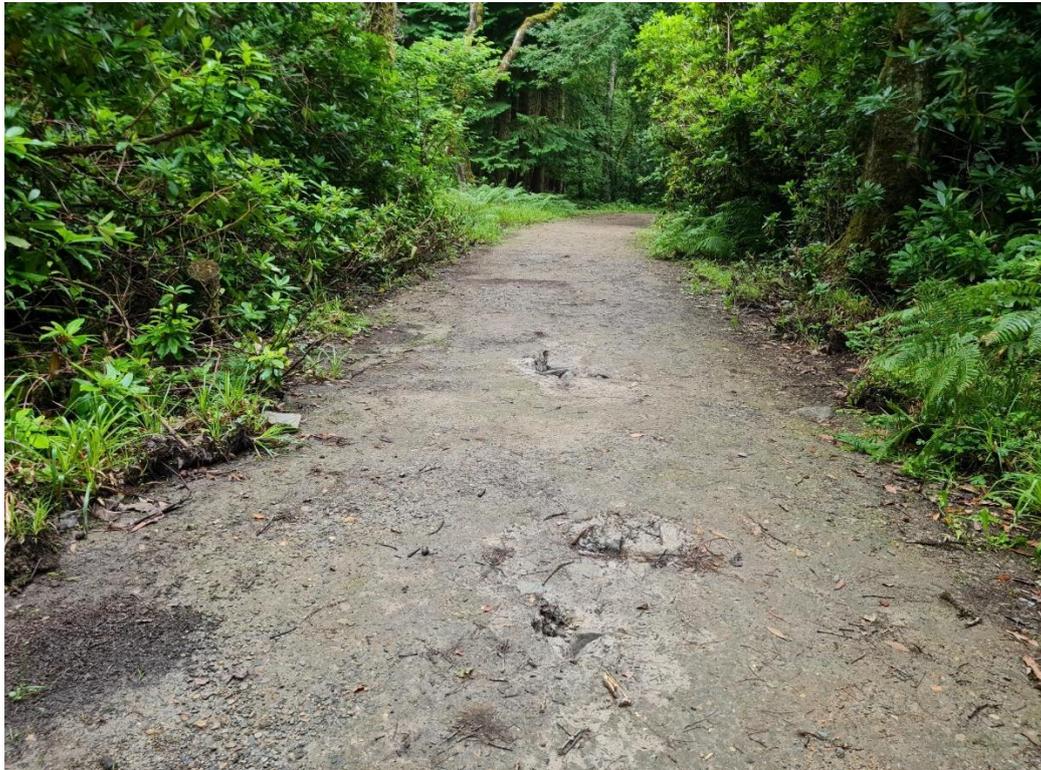
**Plate 3.6** Unsatisfactory gravel pathway recorded in Ards Forest Park (labelled 2 in Figure 3.3 above).

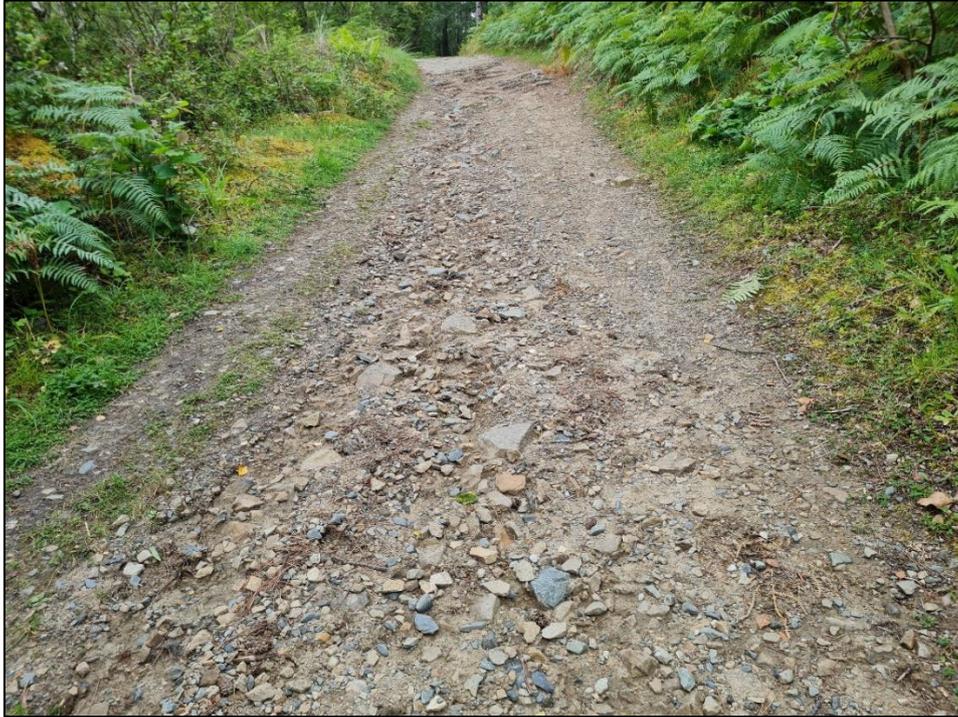
**Plate 3.7** Unsatisfactory gravel pathway recorded in Ards Forest Park (labelled 3 in Figure 3.3 above).

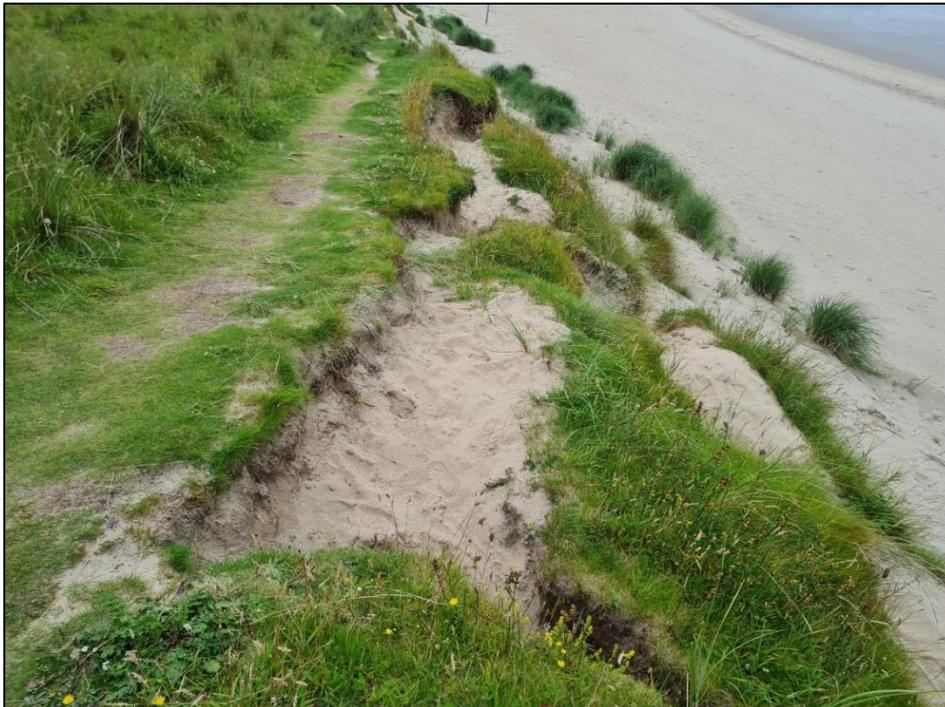
A gravel path leads to a wooden boardwalk through the dunes to the northeast of the car park. The boardwalk terminates after 250m, from which point a bare ground path continues along the coast in an easterly direction through the dunes. A section of the dune along this bare path has crumbled away, causing some habitat loss and damage to the pathway (labelled 4 in Figure 3.3 above).

**Plate 3.8** Unsatisfactory bare ground pathway, between the boardwalk and gravel path, recorded in Ards Forest Park (labelled 4 in Figure 3.3 above).

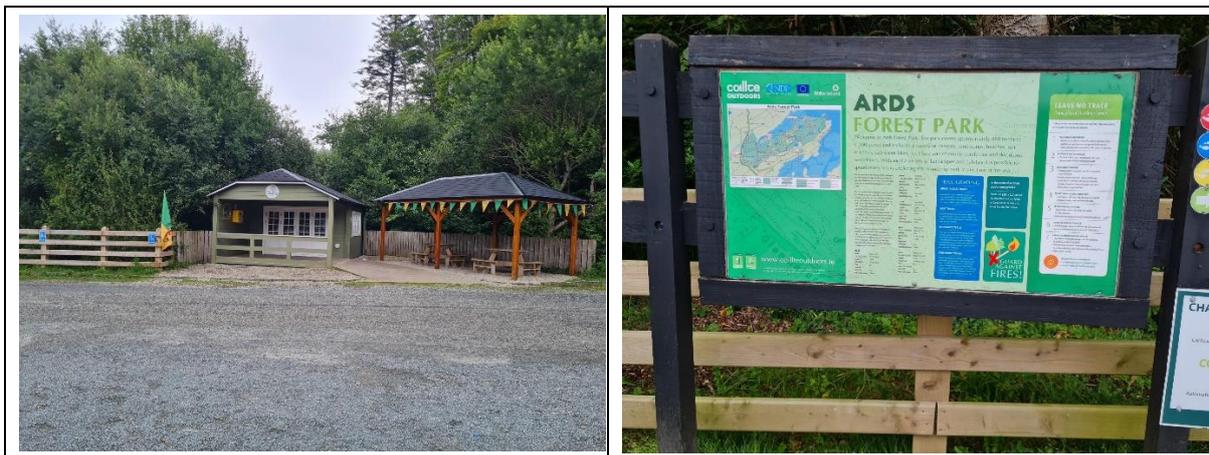
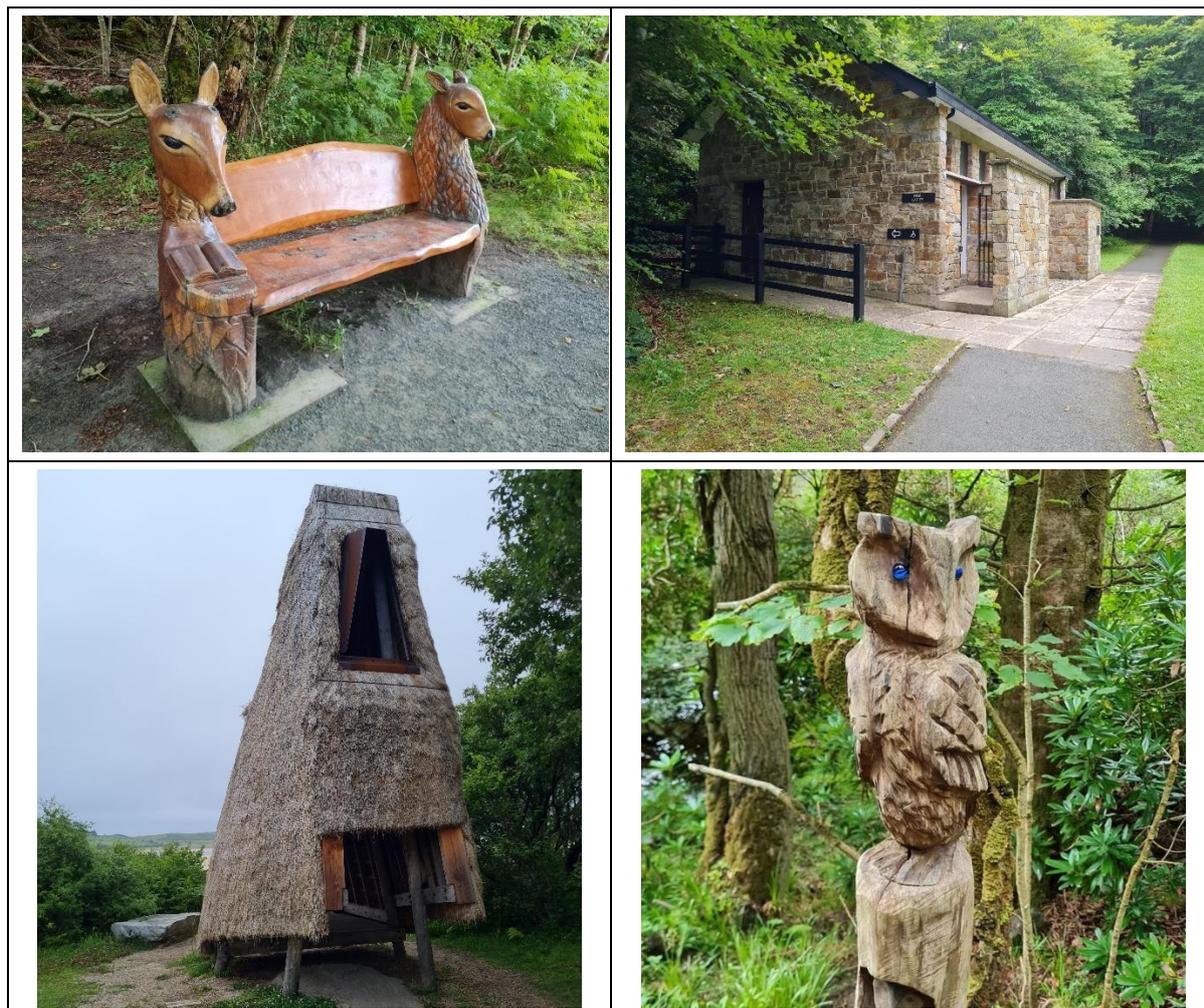
The oldest Sitka Spruce in the forest, the Old Cashellilly Tree, is located along the path to the west of Lough Lilly and is indicated by a small sign that briefly describes its history. Various wood carvings are located adjacent to the pathways where tree stumps have been cut into the shapes of various animals, including owls, rabbits and boars. One bench to the east of the playground has armrests that are carved into the likeness of deer. Jeffrey's House is a structure with a timber frame thatched in flax that overlooks the beach and sand dunes near the beginning of the boardwalk.

**Plate 3.9** Some of the features recorded on site. Ards Coffee Tree (Top right), signage (top left), carved bench (middle left), public toilets (middle right), Jeffrey's House (bottom left) and wooden animal carving (bottom right).

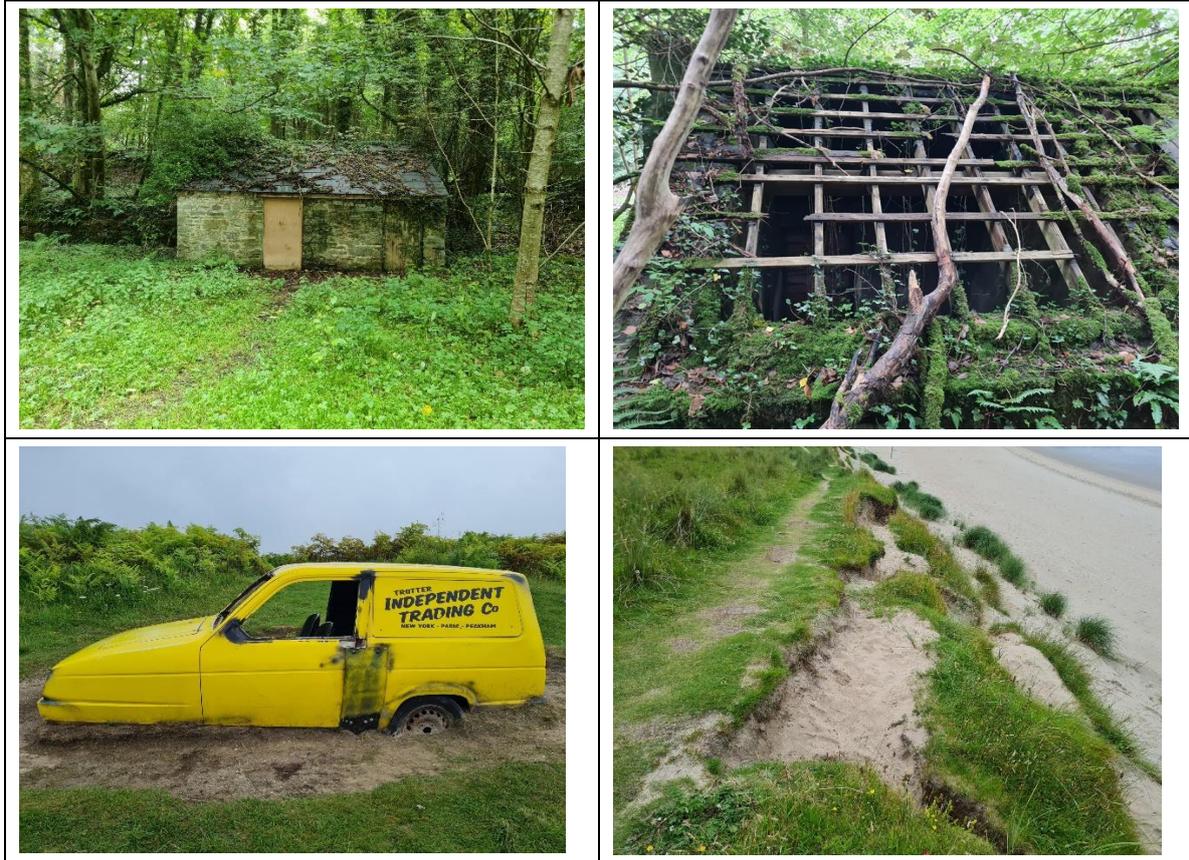
A replica of the Reliant Regal 3-wheeler from the television programme 'Only Fools and Horses' is present submerged in the ground to its undercarriage in the playground. The driver's side door is missing, allowing access to the vehicle. The passenger door is damaged above the door handle, presenting a sharpened edge. Visitors were observed warning their children to avoid touching the door.

The uneven nature of the informal paths through the dunes, with continuous deterioration, have become hazardous. The dune is eroding and collapsing along the informal trail between the boardwalk and the gravel path to its east, which has the potential to be a tripping or falling hazard.

**Plate 3.10** Old building with missing slate roof (top right and left), Reliant Regal 3-wheeler with the damaged door (bottom left) and the eroding dune habitat (bottom right).

- The slate roof of an abandoned cottage has fallen away and due to the sloping ground behind the cottage, the exposed roof is at ground level creating a hazard for visitors. Measures to make this structure safe should be considered e.g. fencing around the house or alternatively the roof could be repaired.

- The removal or repair of the damaged car door in the playground should be considered to ensure the damaged edge poses no risk to children playing in the area.
