# National Tourism and Environmental Monitoring Programme

## Dursey Island 2025

## Report for Dursey Island 2025

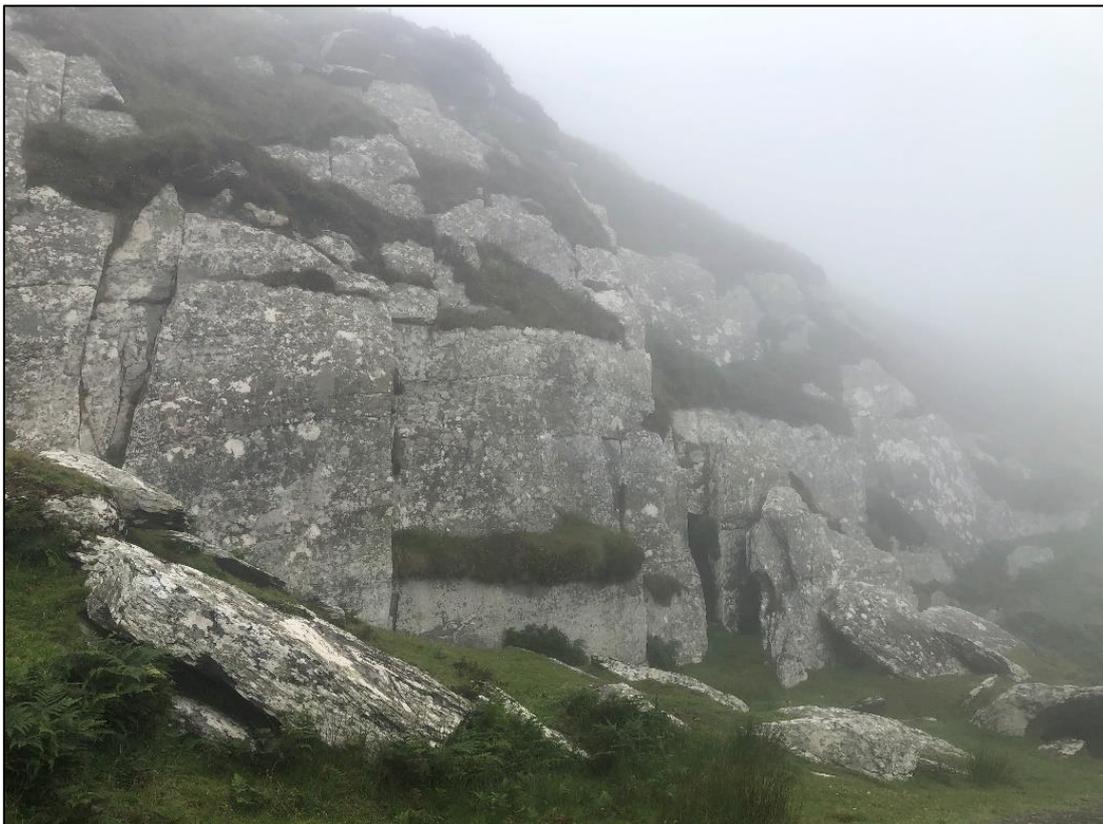
A small area of this habitat is present on the western side of the island. There is little vegetation cover in this area. Species recorded include grasses, Bracken (*Pteridium aquilinum*) and Foxglove (*Digitalis purpurea*). This area is hazardous as loose rock and scree is present underfoot.

**Plate 3.1** Exposed siliceous rock recorded in one area of the site.

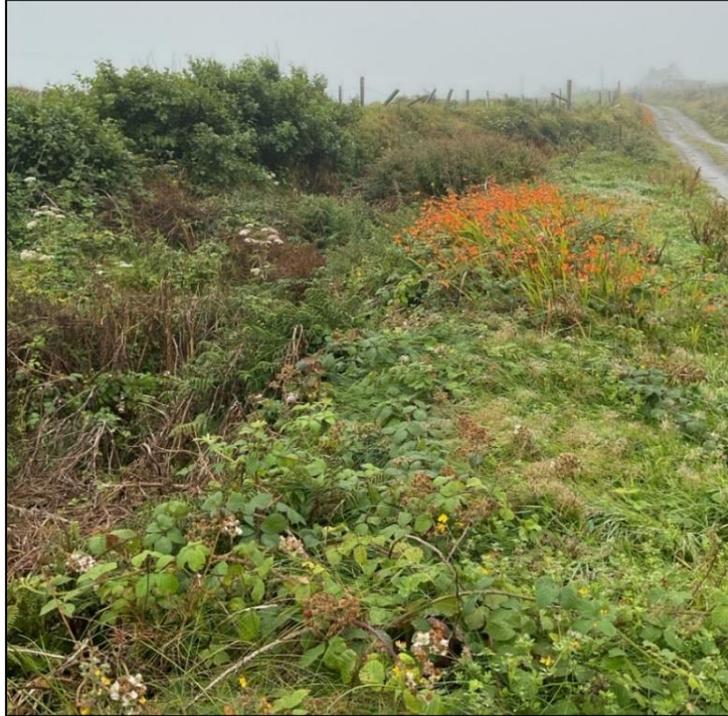
This habitat is present at two locations on Dursey Island, one at the eastern end of the site, which appears to be in use as a drainage ditch from adjacent farms. This is heavily vegetated and species recorded include Bramble (*Rubus fruticosus*), Bracken (*Pteridium aquilinum*), Wild Angelica (*Angelica sylvestris*), Montbretia (*Crocsmia x crocosmiiflora*), Beech (*Fagus*

*sylvatica*) and Fuchsia (*Fuchsia magellanica*). The other occurs further west, intersecting exposed siliceous rock and dry-humid acid grassland.

**Plate 3.2** Heavily vegetated upland / eroding river in use as a drainage ditch

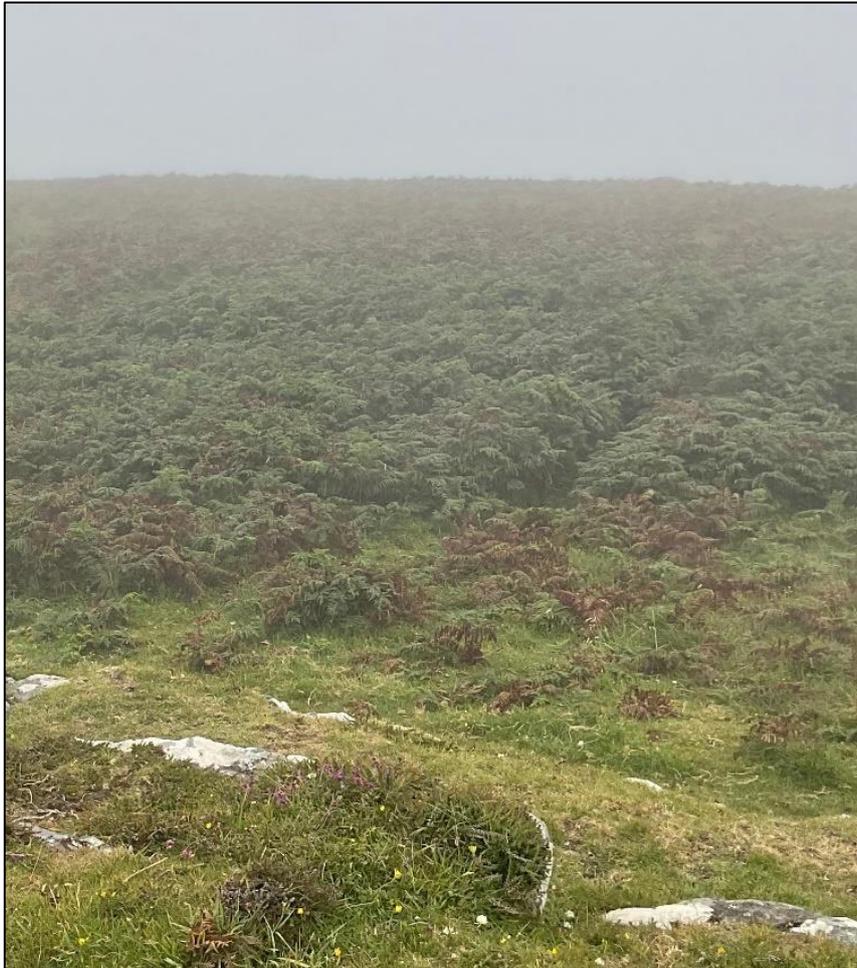
This habitat is present at various locations along sloping hillsides throughout the island. Bracken (*Pteridium aquilinum*) is the dominant species in this habitat.

**Plate 3.3** One of the areas of dense bracken on Dursey Island.

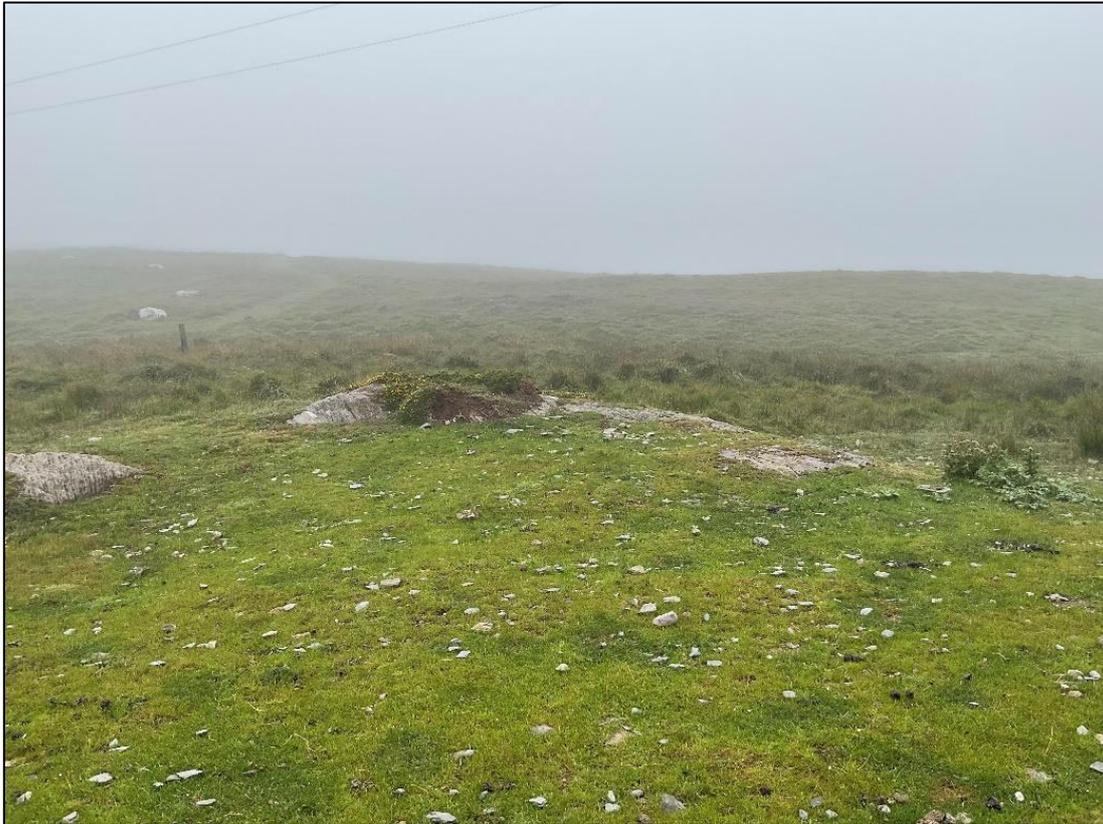
Where dry calcareous heath and wet grassland graded into each other, it was difficult to differentiate between the habitats and they were recorded as a mosaic. This habitat mosaic is present at the east end of the site, in the area surrounding the cable car landing point. The species recorded here include Bell Heather (*Erica cinerea*), Gorse (*Ulex europaeus*), Cross-leaved Heath (*Erica tetralix*), Spear Thistle (*Cirsium vulgare*), Self-heal (*Prunella vulgaris*), Nettle (*Urtica dioica*), Silverweed (*Potentilla anserina*), Crested Dogs-tail (*Cynosurus cristatus*), White Clover (*Trifolium repens*), Wild Thyme (*Thymus drucei*) Silverweed (*Potentilla anserina*), White Stonecrop (*Sedum album*) and Black Bog Rush (*Schoenus nigricans*).

**Plate 3.4** Dry calcareous heath / wet grassland habitat on Dursey Island.

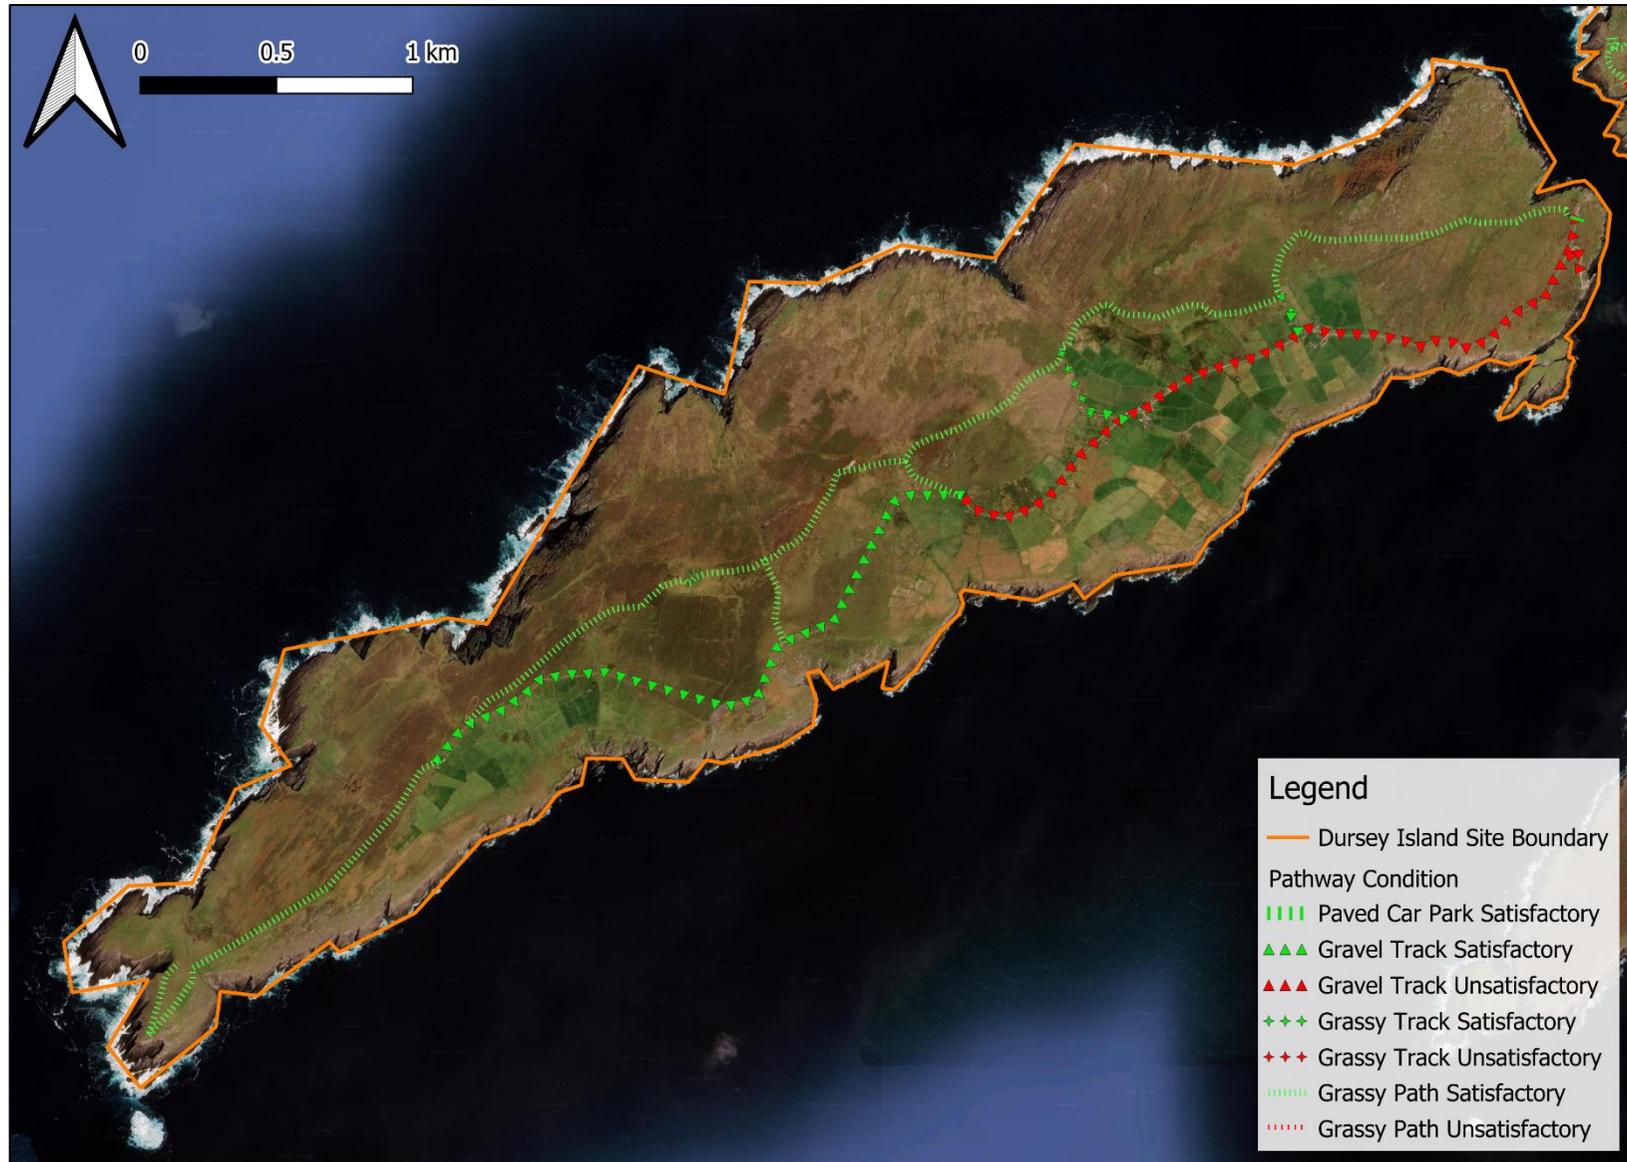
Figure 3.3 Pathway types and conditions present on Dursey Island. Basemap provided by Google.

There is a paved car park on the island, with a concrete ramp leading up to the cable car. The car park grades into a gravel track, which runs from the car park through the townlands of Ballynacallagh and to Kilmichael. This track has many pot holes, loose gravel, scree and uneven surfaces and is therefore classified as unsatisfactory. There is a gravel track that diverts from the main track and leads to the ruined monastery on the east coast of the island. This gravel track is also in an unsatisfactory condition due to the presence of loose spoil, erosion and widening. The main paved road runs as far as Kilmichael, where it becomes a gravel track. At this point, a grassy path diverts north of this gravel track. The grassy track is grazed, but no bare soil is showing, so it is considered to be in a satisfactory condition. The gravel track continues to the townland of Tilickafinna, where it grades into a grassy path. This grassy path is heavily trampled, but no bare soil is exposed and therefore, it is considered to be in a satisfactory condition. At Tilickafinna, a bare ground path runs northward and comprises much of the upper loop.

This pathway is considered to be in a satisfactory condition, although loose stones and rocks are present along this path. It is understood that the rough terrain is part of the appeal of the trail. This bare ground path runs the whole length of the upper loop as shown in Plate 3.5.

- The gravel track from the carpark on Dursey Island was recorded as being in unsatisfactory condition due to potholes, loose gravel and scree. Resurfacing of this track should be considered.

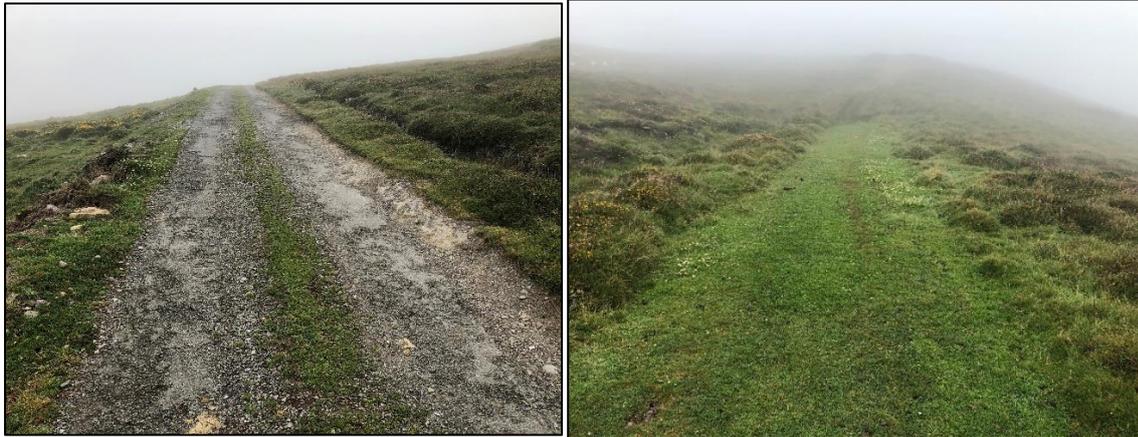
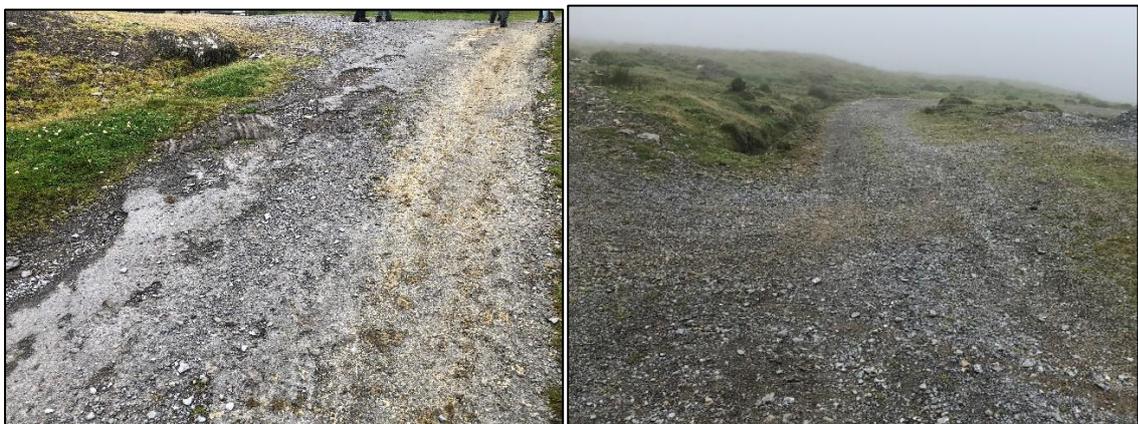
**Plate 3.5 The main pathway types recorded on Dursey Island.**

**Satisfactory Gravel Track (left) and Satisfactory Grassy Path (right)**

**Unsatisfactory Gravel Track**

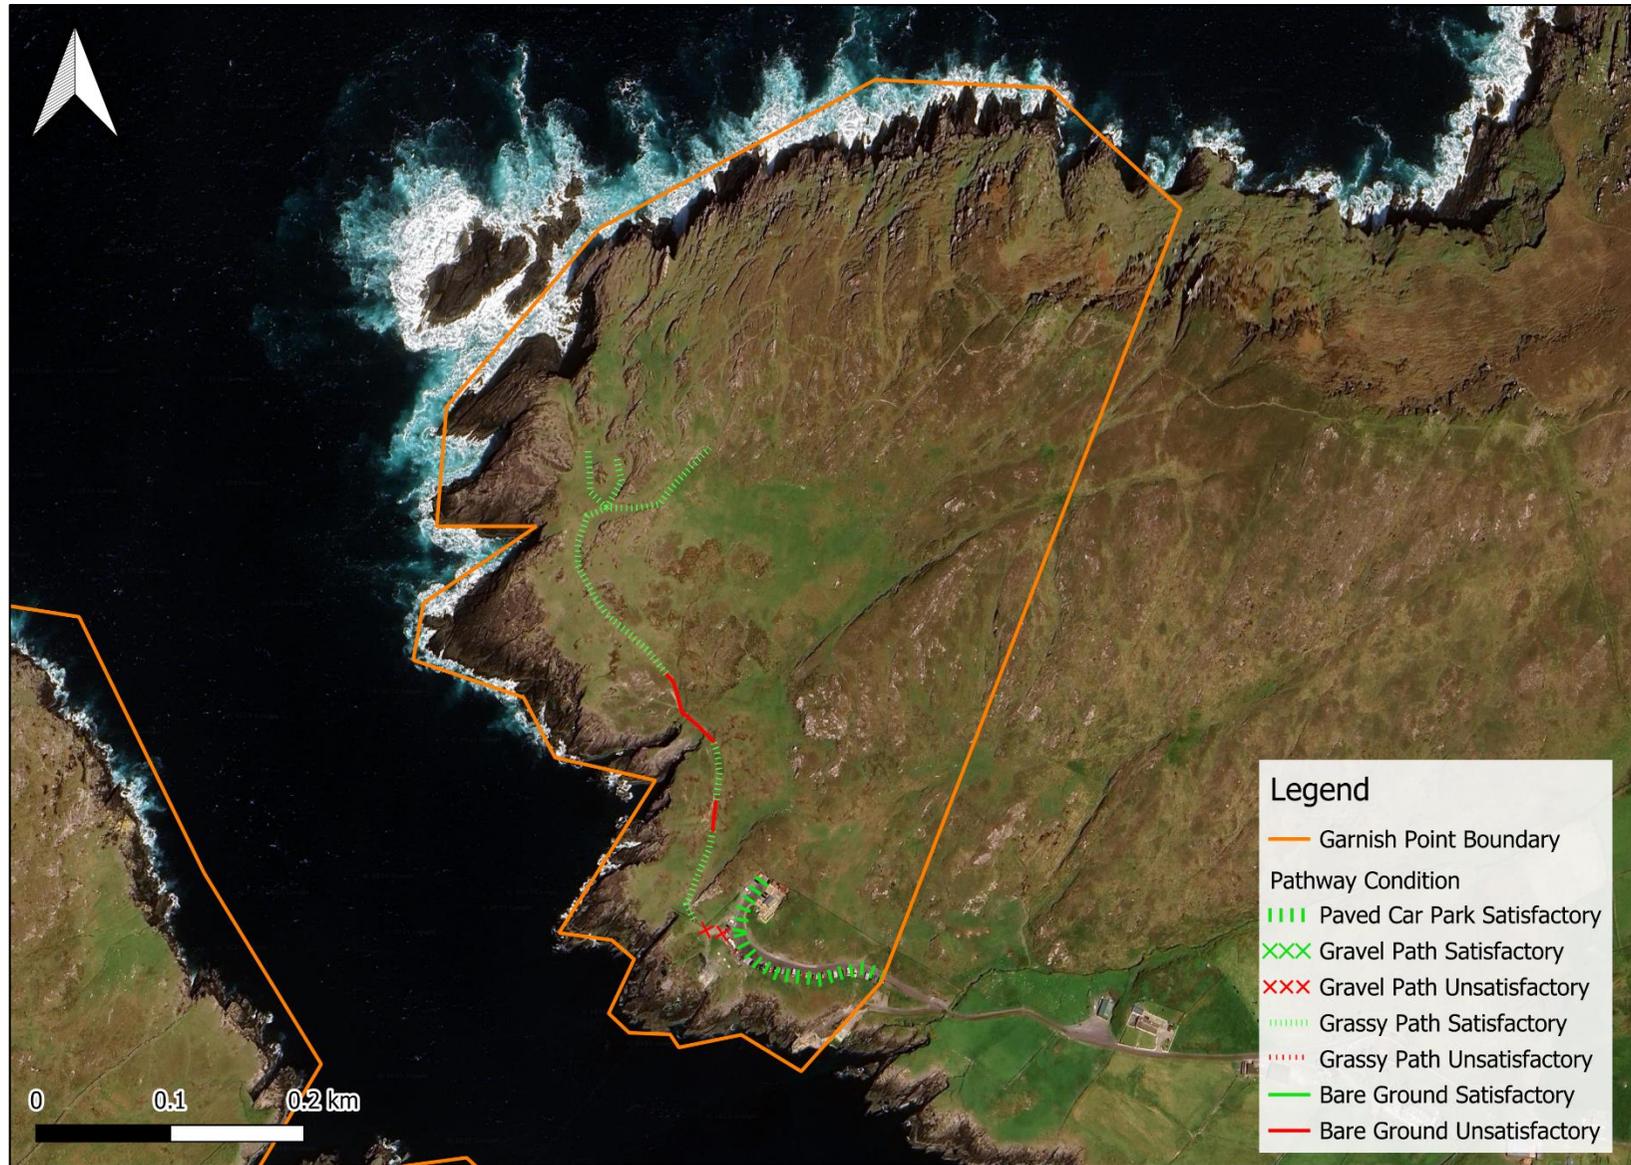
Figure 3.5 Pathway types and conditions present on Garnish Point. Basemap provided by Google.

There is a paved car park on the mainland at the starting point for Garnish Point Loop Trail, which is in a satisfactory condition. There is grassy path in a satisfactory condition at the beginning of Garnish Point Loop Trail. This is the main pathway condition throughout the looped walk, with some areas of unsatisfactory bare ground occurring in places. The main loop walk follows the waymarked points. It should be noted that significant braiding occurs along the looped walk, likely due to the overgrazing and lack of designated pathway. The waymarked points offer a suggested direction, but due to the expanse of low grassy vegetation, there is not considered to be a designated pathway as visitors are likely traversing across the hills rather than along a pathway. This braiding can be seen in Plate 3.6 and Figure 3.6.

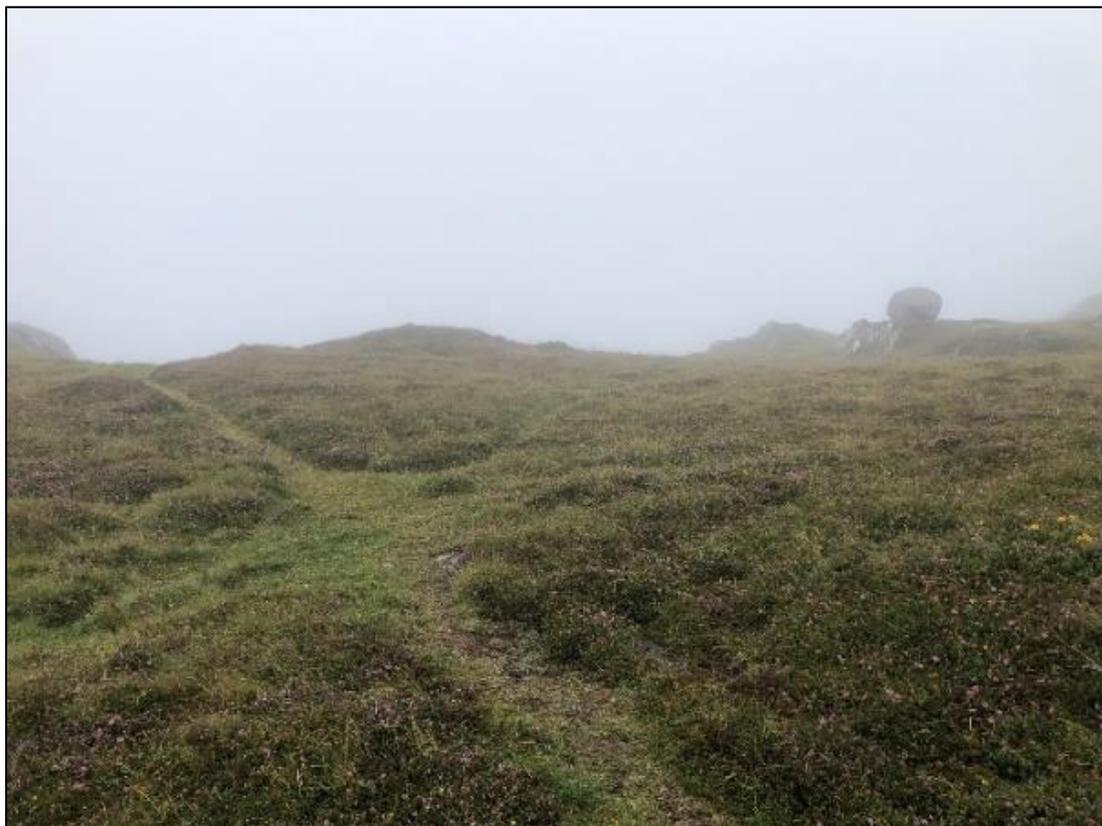
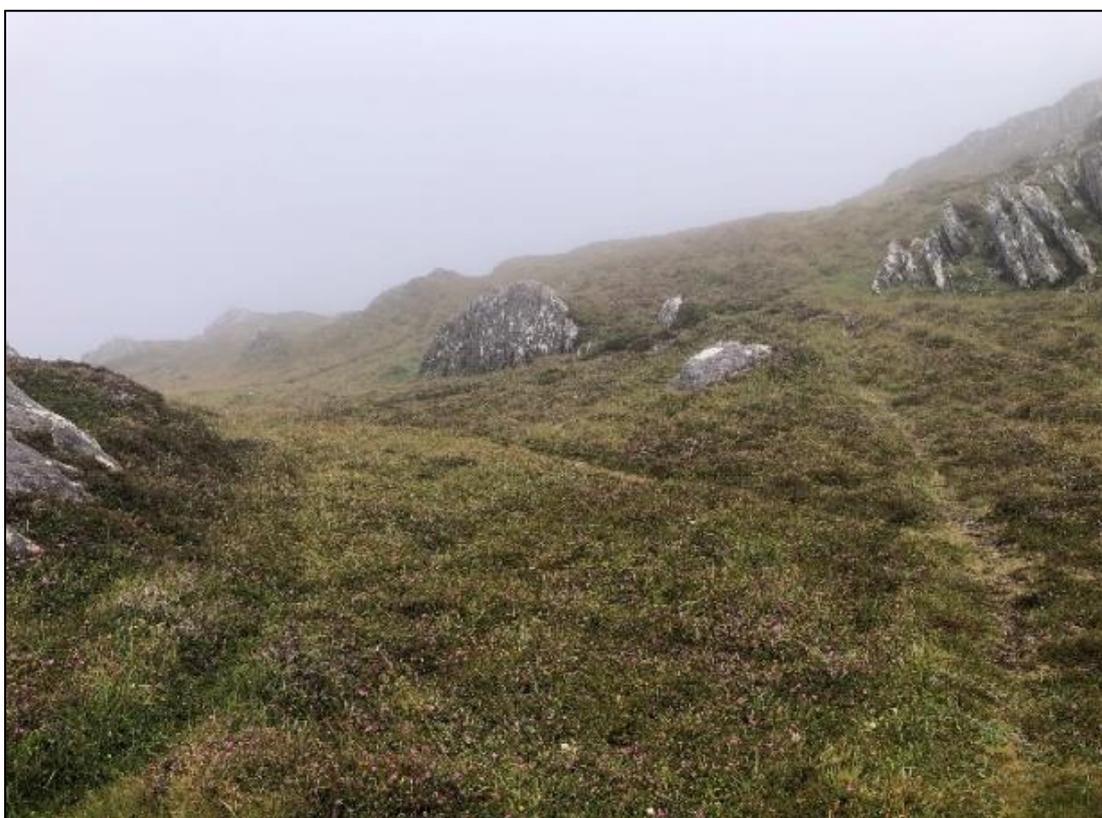
**Plate 3.6 Braiding of grassy paths on the Garnish Point Loop Trail.**

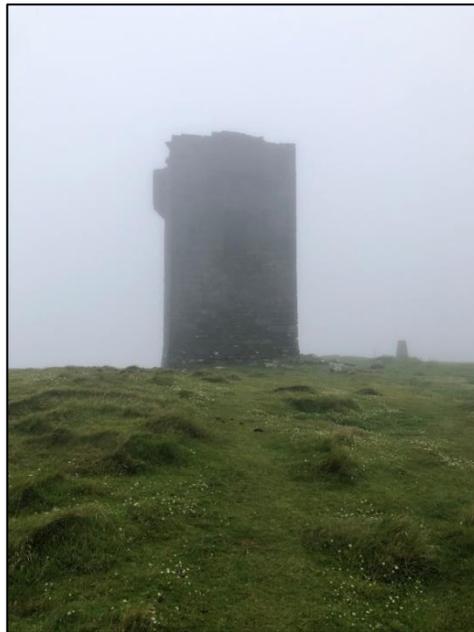
Plate 3.7 Dursey Island Signal Tower located at the highest point of the island.

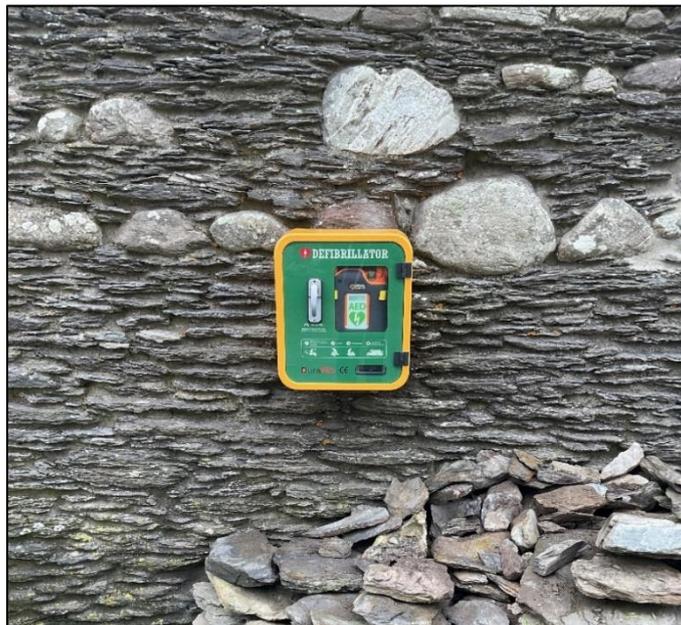
Plate 3.8 Defibrillator recorded in the townland of Ballynacallagh.

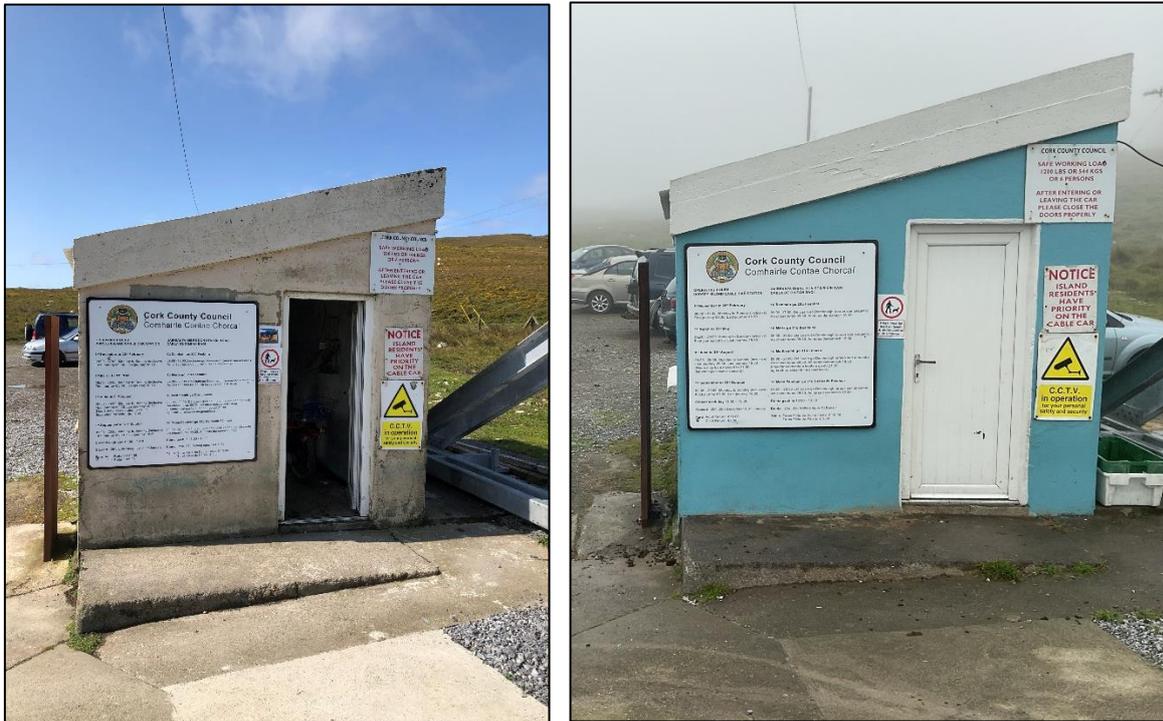
Plate 3.9 Maintenance shed on Dursey Island in 2023 (left) and 2025 (right).

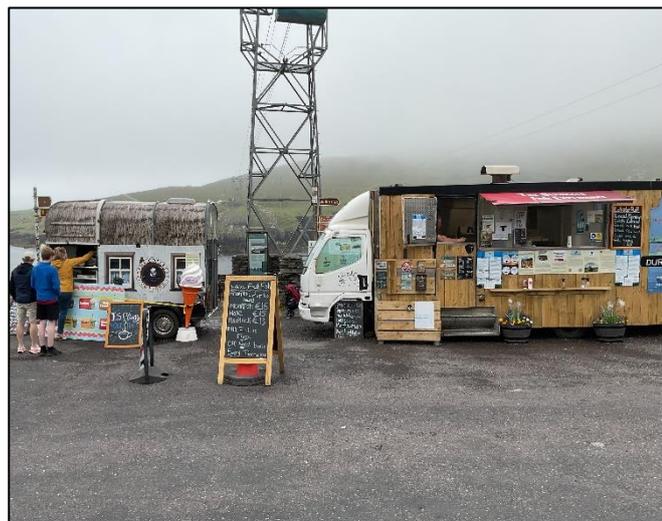
**Plate 3.11** Amenities and signage at the carpark at the start of the Garnish Point Loop Trail.

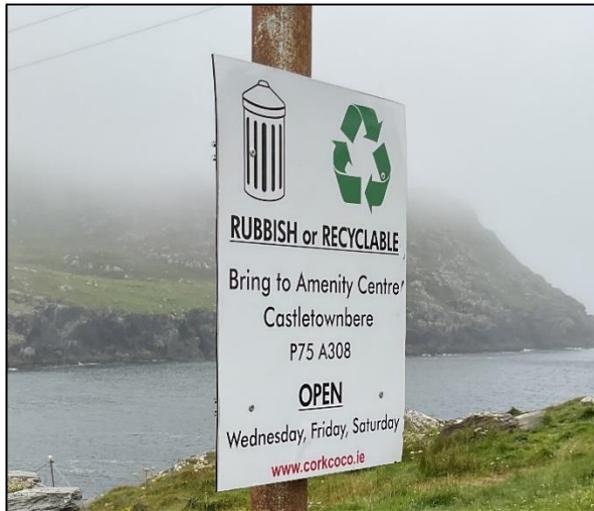
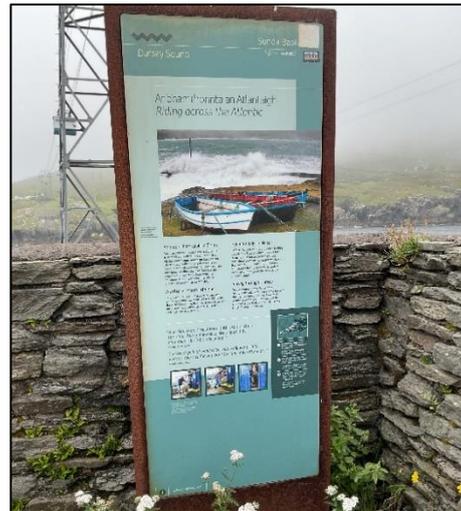
The 2023 National Tourism and Environmental Monitoring Programme Report for Dursey Island recommended that fallen signage be reinstated. A fallen sign recorded in 2023 has been reinstated as of 2025, as shown above in Plate 3.12.

**Plate 3.12** Further signage at the carpark at the start of the Garnish Point Loop Trail.

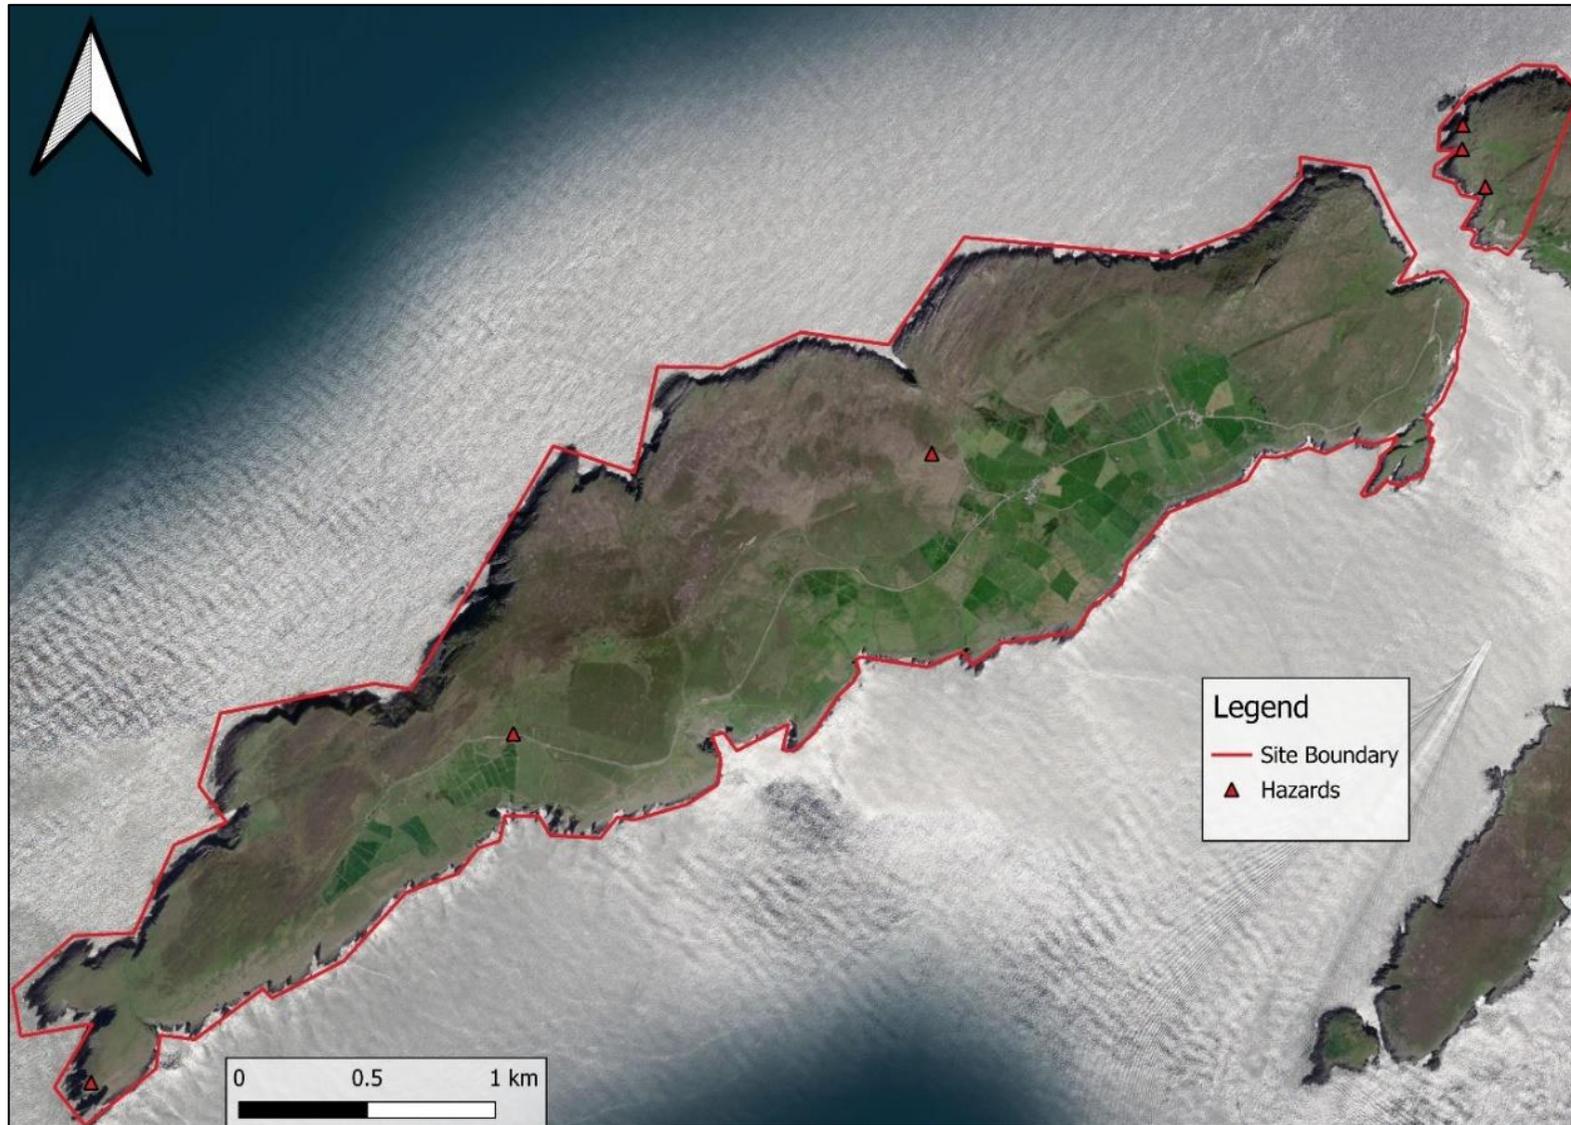
Figure 3.8 Locations of hazards present on site. Basemap provided by Bing.

The steep sea cliffs surrounding the island and the Garnish Point Loop Trail are a hazard. There is no sign at the beginning of the Garnish Point Loop Trail highlighting the cliffs as a hazard. As there are exposed edges, loose gravel and scree on the pathways, trips and falls are a safety hazard (Plate 3.14, Plate 3.15). Along one area close to steep edges, fencing is used, as seen in Plate 3.13. All hazards recorded on site during the survey are mapped below in Figure 3.8.

- At the start of Garnish Point Loop Trail, one sign was recorded regarding the cliff edges. Due to the exposed cliff edges, additional signage warning of the hazardous nature of the steep cliffs, should be provided to limit the risk to users.

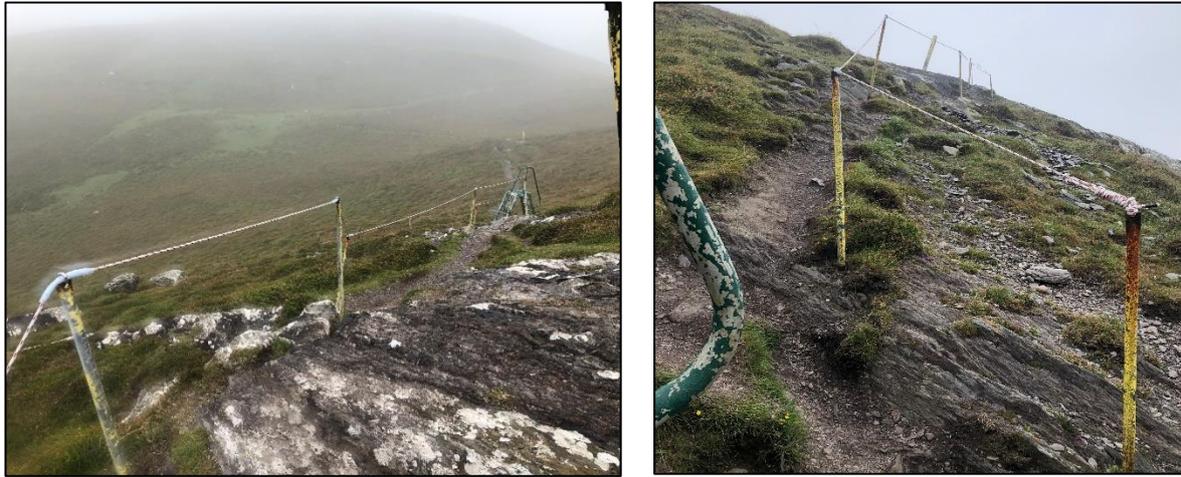
**Plate 3.13** Fencing used in one steep area along the bare ground path on the upper loop.

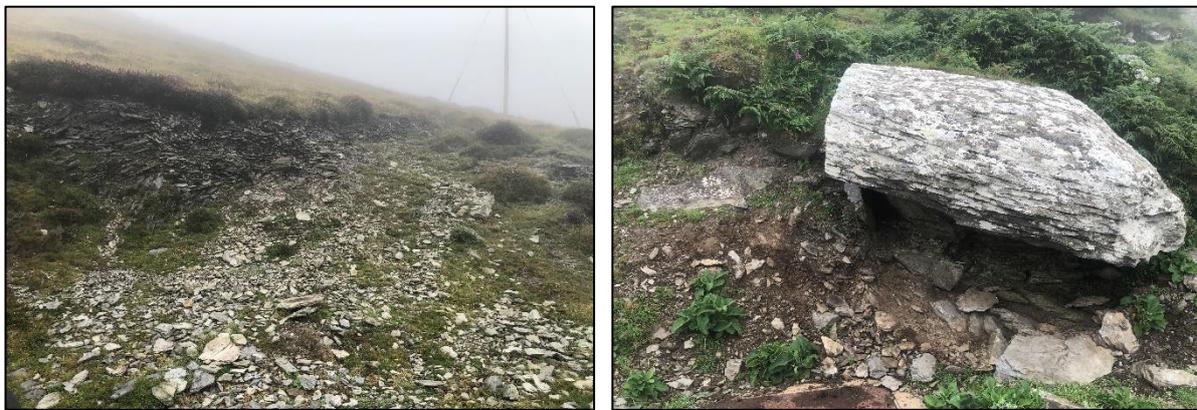
**Plate 3.14** Loose rock and scree recorded as hazards along the pathway.

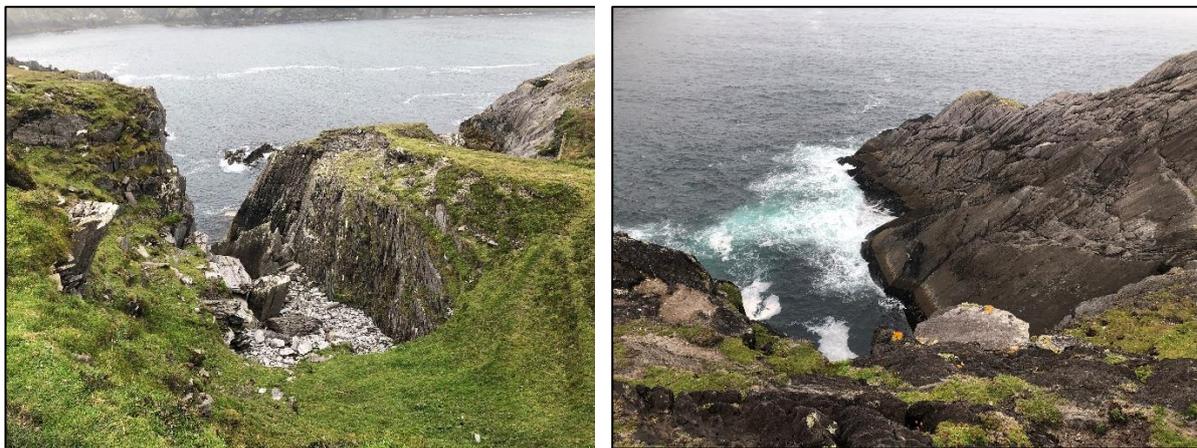
**Plate 3.15** Steep exposed rocky cliffs on the Garnish Point Loop Trail.
