National Tourism and Environmental Monitoring Programme Inch Beach 2024

National Tourism and Environmental Monitoring Programme

Report for Inch Beach 2024

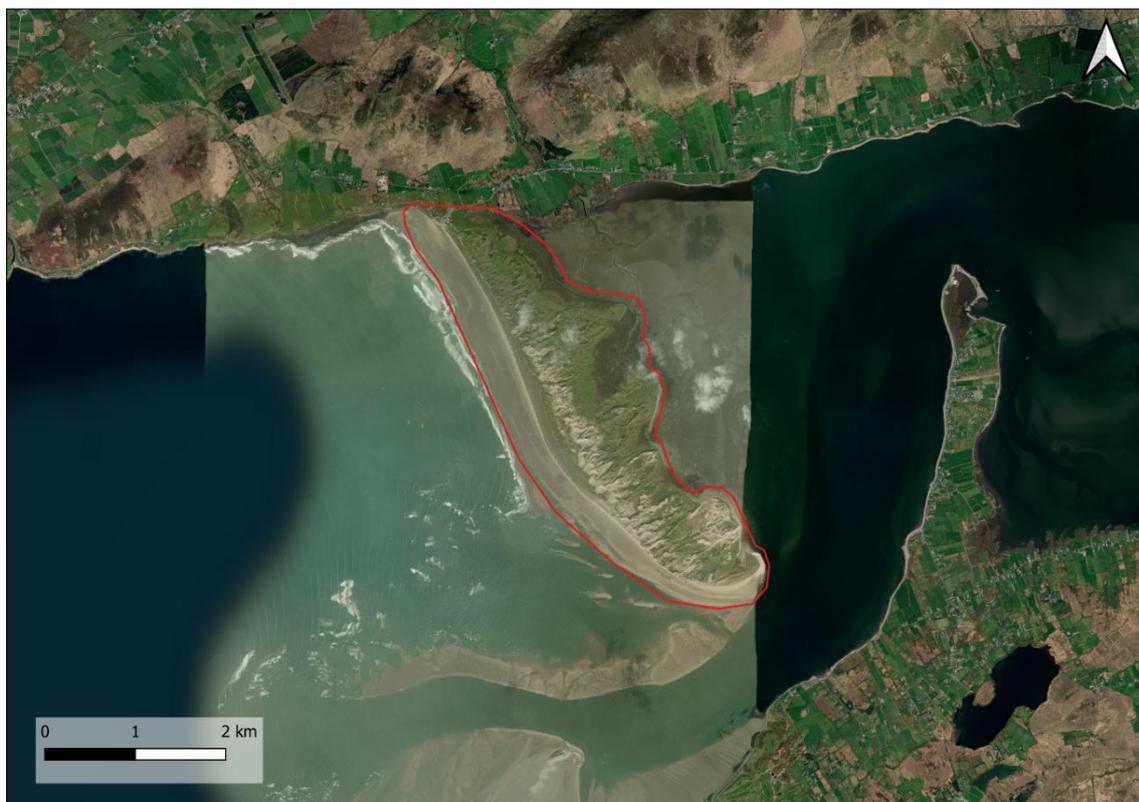
Figure 1.2 Site boundary outlined in red. Basemap provided by ESRI.

Inch Beach is located in Co. Kerry, approximately 1.2km southwest of Inch village, a linear village along the R561. It is accessible via the R561. The area being surveyed for this report ("the site") consists of Inch Beach and the lands to the east. The site boundary is presented in Figure 1.2 below. Parking, public toilets, informative signage, a café and bins are available on site. Inch Beach is a Blue Flag Beach, and lies within the Kerry Seas National Park (Páirc Náisiúnta na Mara, Ciarraí), Ireland's first marine National Park. The Kerry County Development Plan (CDP) notes that the sand dune habitats found in Inch among the most extensive in the southwest of Ireland, some of which are Annex I habitat. They also support a range of species including rare plants and many of special conservation interest. (KCC, 2022). Inch is also among the coastlines in Kerry most at risk of coastal erosion (KCC, 2022).

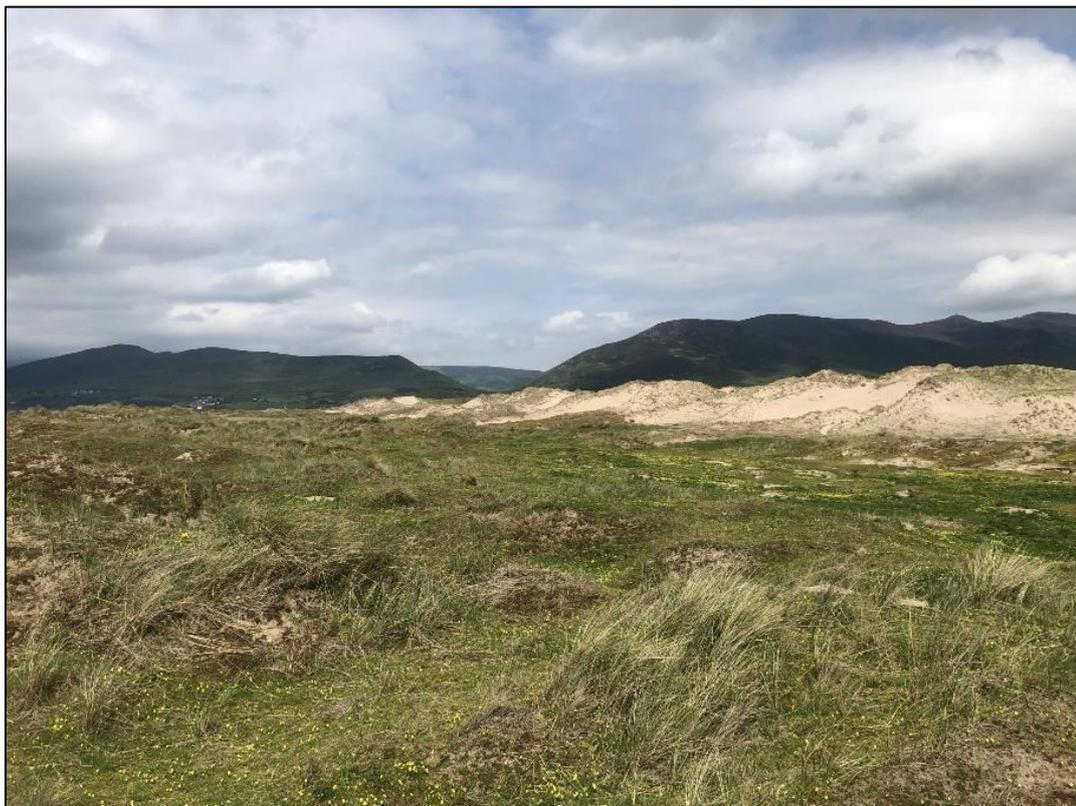
Plate 3.1 Dune habitats at Inch Beach.

Fixed dunes (CD3) are the dominant habitat type at Inch Beach. This habitat is separated from the main beach by narrow stretches of Marram dunes (CD2) and Embryonic dunes (CD1). Visitor pressure has contributed to habitat deterioration. This is discussed further in Section 3.2 below. There are several areas where erosion has led to large areas of bare sand with no vegetation cover. Litter was also recorded in these areas. There was evidence of grazing by rabbits which exacerbated the issue of erosion on the site.

Grasses such as Bents (*Agrostis* spp.) and Marram (*Ammophila arenaria*) were recorded across much of the dunes, with Sand Pansies (*Viola tricolor* ssp. *curtisii*), Speedwells (*Veronica* sp.) Ragwort (*Jacobaea vulgaris*), Yarrow (*Achillea millefolium*), Sea Spurge (*Euphorbia paralias*), Cat's-ear (*Hypochaeris radicata*), Scarlet Pimpernel (*Anagallis arvensis*), Rosebay Willowherb (*Chamaenerion angustifolium*), Common Milkwort (*Polygala vulgaris*), Cut-leaved Crane's-bill (*Geranium dissectum*), Common Bird's-foot Trefoil (*Lotus corniculatus*), Marsh Orchid (*Dactylorhiza Kerryensis*), New Zealand Flax (*Phormium* sp.), Polypody (*Polypodium* sp.), Sand Sedge (*Carex arenaria*), Alder (*Alnus glutinosa*), and mosses also present. White Clover (*Trifolium repens*), Ribwort Plantain (*Plantago lanceolata*), Daisy (*Bellis perennis*), Common Vetch (*Vicia sativa*), Broad-leaved Everlasting-lasting Pea (*Lathyrus latifolius*), and Portland Spurge (*Euphorbia portlandica*) are also present in the northern section of the dunes. This habitat is presented in Plate 3.1 above.

- Erosion of the dune habitat is exacerbated by overgrazing by rabbits. Any dune protection measures should consider the localised exclusion of rabbits, as well as people, using fencing, to allow damaged habitat to recover.

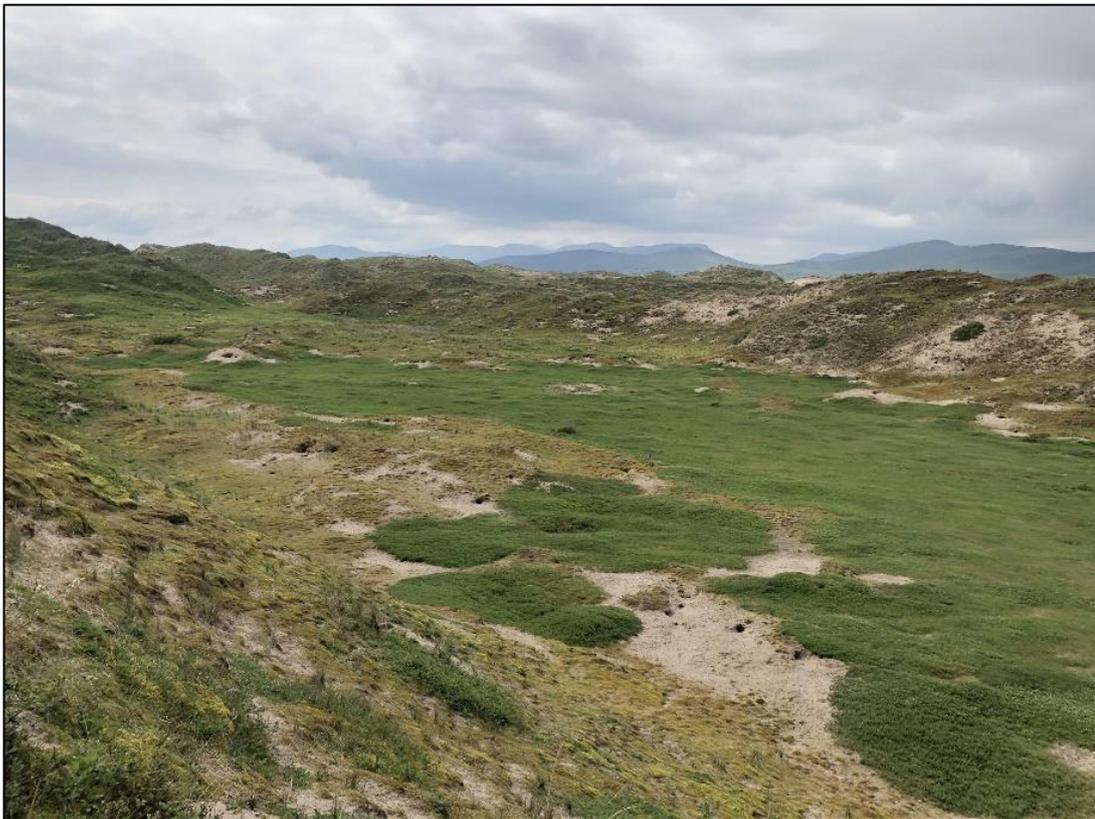
Plate 3.2 Dune Slacks (CD5) habitat at Inch Beach.

Dune slacks is present southwest of the large area of salt marsh at the site, and two small pockets of dune slacks are present in the southeast of the site. Creeping Willow (*Salix repens*) and mosses dominated this habitat. Ragwort, Sand Pansy, Cut-leaved Crane's-bill, Birds-foot Trefoil, Silverweed (*Argentina anserina*), Germander Speedwell (*Veronica chamaedrys*), Daisy, Lesser Spearwort (*Ranunculus flammula*), Common Dog Violet (*Viola riviniana*), Lady's Bedstraw (*Galium verum*), Field Wood-rush (*Luzula campestris*), Soft Rush (*Juncus effusus*), Willows (*Salix* spp.), and Sedges were also found in this habitat. This habitat is displayed in Plate 3.2 below.

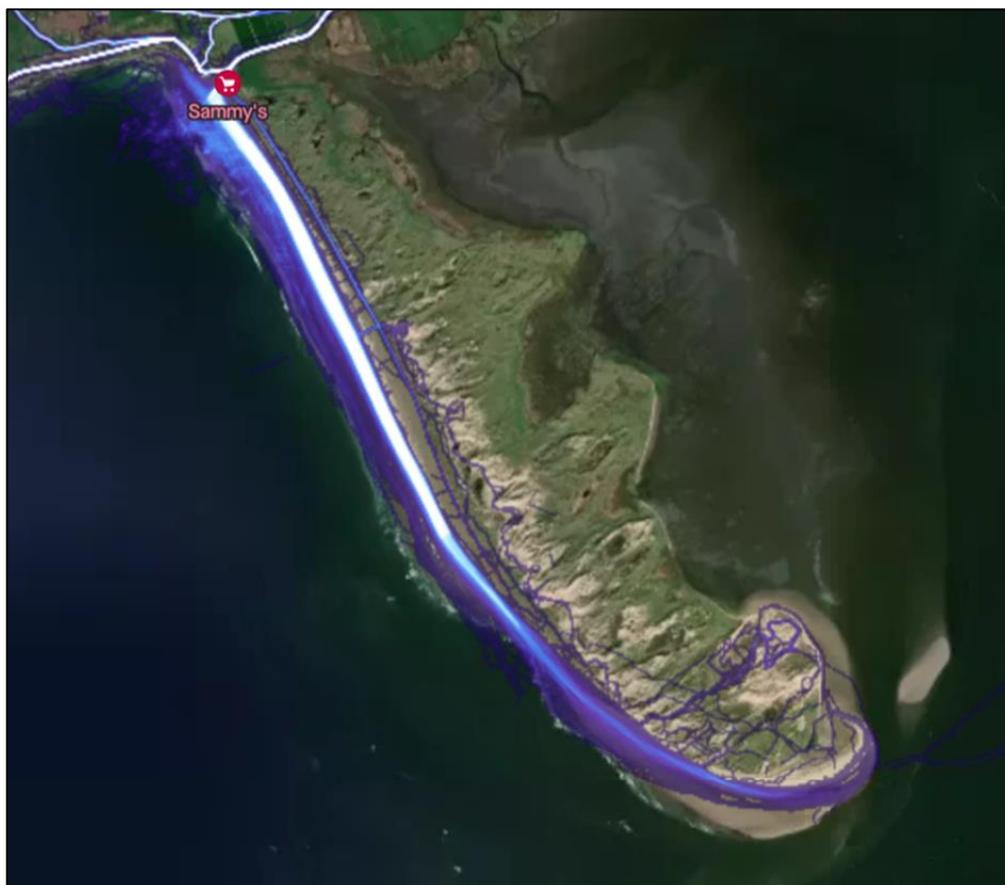
Figure 3.2 Heat map of visitor movements at Inch Beach (Strava, 2024).

Figure 3.2 presents a Strava heat map for the site. Strava aggregates data from users on its app who opt-in to share their activities and locations.

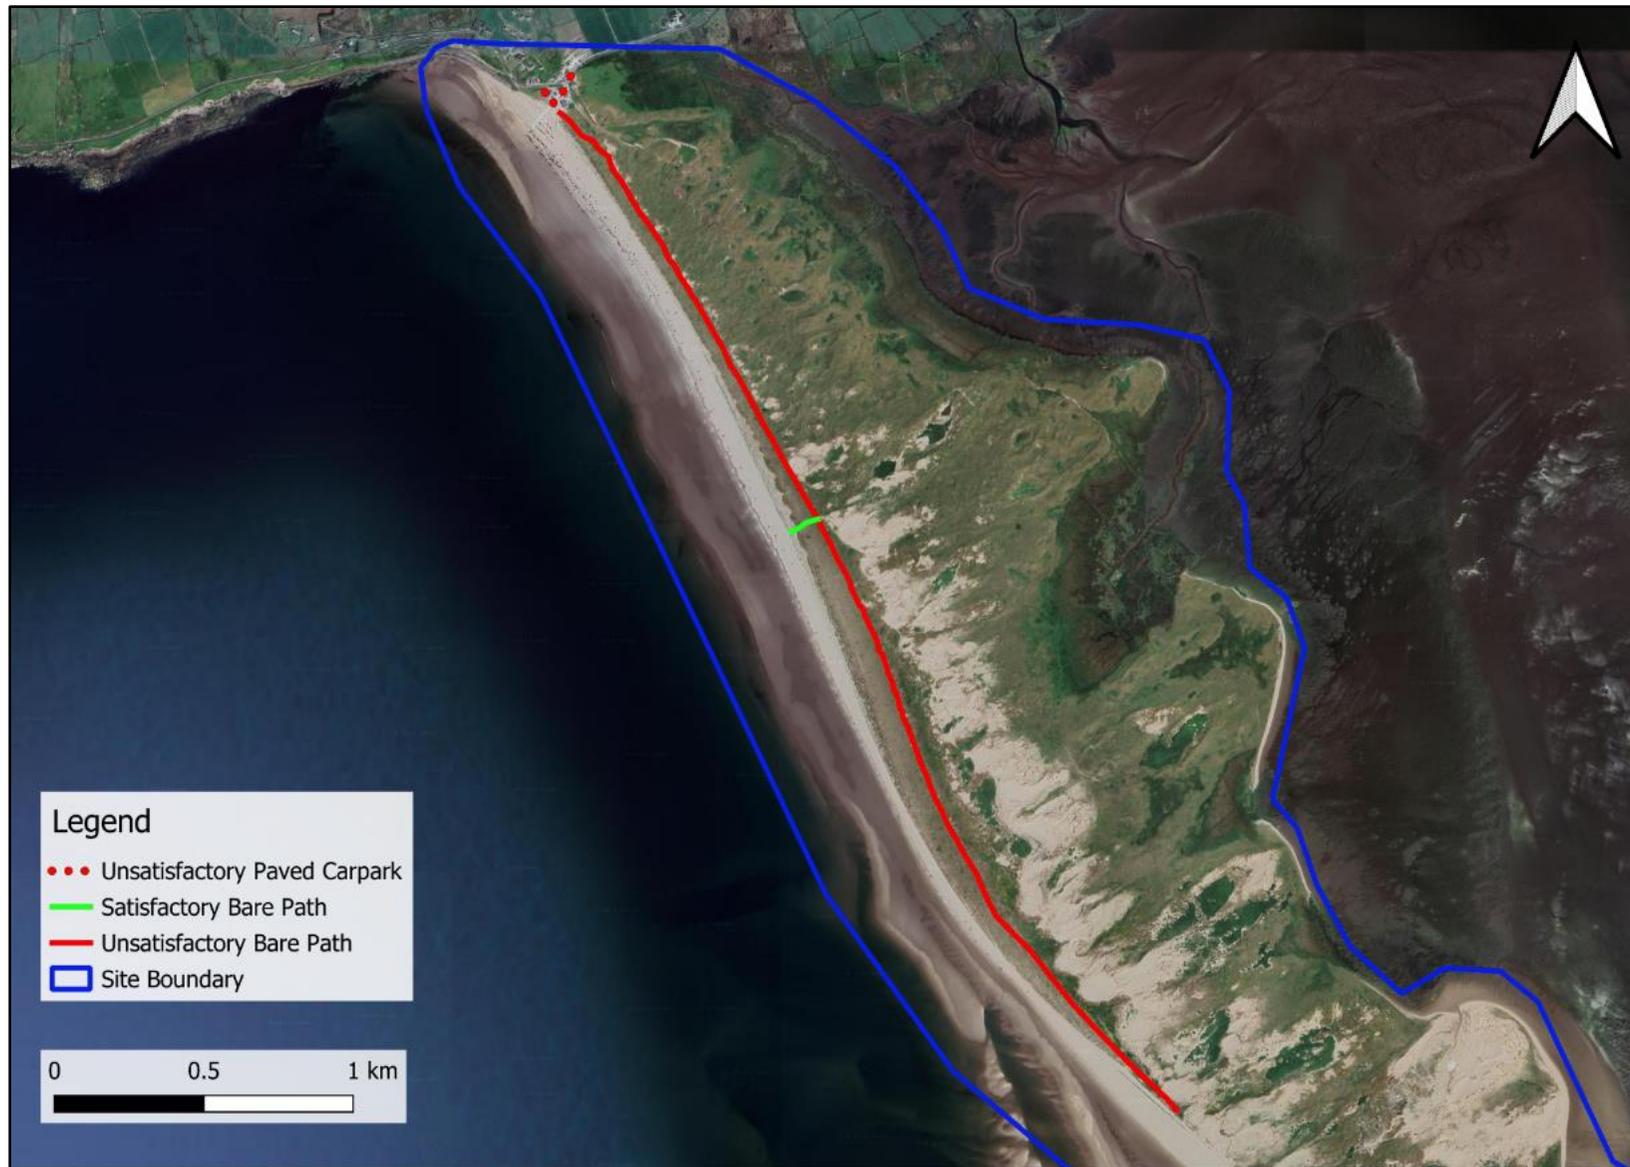
Figure 3.3 Pathway types and conditions present on the site. Basemap provided by Google.

The paved carpark in the north of the site is small and in an unsatisfactory condition. Sand has blown into the carpark. This has resulted in inefficient parking, resulting in fewer space available for parking. This is displayed in the top left corner of Plate 3.4 below. Leading southeast from the carpark, a bare path runs through the dunes, parallel to the beach (See Figure 3.2). Numerous small paths have been created between the beach and the main path running parallel to the beach through the dunes. Due to how widespread nature of the paths, they have not been mapped.

The entirety of this main path is in an unsatisfactory condition. Erosion, widening and braiding occurs along its entire length. This is displayed in the top right corner of Plate 3.4 below, and an example of severe pathway braiding is displayed in the bottom left corner of Plate 3.4. The pathway is approximately 3.9 km in length, after which it gently rejoins the beach at the south end of the site. The only satisfactory pathway recorded on Inch Beach was a small bare pathway approximately 1.5 km south of the carpark. This satisfactory bare path ran perpendicular to the main bare path, between the main beach and the dunes to the east. This path was approximately 1.2 m wide and is considered satisfactory due to its uniformity, and a lack of evidence of the pathway encroaching on the surrounding habitat. This pathway is displayed in the bottom right corner of Plate 3.4 below. The pathway condition assessment map is provided in Figure 3.3.

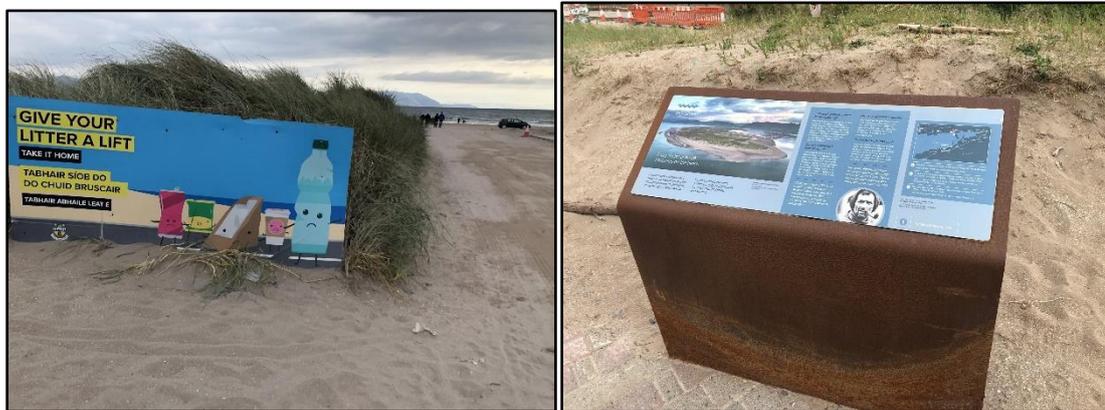
Plate 3.5 Signage regarding littering (left) and history and local heritage (right).

The carpark has limited spaces available, which are difficult to see due to the amount of sand. This is discussed further in Section 3.3.2 below. Due to the limited carparking availability at the beach, visitors are permitted to park on the beach. Rubbish bins are available in the carpark and along the beach access road beside the café. No designated dog waste bins were recorded on the site. Toilet facilities in a shipping container were recorded in the beach carpark at the time of the survey. The café is located on the southside of the beach access road to the carpark. There are a number of picnic benches for café patrons separated from the beach by large rocks. Signage (Plate 3.5, 3.6) relating to beach safety, parking, history and local heritage, geology, biodiversity, and the beach is at the beach carpark and the café patio. Some signs have deteriorated and are difficult to read. Signage has been erected along the chestnut fencing in the carpark, indicating that dune restoration works were being undertaken. Some of these signs have fallen or become covered over by marram grass, rendering some of the signs illegible. Deteriorated and fallen signage is presented below in Plate 3.6 below.

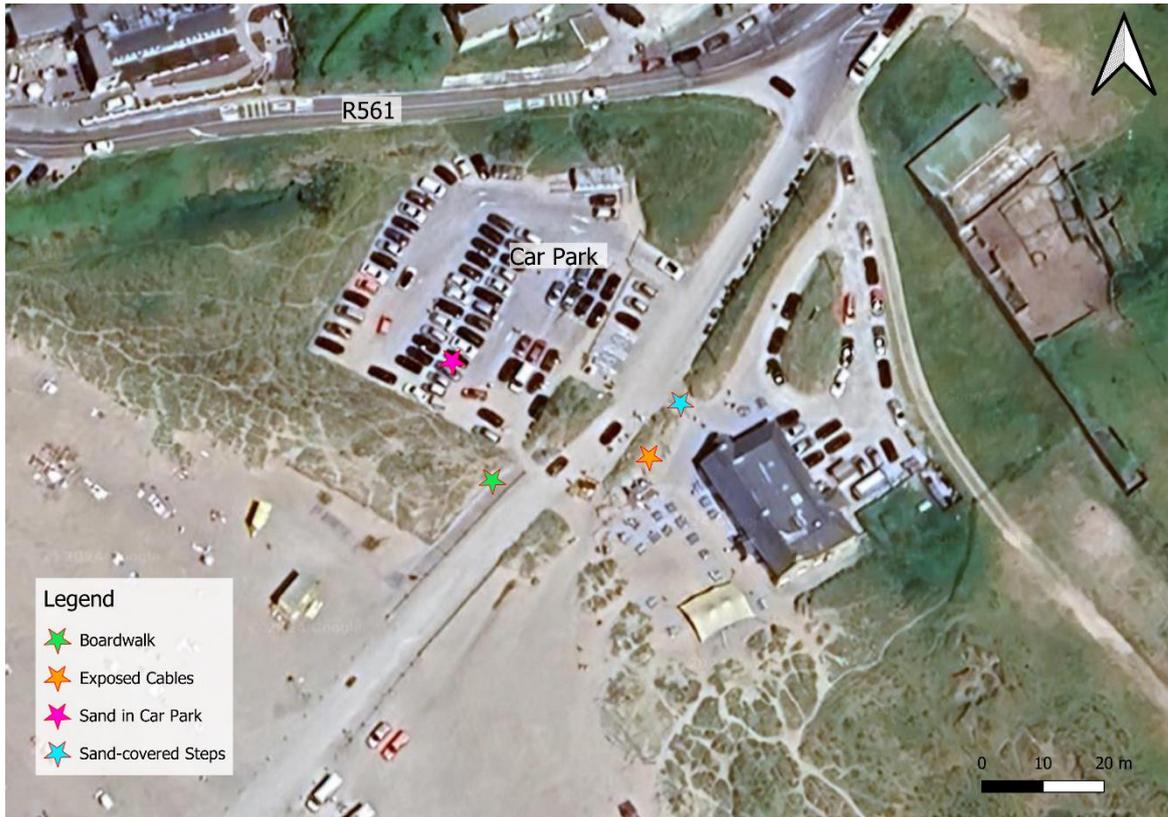
Figure 3.4 Hazards encountered at Inch Beach (all located near the car park). Basemap provided by Google.

Sand has been blown onto a significant area of the carpark at Inch Beach covering the road markings. The sand is not deep enough to affect accessibility and the result is limited to cars parking further apart than they would if the spaces were marked. This will in turn lead to more pressure for parking outside the car park. Additionally, the steps to the café from the beach access road across from the carpark are also covered in sand, creating a potential risk for visitors to slip or fall. An incomplete or temporary boardwalk² was installed between the carpark and the beach, presumably for safer pedestrian access to the beach. However, this boardwalk is in poor condition and was closed-off to the public at the time of the survey. As a result, the area for safe pedestrian passage to the beach is reduced, causing visitors to have to walk closer to traffic. Barriers around the boardwalk are blocking access to information signage. Exposed cables connected to a utilities box close to the carpark was recorded. This is likely to service commercial activities on the beach and to allow them to operate without the need for generators. site. The exposed cables are a trip hazard, and their presence might also lead to vandalism and a risk of electrocution. The potential hazards are presented in Plate 3.7 below. The locations of each hazard are presented below in Figure 3.4.

² Since the site visit was undertaken for Inch Beach, Fáilte Ireland visitor monitoring was undertaken and identifies some of these hazards as being resolved, including the removal and replacement of the boardwalk (See Appendix 1).
