Keem Bay

National Tourism and Environmental Monitoring Programme

Report for Keem Bay 2025

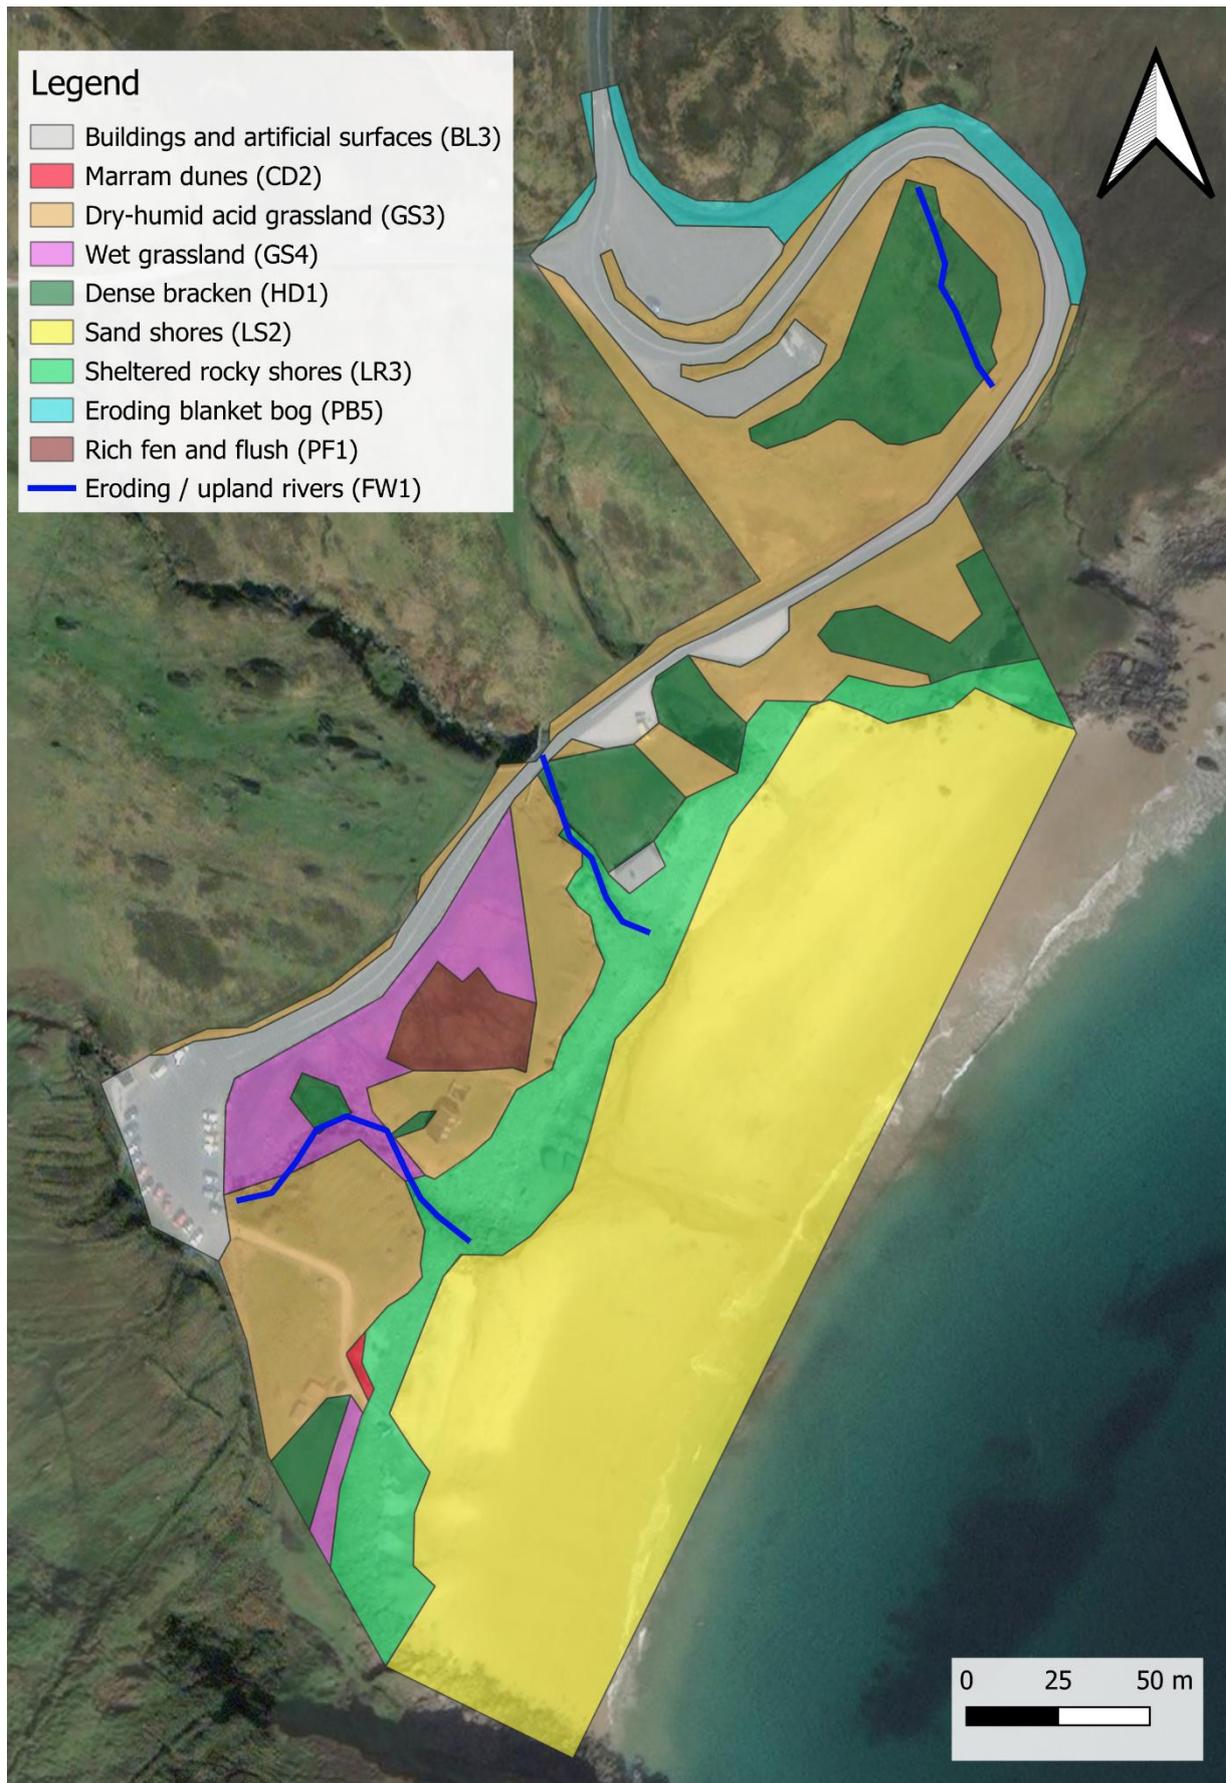
Figure 3-1 Habitat map of Keem Bay. Basemap provided by Bing.

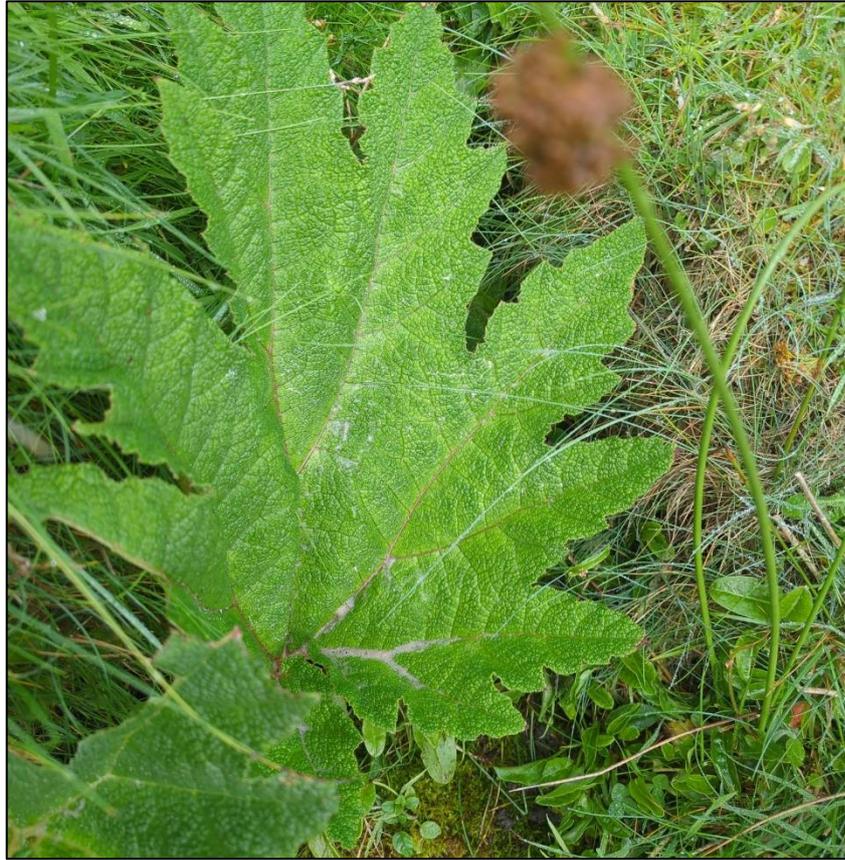
A single stand of invasive giant-rhubarb was recorded in the strip of wet grassland southwest of the lifeguard hut (shown below in Plate 3-1). This plant is listed on the third schedule of the European Union (Invasive Alien Species) Regulations 2024 S.I. No. 374/2024.

Plate 3-1 Giant-rhubarb (*Gunnera tinctoria*) in an area of wet grassland southwest of the lifeguard hut.

- The treatment of the stand of giant-rhubarb (*Gunnera tinctoria*) at the site should be prioritised to prevent the further spread of this species.
- Additional signage should be considered to inform visitors about the two SACs (Achill Head SAC and Croaghan / Slievemore SAC) in which the site is located, and about the biodiversity that is present at the site.

- Treatment of the stand of giant-rhubarb located southwest of the lifeguard hut should be prioritised to prevent the further spread of this species throughout the site.
- The installation of further signage should be considered to inform visitors about the two SACs (Achill Head SAC and Croaghan / Slievemore SAC) in which the site is located. This could be complemented with signage containing information on the biodiversity present the site (interesting/rare species, habitats, plants etc.).

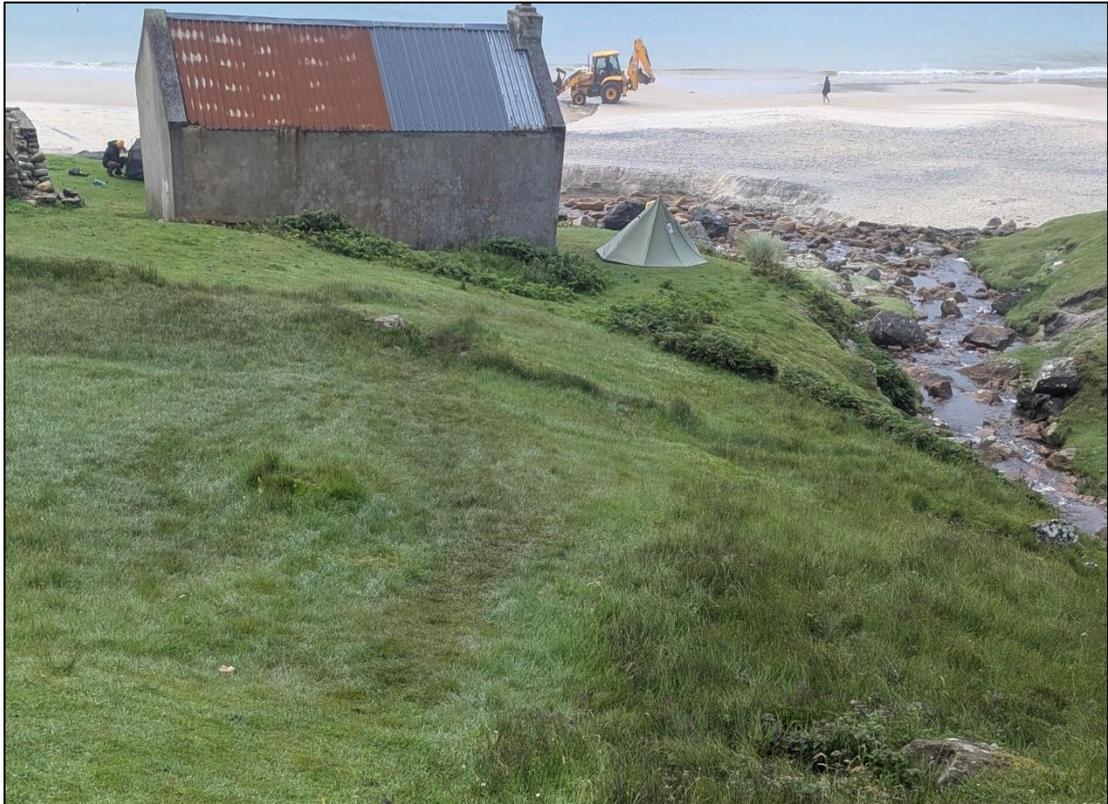
Plate 3-2 Dry-humid acid grassland (left foreground/middle ground), wet grassland (right foreground), eroding/upland rivers (right middle ground), dense bracken (centre middle ground), sheltered rocky shores (right middle ground/background) and sand shores (background).

This habitat is found in the area between the upper car parks and the road leading down to the lower car park. It also forms a mosaic with various other habitats between the road and the beach area. It is largely grazed by sheep. Species recorded in this habitat include borage (*Borago officinalis*), broadleaf plantain (*Plantago major*), common chickweed (*Stellaria media*), common daisy (*Bellis perennis*), common scurvygrass (*Cochlearia officinalis*), common sorrel (*Rumex acetosa*), creeping thistle (*Cirsium discolor*), crested dog's-tail (*Cynosurus cristatus*), lesser spearwort (*Ranunculus flammula*), ribwort plantain (*Plantago lanceolata*), self-heal (*Prunella vulgaris*), spear thistle (*Cirsium vulgare*), smooth meadow-grass (*Poa pratensis*), white clover (*Trifolium repens*), yarrow (*Achillea millefolium*) and Yorkshire fog (*Holcus lanatus*). This habitat is shown below in Plates 3-2 and 3-3.

This habitat comprises three narrow, unnamed streams flowing in a southerly direction from the upland areas at Keem Bay towards the beach area. Species recorded within this habitat were colt's-foot (*Tussilago farfara*), marsh pennywort (*Hydrocotyle vulgaris*) and water-cress (*Nasturtium officinale*). This habitat is shown below in Plate 3-2 and Plate 3-3.

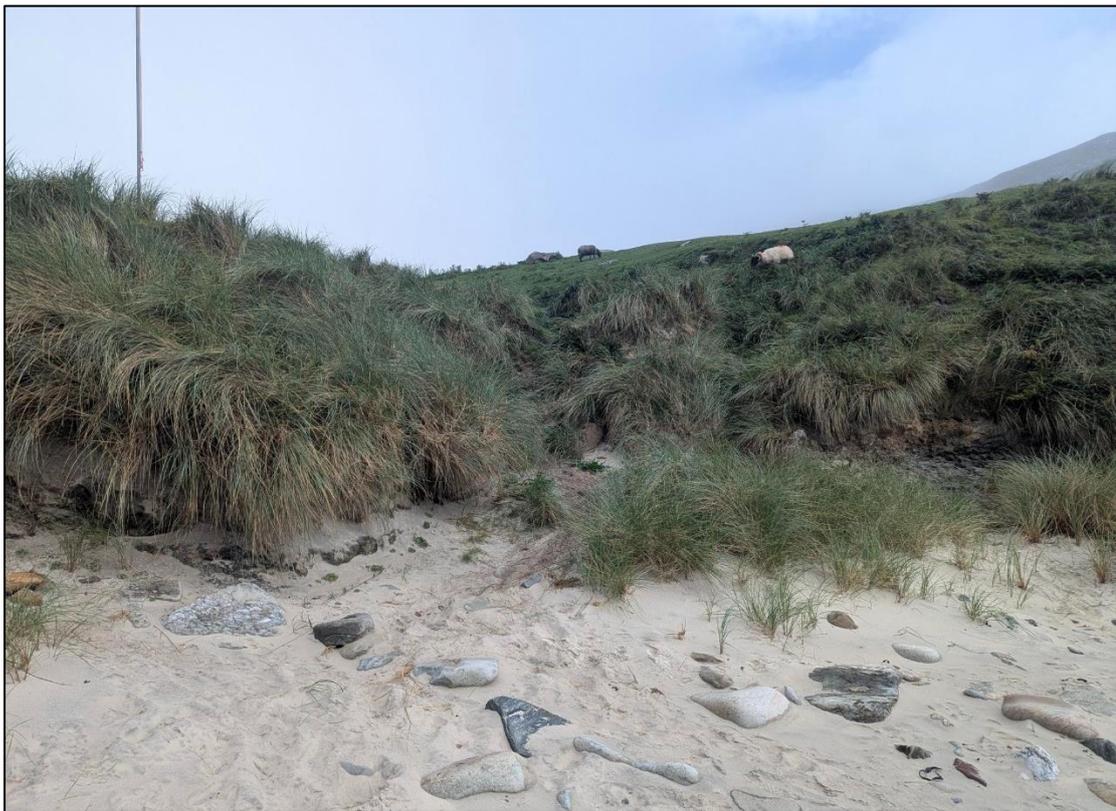
Plate 3-4 Marram dunes.

A very small area of this habitat is found directly adjacent to the access path to the beach. It is comprised of bare sand and dense tussocks of marram (*Ammophila arenaria*). This habitat is shown below in Plate 3-4.

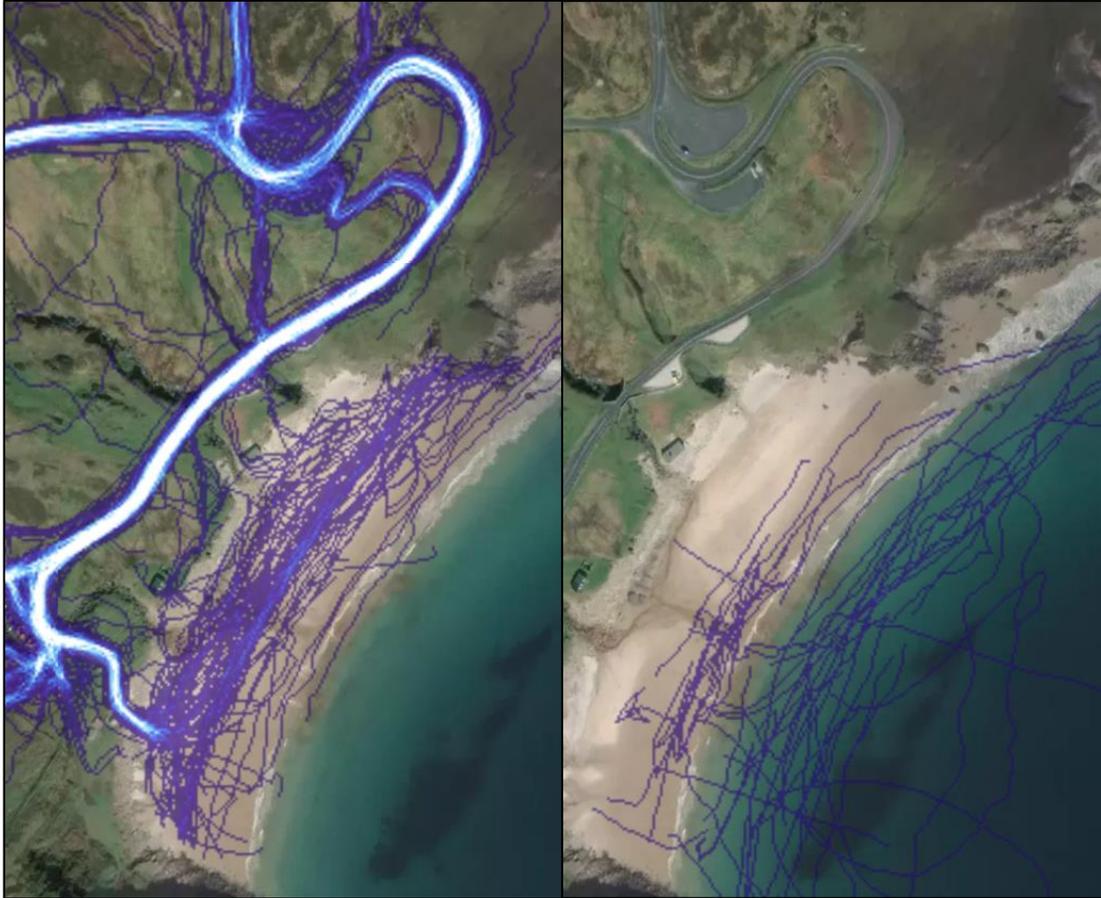
Figure 3-2 Heat map of visitor movements classed under “Foot Sports” (left) and “Water Sports” (right) at Keem Bay (Strava, 2025).

Figure 3-2 presents Strava heat maps for the site. Strava aggregates data from users on its app who opt-in to share their activities and locations. The pathway condition assessment map is presented in Figure 3-3 below.

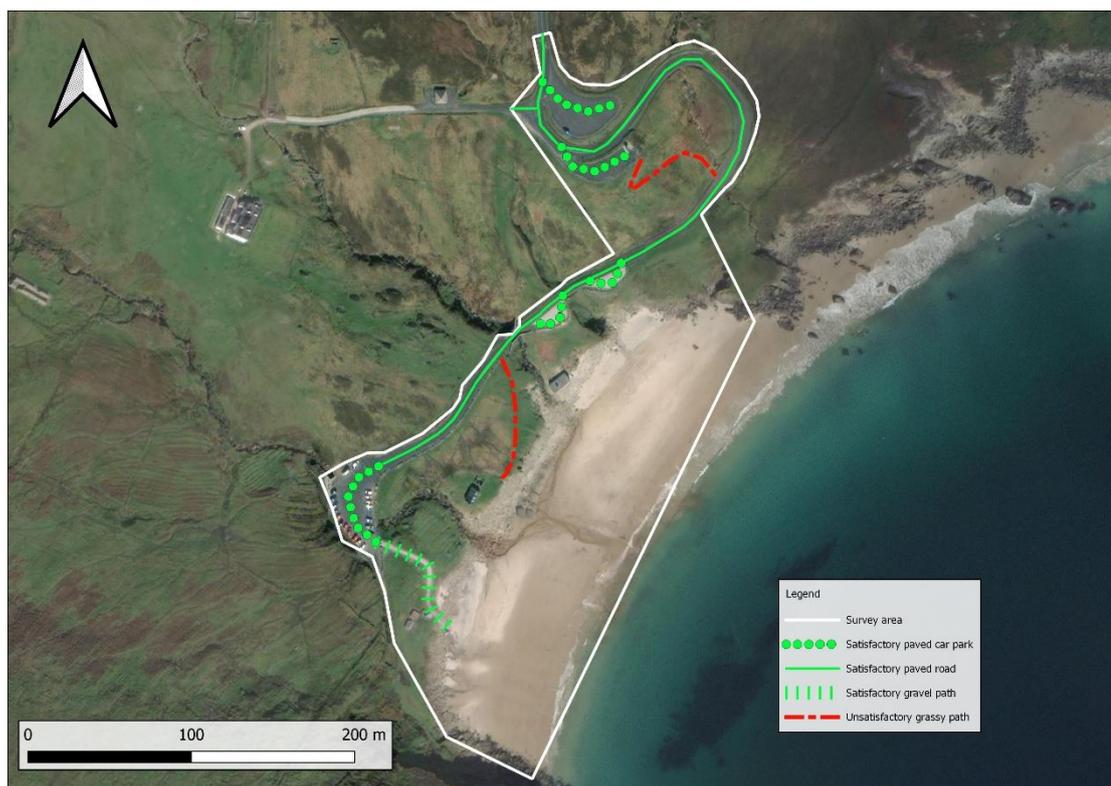
Figure 3-3 Pathway types and conditions present at Keem Bay

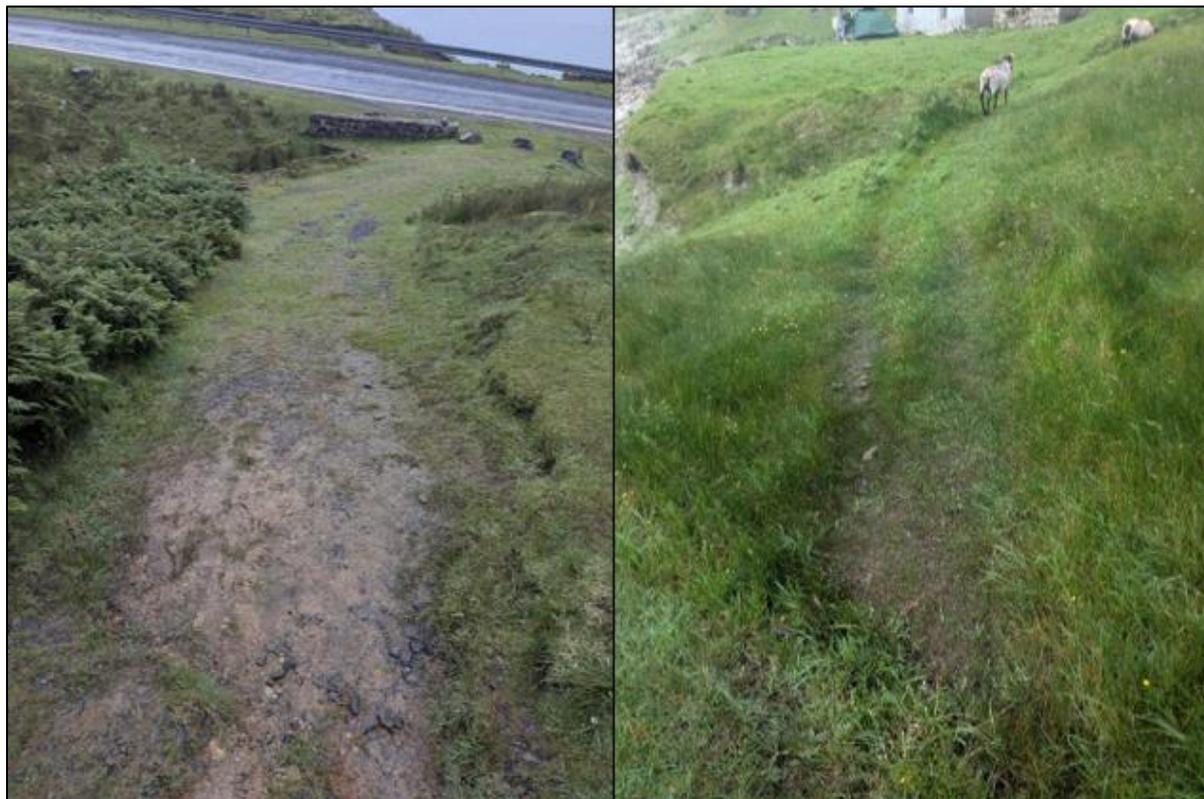
At Keem Bay, a paved road connected to the R319 at the north of the site winds southward from the upper car park down to the lower car park. From this area, access to the beach area is provided by a paved gravel path. Both the road and the gravel path are in a satisfactory condition. Two small, paved areas overlooking the bay are located at the midpoint of the access road into the site. These areas are in a satisfactory condition and function as viewing areas and as car parks for a small number of cars. Two informal grassy paths are present at the site, which are desire lines that allow pedestrians to take shortcuts without having to follow the winding road between the car park and the beach. The first of these paths travels from the upper car park down to the road. The second path travels from the bridge area to the old house/ruin beside the beach. Neither of these paths have been formalised and are likely a result of pedestrians trying to travel to old house/beach area as directly as possible (i.e., avoiding the road). As such, both of these paths are in unsatisfactory condition due to the trampling of vegetation which has caused some erosion and degradation of the grassland habitats through which they travel (see Plate 3-5 below). There are also numerous areas where trampling was evident in the acid grassland behind the beach.

Plate 3-5 Informal grassy paths in unsatisfactory condition due to erosion leading to slippery conditions.

- The formalisation of the two informal grassy paths that are present at the site should be considered to prevent habitat degradation in these areas and to facilitate improved access of pedestrians.

- Consideration should be given towards the formalisation of the two existing informal grassy paths between the upper car park area and the road, and the road and the old house/ruin area. This would prevent further degradation of the habitats in these areas and provide a direct route for visitors to one of the primary attractions at the site. This could be implemented with in-laid stone steps in harmony with the character of the site. An example where this has been achieved is at Sliabh Liag, Co. Donegal (Plate 4-1 below).

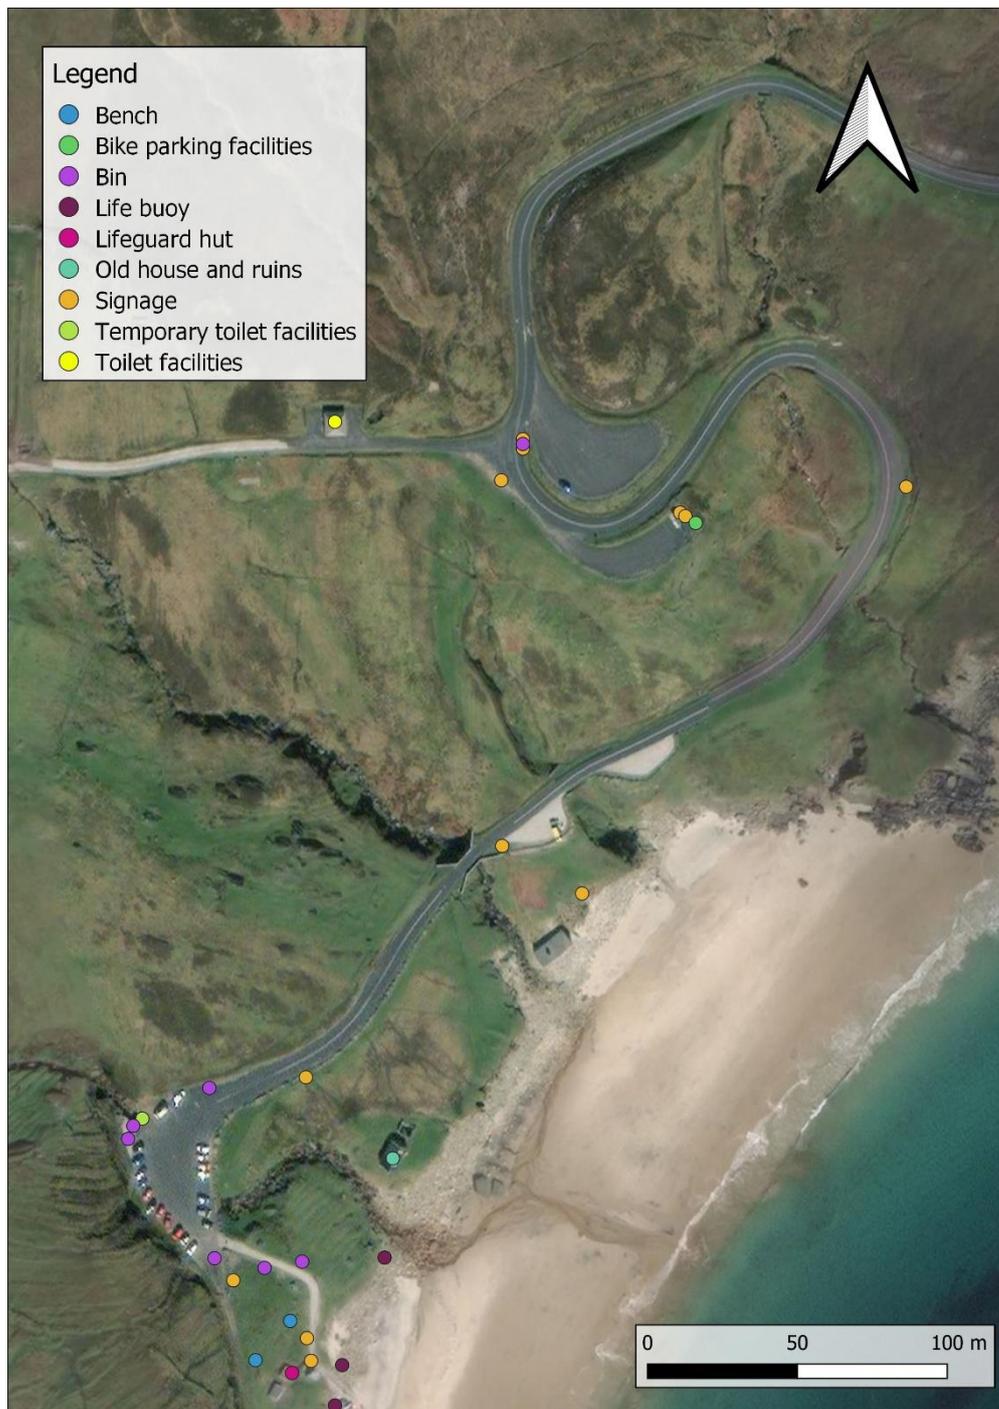
Bicycle parking facilities are available at the upper car park area. Toilet facilities are located west of the upper car parks and within the lower car park area. A coffee van and food truck are located at the lower car park area, along with several picnic benches. A lifeguard hut is located on site, with life buoys present along the beach. Figure 3-6 illustrates the features and signage present at Keem Bay.

Figure 3-6 Features and signage mapped at Keem Bay. Basemap provided by Google.

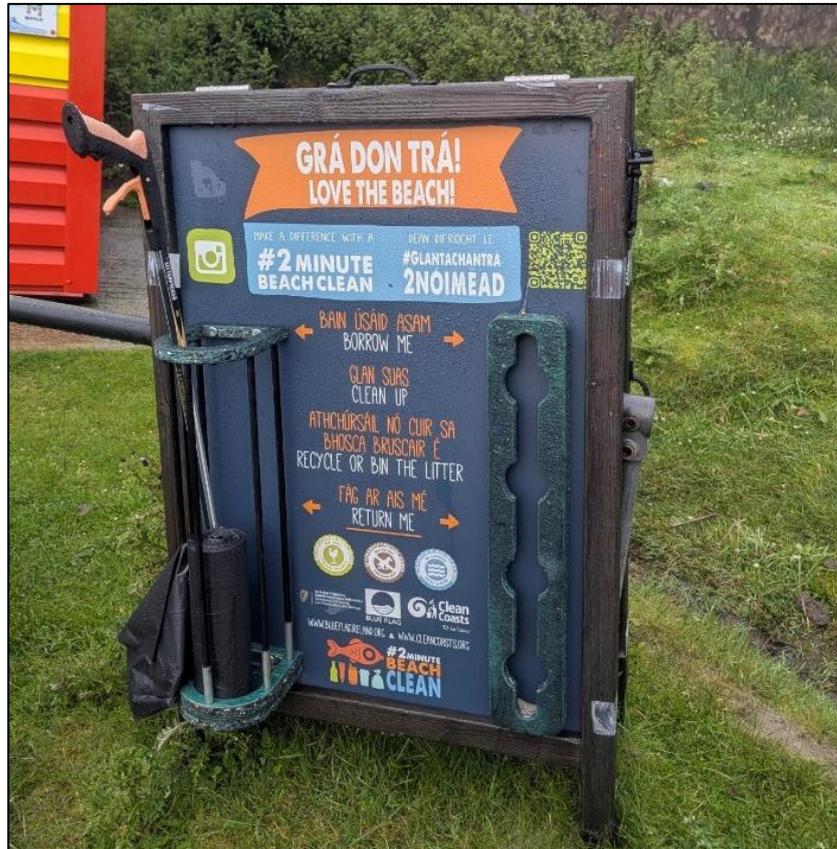
A total of 7 No. bins are located throughout the site, which was notably litter-free at the time of surveying. A sign instructing visitors to pick up litter with an accompanying litter picker and waste bag is located in front of the lifeguard hut (shown below in Plate 3-6). A warden is employed at the site by Mayo County Council during the summer months.

Plate 3-6 Signage instructing visitors to remove litter with an accompanying litter picker and waste bags.

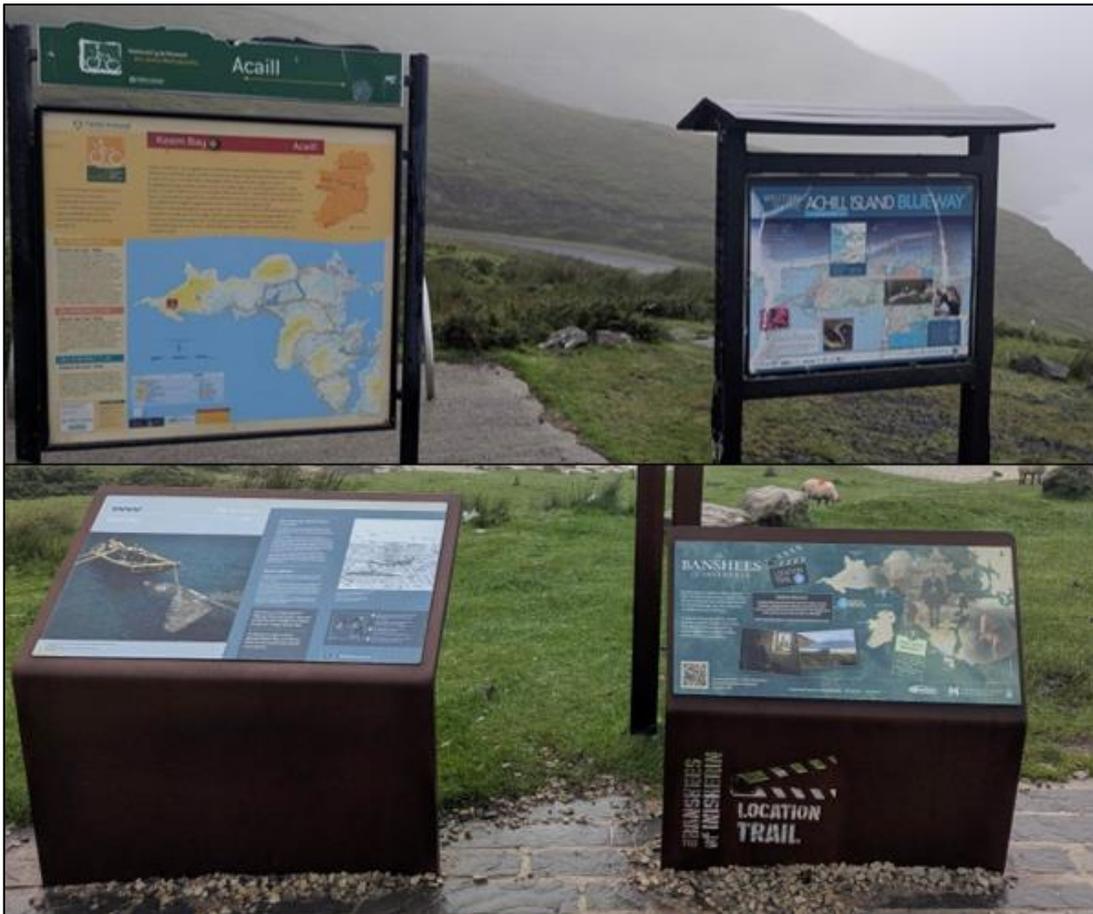
Plate 3-7 Informational signage at the upper and lower car parks.

Informational signage regarding the history of the site, walking and cycling trails in the vicinity and information on the Achill Island Blueway are located at the car park areas. Signage instructing visitors against overnight camping, parking camper vans, lighting campfires, the removal of beach material and walking dogs off leads are located throughout the site. Signage outside the lifeguard hut provides information on the lifeguard flag codes and advises visitors to seek information from the lifeguards before entering the water. An old house/ruin is located to the west of the lower car park. At the time of the survey, a number of visitors were noted camping in front of this house and at the north end of the beach. Plate 3-7, Plate 3-8 and Plate 3-9 below show some of the signage at the site and the old house/ruin.

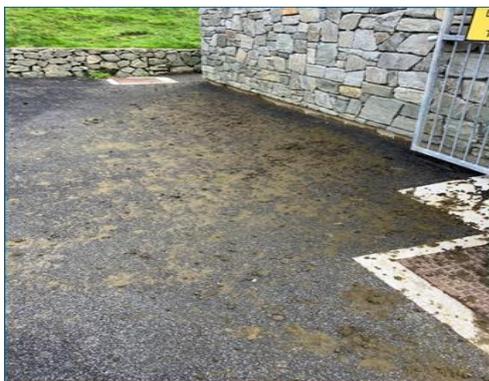
Waste bins were observed well maintained and the toilet block also clean inside. The exterior of toilet ground was observed covered in sheep droppings (see photo) with sheep most likely using the building to shelter from the wind/rain.

Photo 2: Exterior of Toilet block covered in sheep droppings
