# National Tourism and Environmental Monitoring Programme Lisfannon Beach 2024

## Report for Lisfannon Beach 2024

Lisfannon Beach is located in Co. Donegal, northwest of Fahan. Lisfannon Beach is accessible by vehicle via the Railway Road (R238) or by walking approximately 20 minutes via a footpath from Fahan. The area being surveyed for this report (“the site”) consists of the lands at Lisfannon Beach and the Lough Swilly Marina. The site boundary is presented in Figure 1.2 below. Informative signage, dog waste bins, and car and bike parking facilities are available on site. Lisfannon Beach has previously held a Blue Flag award but has not retain it in recent years due to water quality issues.

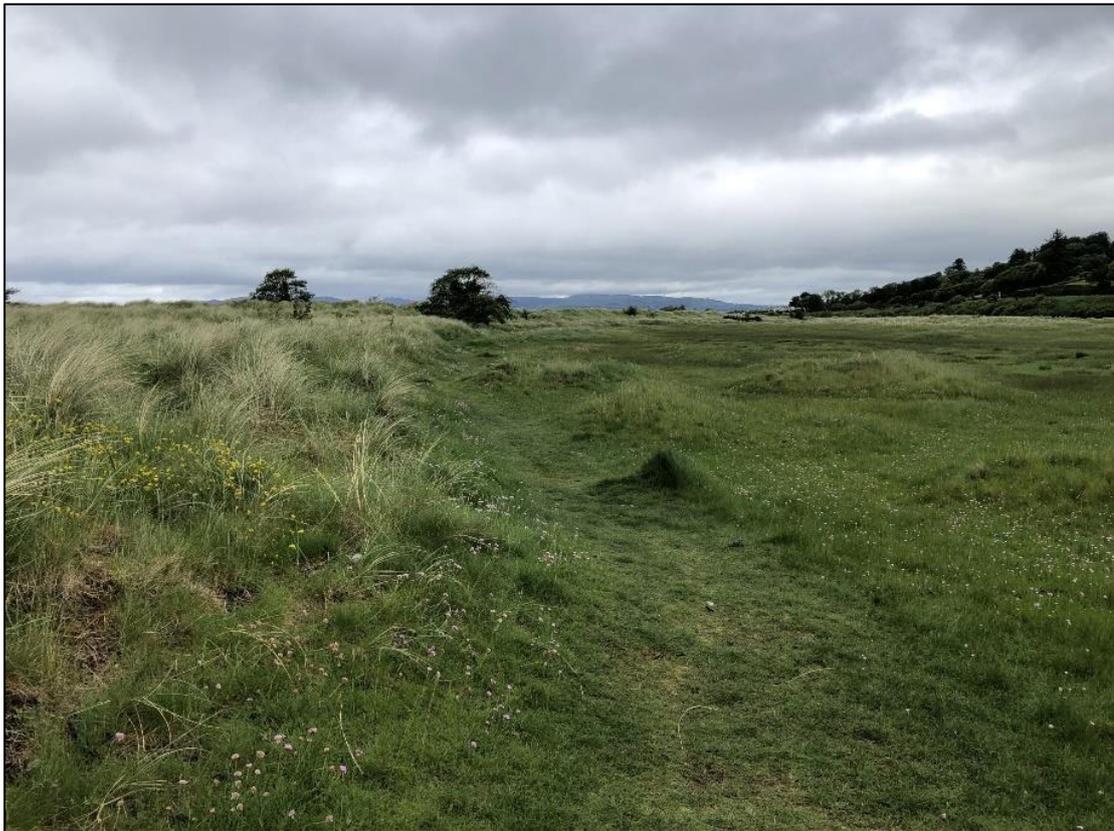
This was one of the most prevalent habitats on the site (Plate 3.1). Trampling and erosion was widespread in this habitat, which is discussed in further detail in Section 3.2. Despite signage requesting that dogs be kept on leads on the site, dogs were seen free roaming in this habitat during the survey. The upper salt marsh habitat is dominated by Thrift (*Armeria maritima*) and grasses, with rushes present further away from the sea. Sea-milkwort (*Lysimachia maritima*), Common Scurvygrass (*Cochlearia officinalis*), Sea Plantain (*Plantago maritima*) and Birds-foot Trefoil were also recorded.

Plate 3.1 Fixed dunes (CD3) and upper salt marsh (CM2) habitats at Lisfannon Beach

- Signage advising recreation and amenity users to stay on the beach and avoid the dune and salt marsh habitats should be considered. This would reduce habitat degradation as a result of visitor movements through these habitats. This measure should be accompanied by signage indicating that dogs should remain on a lead by the beach, salt marsh and dunes, given that these areas are of value to foraging and ground-nesting birds.

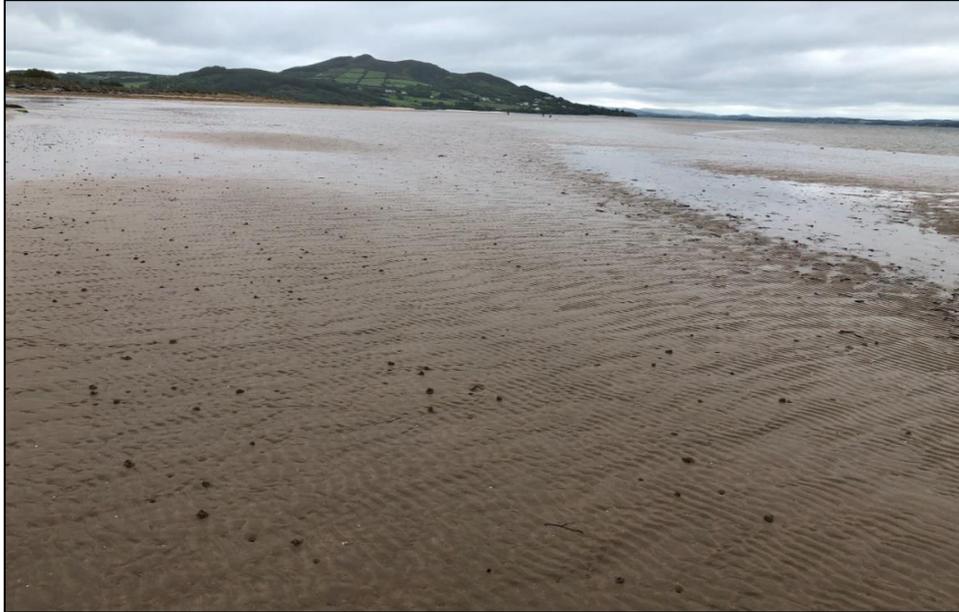
**Plate 3.2** Lugworm (*Arenicola* sp.) casts in the Muddy sand shore habitat

This habitat was present along the shore in the west of the site. Evidence of Lugworms (*Arenicola* sp.) was recorded in this habitat (Plate 3.2). Oystercatcher (*Haematopus ostralegus*) and Ringed Plover (*Charadrius hiaticula*) were recorded feeding in this habitat.

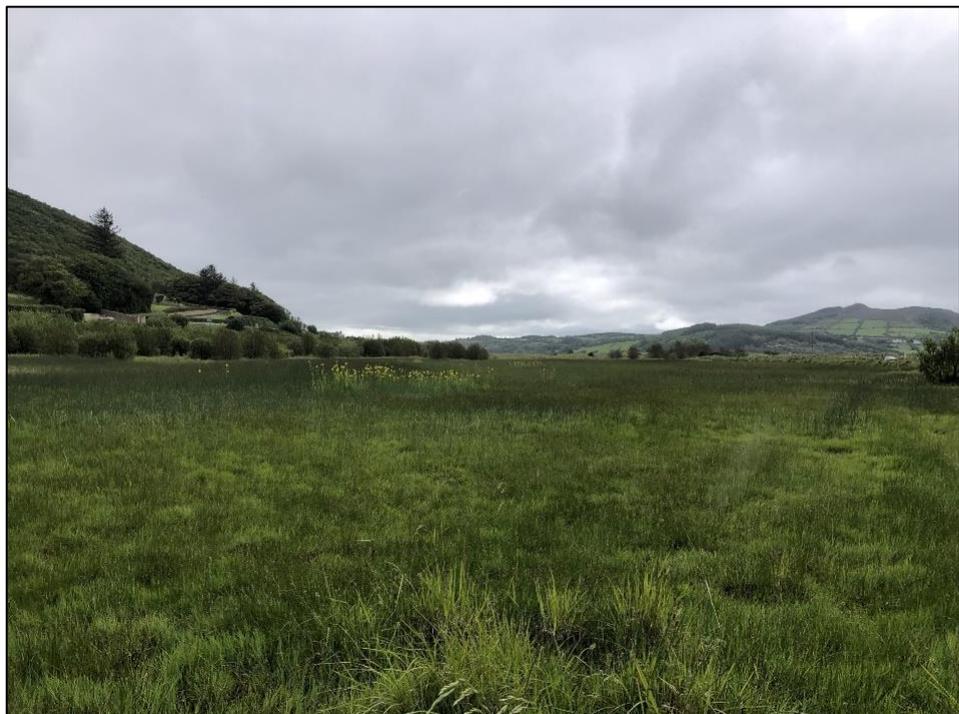
**Plate 3.3** Wet grassland (GS4) habitat at Lisfannon Beach.

A small area of wet grassland is present north of the beach carpark (Plate 3.3). The dominant species in this habitat were Deergass (*Trichophorum germanicum*), Black Bog-rush (*Schoenus nigricans*), and Yellow Flag Iris (*Iris pseudacorus*).

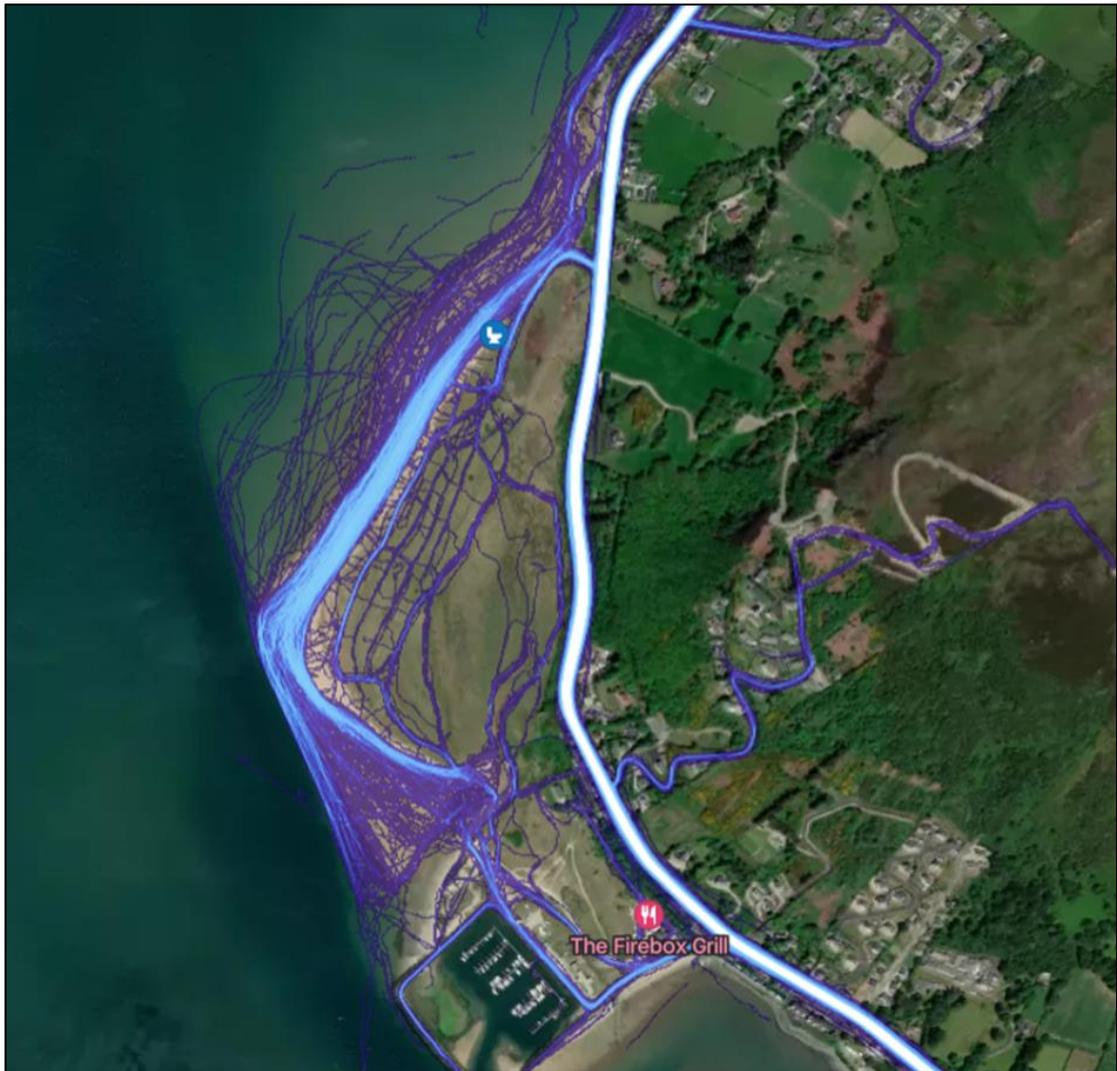
Figure 3.2 Heat map of visitor movements at Lisfannon Beach (Strava, 2024).

Figure 3.2 presents a Strava heat map for the site. Strava aggregates data from users on its app who opt-in to share their activities and locations.

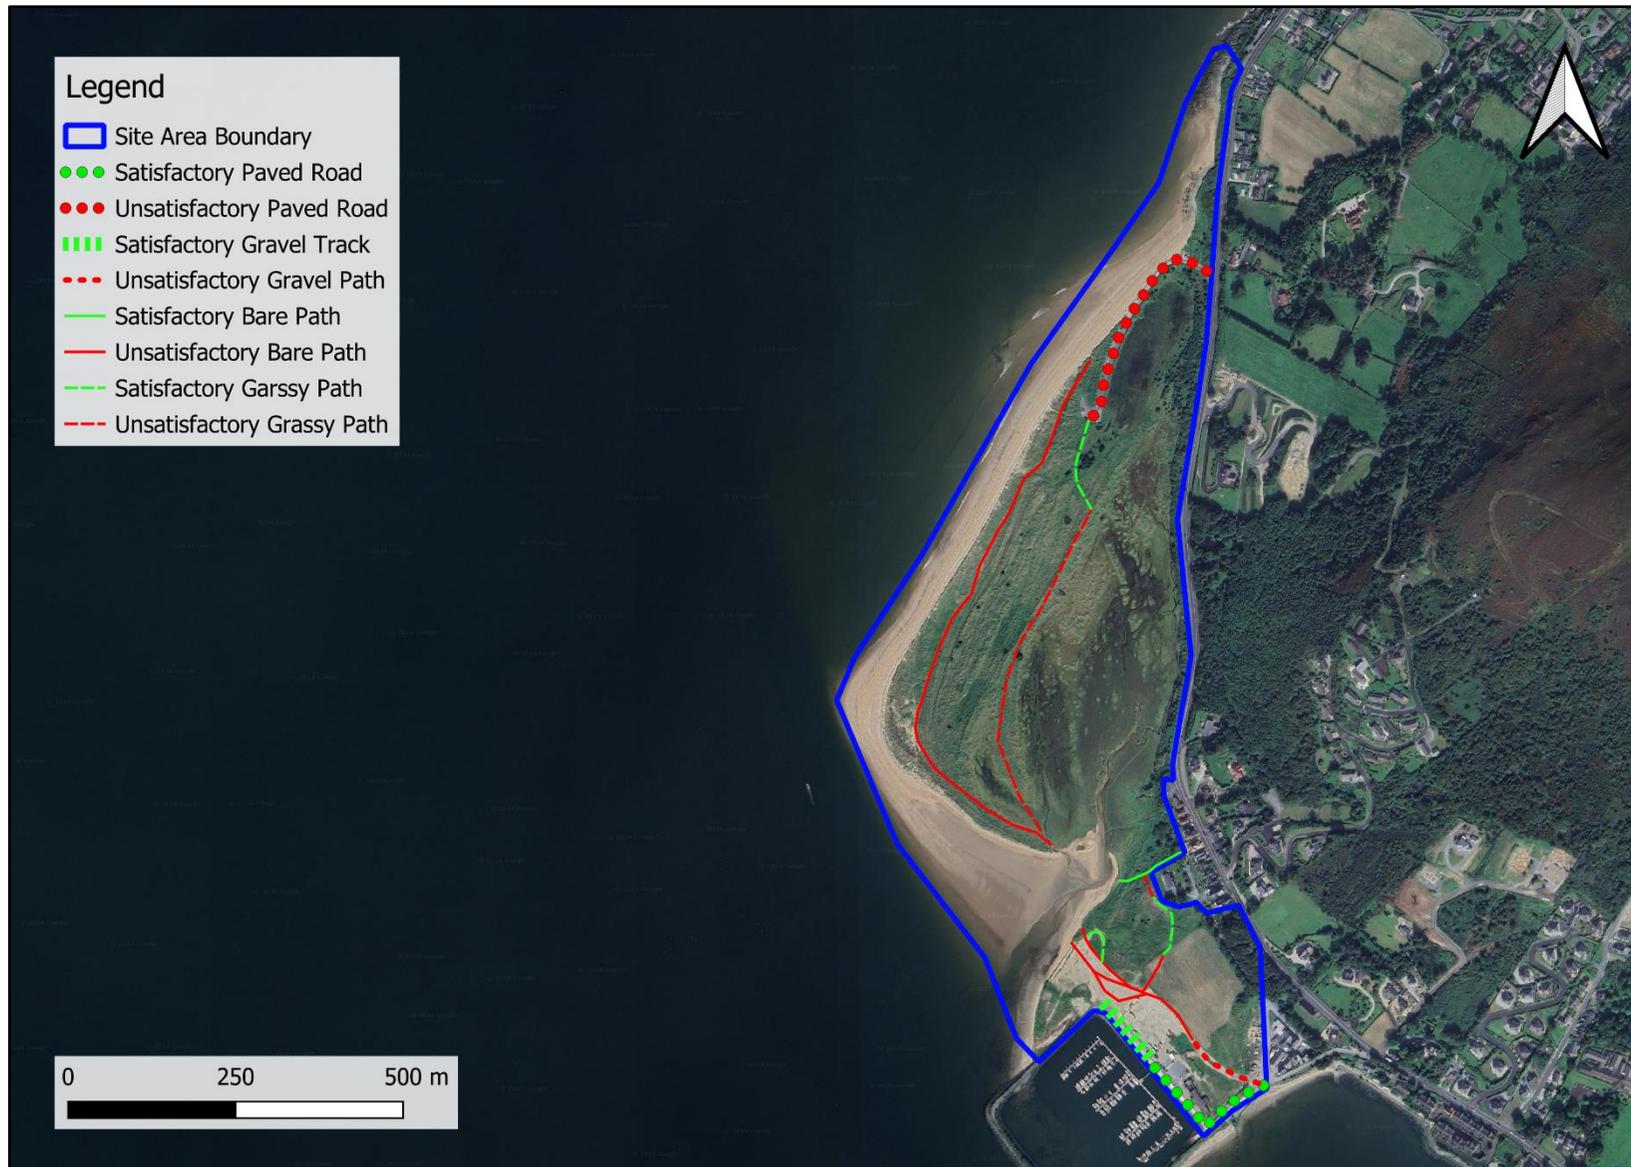
Figure 3.3 Pathway types and conditions present on the site. Basemap provided by Google.

The tarmac road from the main Lisfannon Beach entrance to the carpark is in an unsatisfactory condition, with potholes and a large amount of sand on the road, making it uneven and difficult to traverse. This is presented in the top left corner of **Plate 3.14** and discussed further in Section 3.3.2 below. South of the carpark, a grassy path has been created, heading south of the carpark towards the salt marsh habitat. The condition of the pathway is satisfactory at the carpark, but it gradually deteriorates with widening, braiding and erosion evident further south. The path runs along the western side of the salt marsh habitat (top right corner of **Plate 3.14**). There is also a bare ground pathway through the dunes between the main beach and the saltmarsh habitat. This pathway is in unsatisfactory condition, with trampling and erosion leading to braiding and widening of the pathway, particularly where visitors are accessing the beach. The erosion is particularly prevalent in the southwest corner of the dunes.

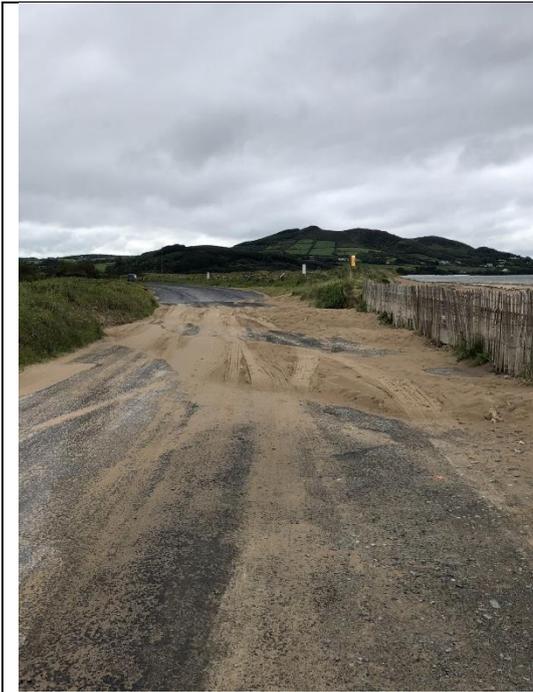
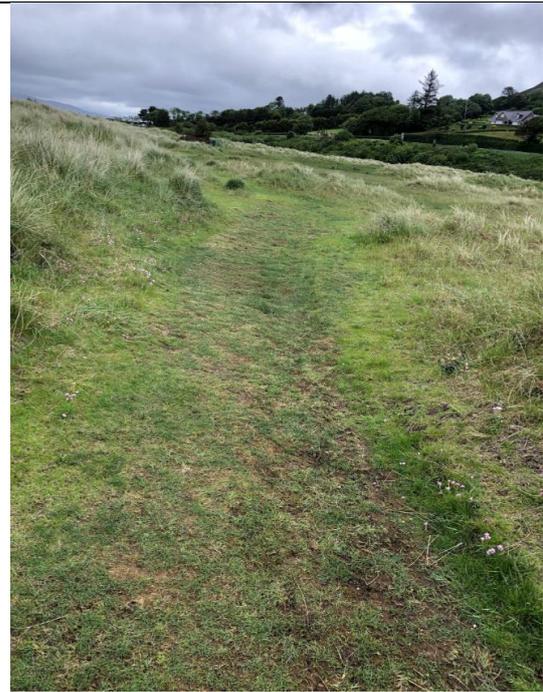
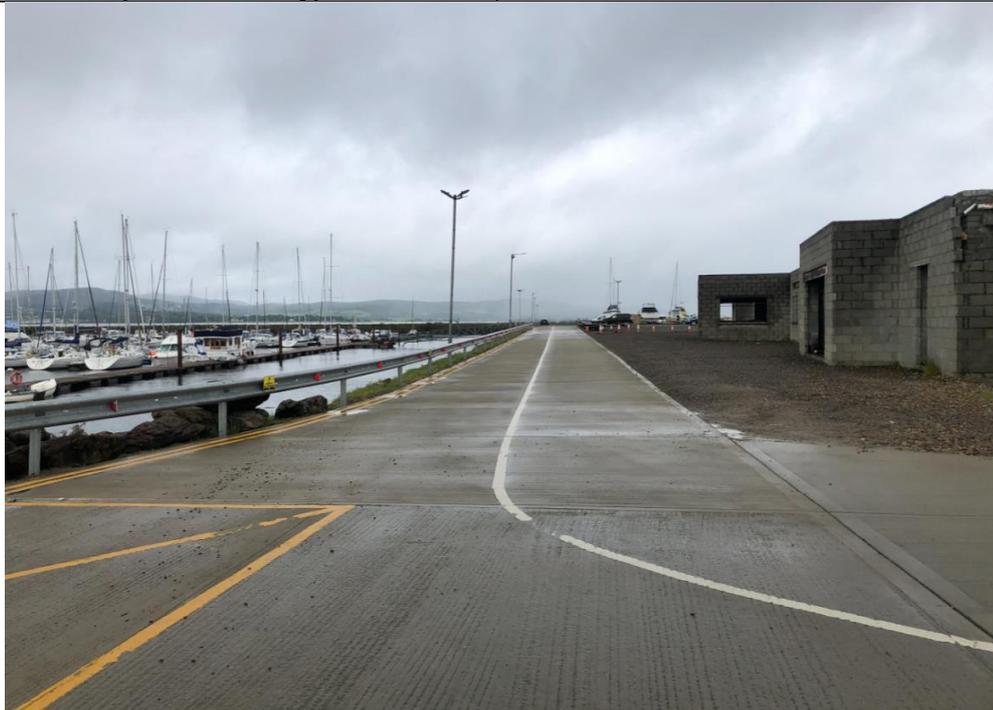
**Plate 3.4 The main pathway types recorded at Lisfannon Beach**

The recently constructed road from the entrance of the marina to the carpark is paved and in satisfactory condition (bottom of **Plate 3.14**). The paved section becomes a gravel track, which is also in satisfactory condition. A gravel path diverts from the paved section close to the marina carpark entrance and leads north towards the beach. This pathway becomes a bare path, which braids into a number of smaller paths leading to the beach, and are considered unsatisfactory, due to their braiding nature and their potential to encroach further on the surrounding habitat. A small grassy path leads from this area, but loops back into it, and is considered satisfactory. An additional unsatisfactory bare ground pathways leads northeast off of this pathway. This transitions into a grassy path, which is relatively uniform and satisfactory, however as it proceeds north, it widens in places, and as such is unsatisfactory in these areas. A satisfactory bare ground path runs perpendicular to this pathway. The pathway condition assessment map is presented in Figure 3.3 below. **Plate 3.14** displays some of the pathways encountered at Lisfannon Beach.

**Tarmac Road to the beach carpark  
(Unsatisfactory)**

**Grassy Path (Unsatisfactory)**

**Paved Road near marina entrance (Satisfactory)**

- The tarmacadam road between the main beach entrance and the car park is in poor condition. This is likely largely due to coastal erosion and storm surges. Potholes should be filled in and sand should be cleared as a temporary road improvement measure. Fáilte Ireland along with Donegal County Council should consider developing a masterplan for Lisfannon Beach to examine the requirements for a programme of coastal protection (including dune restoration) and visitor management requirements. Given the current issue of coastal erosion, Fáilte Ireland continue to support stakeholders NPWS and Donegal County Council to relocate the existing beach carpark and WAW Discovery Point further inland, away from dune and saltmarsh habitat.

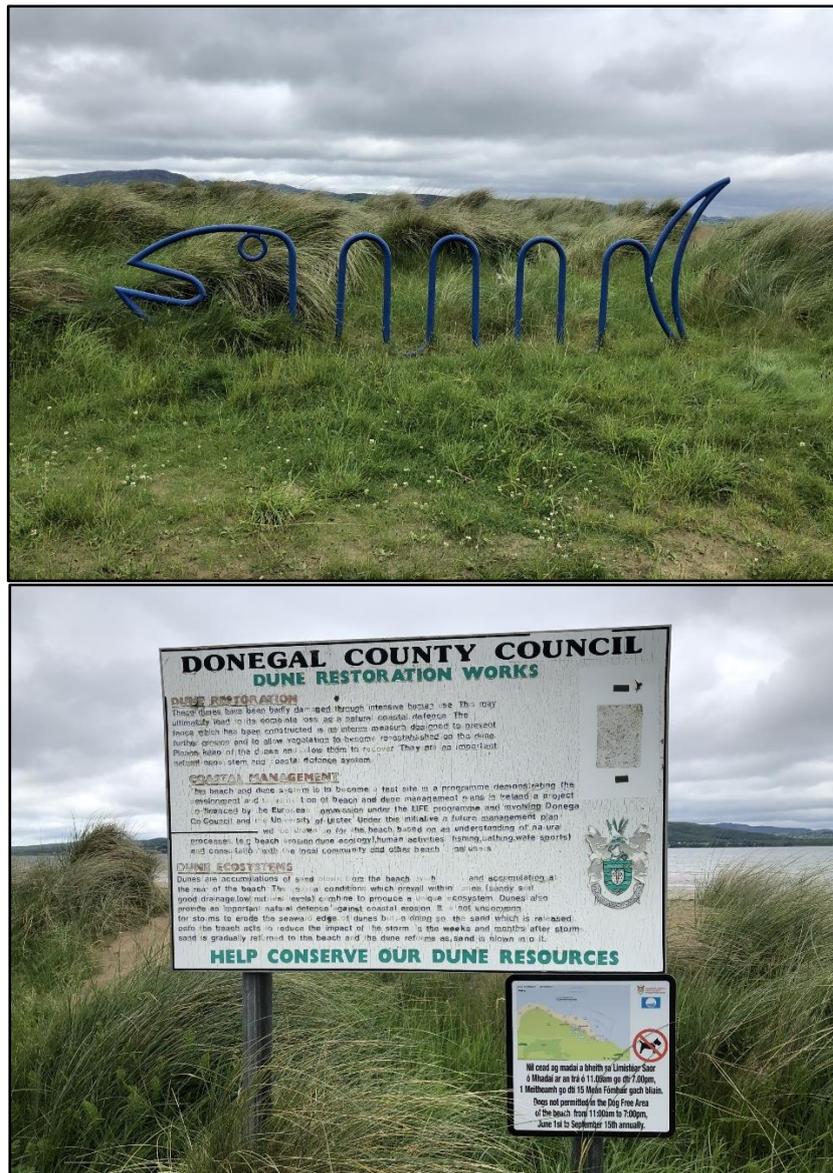
There are signs throughout the site relating to history, biodiversity, dune restoration, water safety, notices relating to dogs on lead and byelaws. The sign regarding dune restoration works provided by Donegal County Council (DCC) is deteriorated and difficult to read. There is also signage advising visitors to keep their dogs on leads is present on the site, along with signage which provides a map of the 'dog free zone' at Lisfannon Beach. This area is located in the northern section of the beach, and is implemented between 11:00am and 7:00pm from the 1<sup>st</sup> of June to the 15<sup>th</sup> of September. A Buncrana Tidy Towns sign was recorded on the site asking visitors to pick up their litter, however other than dog waste bins, no rubbish bins are provided on the site, resulting in littering and dumping due to the lack of suitable waste facilities. Images of the signage and features on the site are shown in Plate 3.5 below.

Plate 3.5 Decorative bicycle parking (top) and damaged dune restoration works signage (bottom)

- Damaged signage and fencing should be repaired or replaced.
- The fallen lifebuoy stand should be repaired or replaced.
- Donegal County Council should consider providing screened segregated public waste bins at sensitive locations. This should be supplemented with instructional signage, adopting the leave no trace principles to work towards reducing littering.

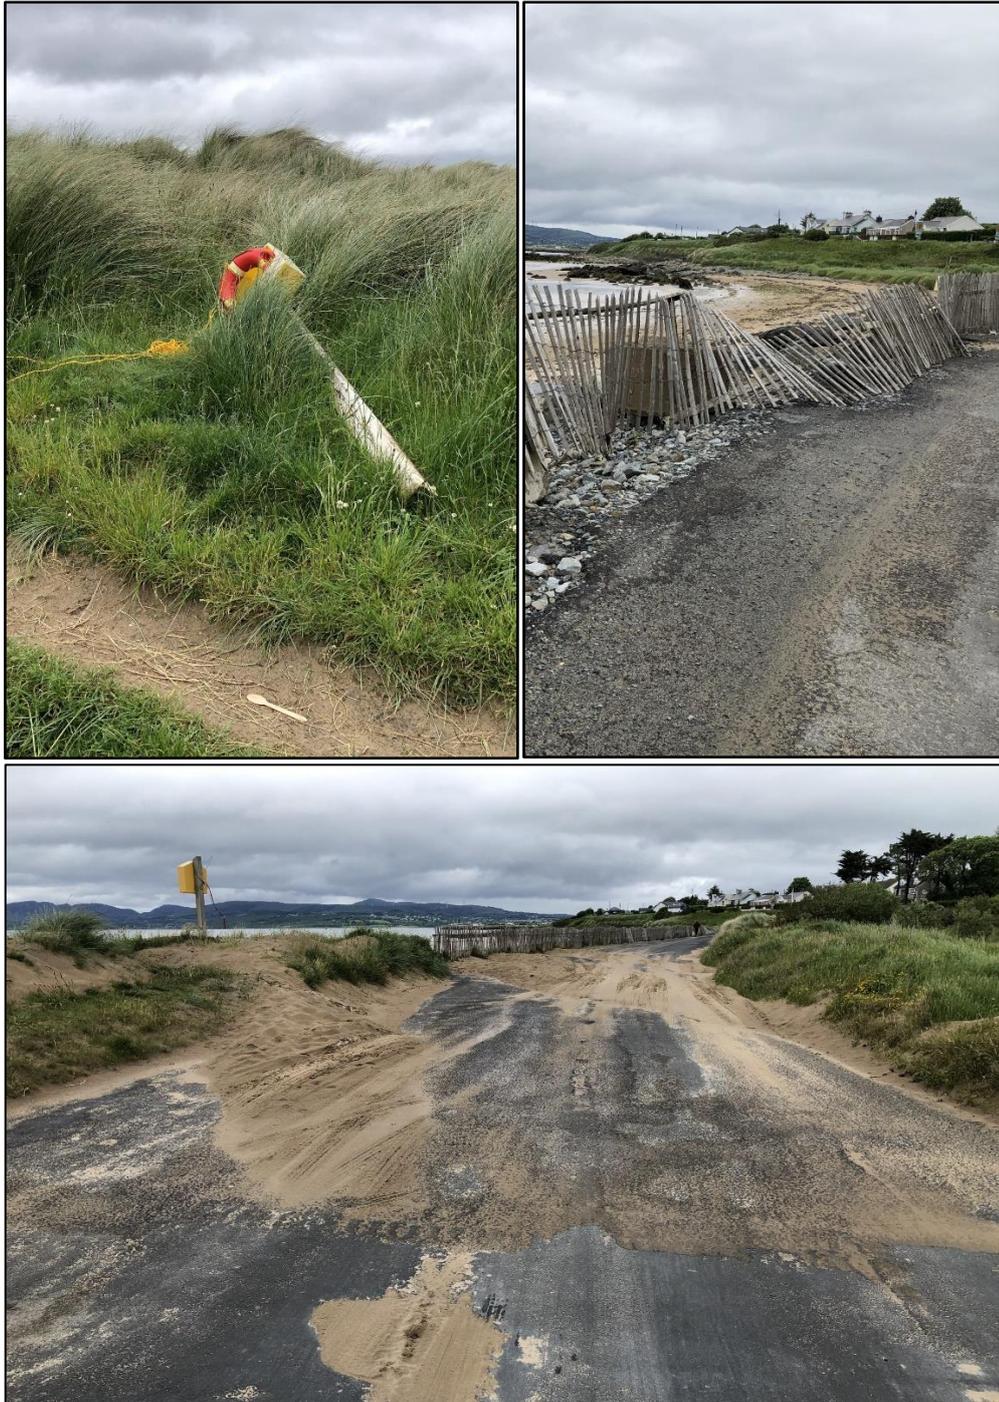
A lifebuoy stand at the beach carpark entrance has fallen over and the rope connected to it is tangled in the grass next to the lifebuoy. In an emergency situation, this could lead to a delay in reaching a person in distress. The chestnut fencing which separates the beach from the road and parking area has collapsed in places. Sand has blown out onto the roadway leading to the beach carpark. This, along with the poor condition of this roadway overall, and the fallen fencing makes the area unsafe for drivers and pedestrians. These hazards are displayed below in Plate 3.6 and in Figure 3.4.

**Plate 3.6** Fallen lifebuoy (top L), broken fencing (top R) and sand blowout (bottom) at Lisfannon Beach.

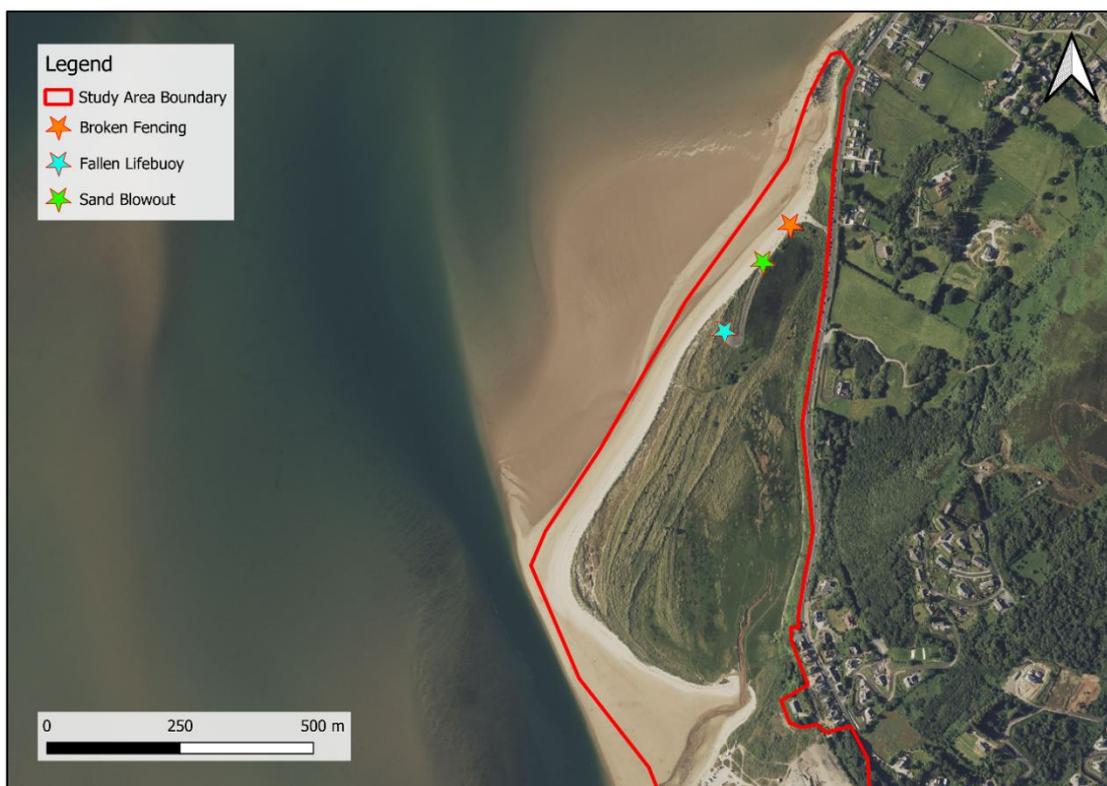
Figure 3.4 The location of hazards recorded at Lisfannon Beach. Basemap provided by Bing.
