National Tourism and Environmental Monitoring Programme Portmarnock Beach 2024

National Tourism and Environmental Monitoring Programme

Report for Portmarnock Beach 2024

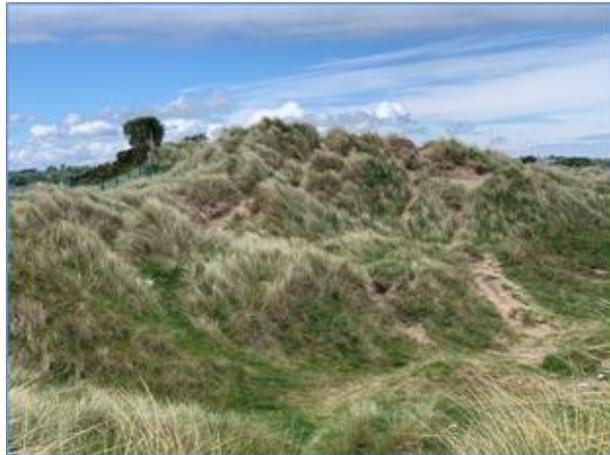
This habitat is present along the coast in a narrow strip (c. 50m wide) between the beach and the golf course, and along the path between the beach and the meadow by the car park. Along the beach, erosion is a significant problem, with numerous paths through the dunes. It is likely that the marram dunes which would have formed the boundary between the beach and the fixed dunes have been eroded. Marram grass forms the main component

of the dunes, especially closer to the beach, but there is also a significant coverage of herbaceous species including creeping bent, red fescue, birds foot trefoil, wild pansy, common milkwort, hawkbit species and burnet rose.

This habitat also occurs along the path between the grassland next to the car park and the beach. Marram grass is present but to a lesser extent. Other species recorded in this habitat are burnet rose, common vetch, dandelion and bramble. The southern end of this habitat grades into scrub dominated by hawthorn and gorse. This habitat is displayed below in Plate 3.1.

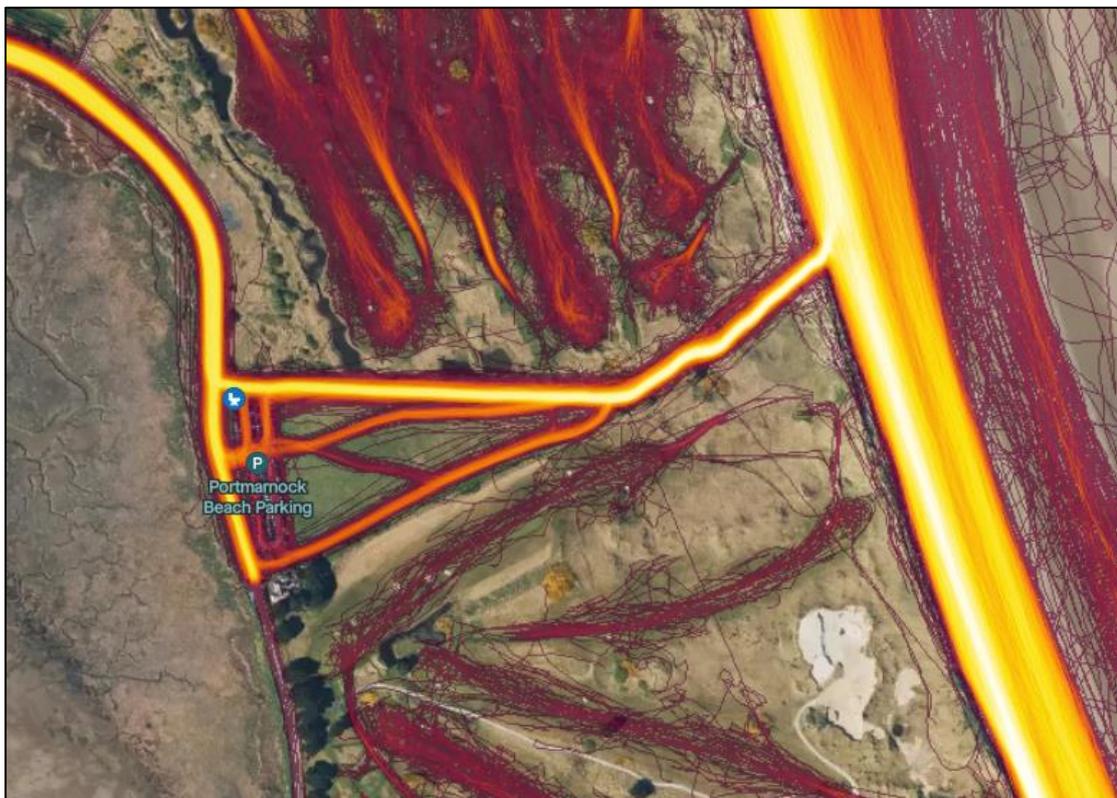
Figure 3.3 Heat map of visitor movements in Portmarnock, with the fairways clearly visible north and south of the beach access (Strava, 2024).

There are car parking facilities at Portmarnock Beach south included a paved area and an overflow car park which is a mix of gravel and bare ground with cell-web reinforced parking spaces. For the purposes of this report, it is considered a gravel car park. There is a grassy path from the car park to the area fixed dunes where a boardwalk is currently under construction. This pathway is in poor condition, with path widening, braiding and an uneven surface leading to puddles forming. There are two additional well-used informal grassy paths leading from the car park to the boardwalk, each of which has less used paths leading to one another. The boardwalk leading to the beach is currently under construction and an informal grassy path has formed parallel to the boardwalk where construction is taking place. There are golf courses directly to the north and south of the study area. Figure 3.3 presents a Strava heat map for the site. Strava aggregates data from users on its app who opt-in to share their activities and locations. The pathway condition assessment map is presented in Figure 3.4 below. Plate 3.1 displays some of the pathways encountered in Portmarnock.

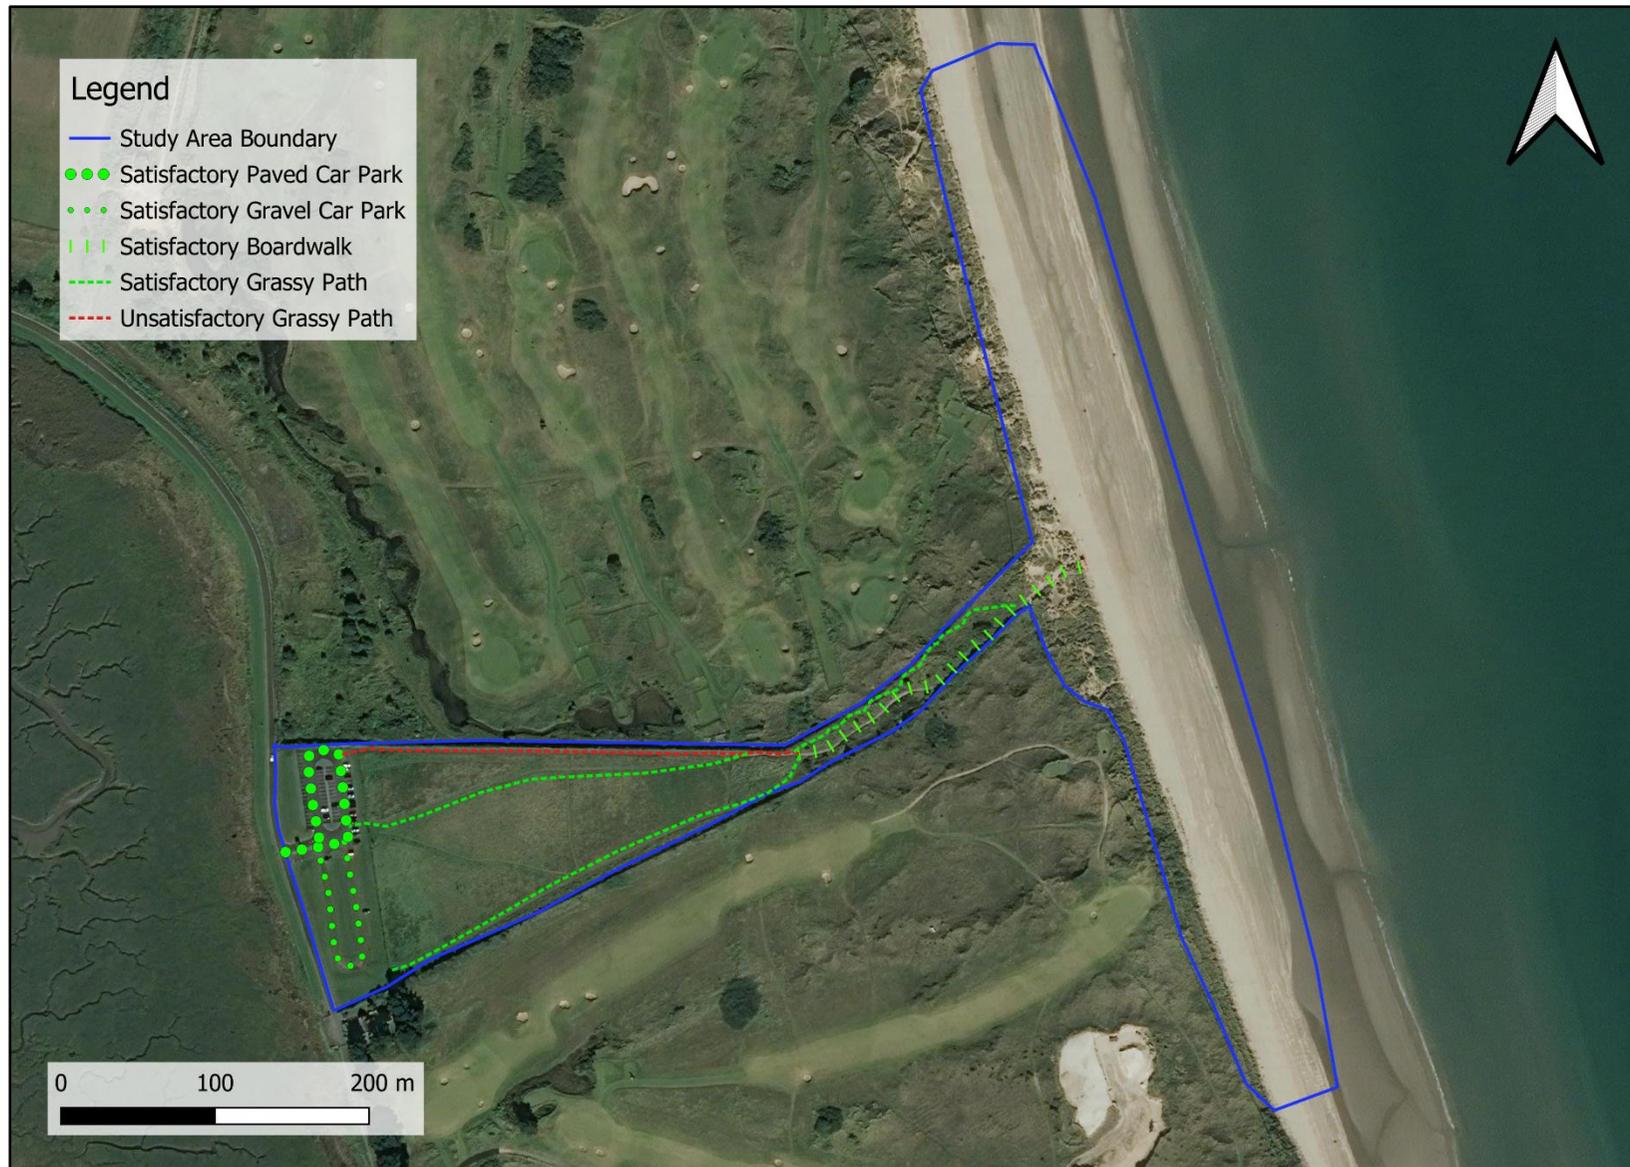
Figure 3.4 Pathway types and conditions present on the site. Basemap provided by Bing.

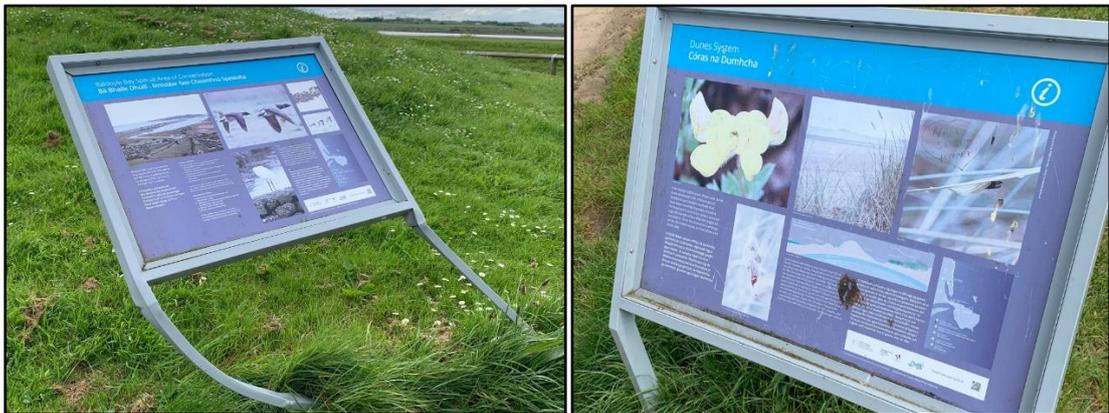
Plate 3.2 Damaged signage on biodiversity and environment in the car park.

- The repair or replacement of the existing damaged signage should be considered. Where signage is being implemented, teleological signage (signage with instruction and justification for the instruction) should be used.

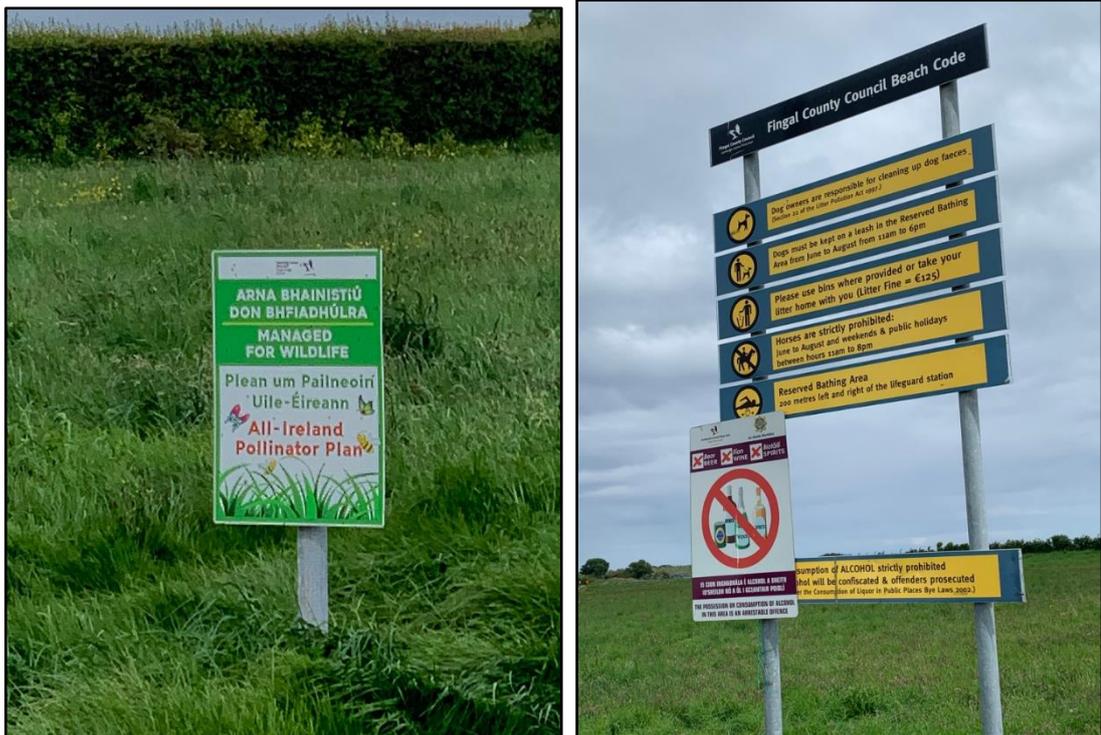
Plate 3.3 Instructional signage for site preservation by the car park.

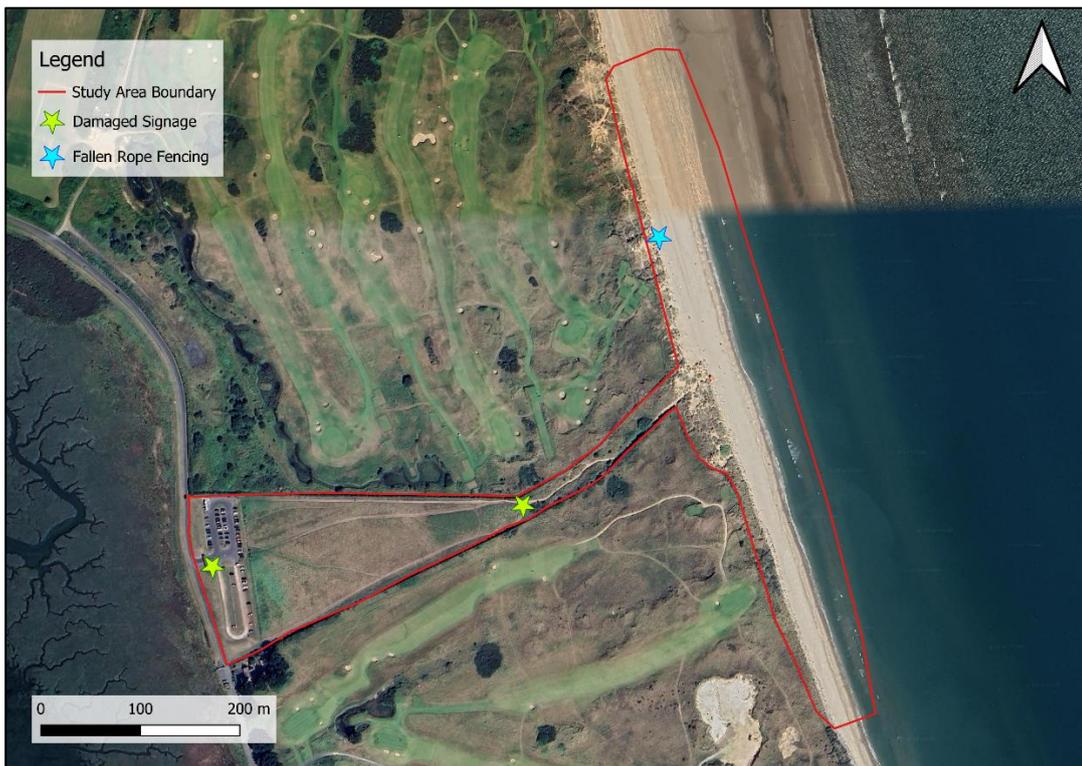
Figure 3.5 The location of the damaged signage and fallen rope fencing in Portmarnock. Basemap provided by Google.

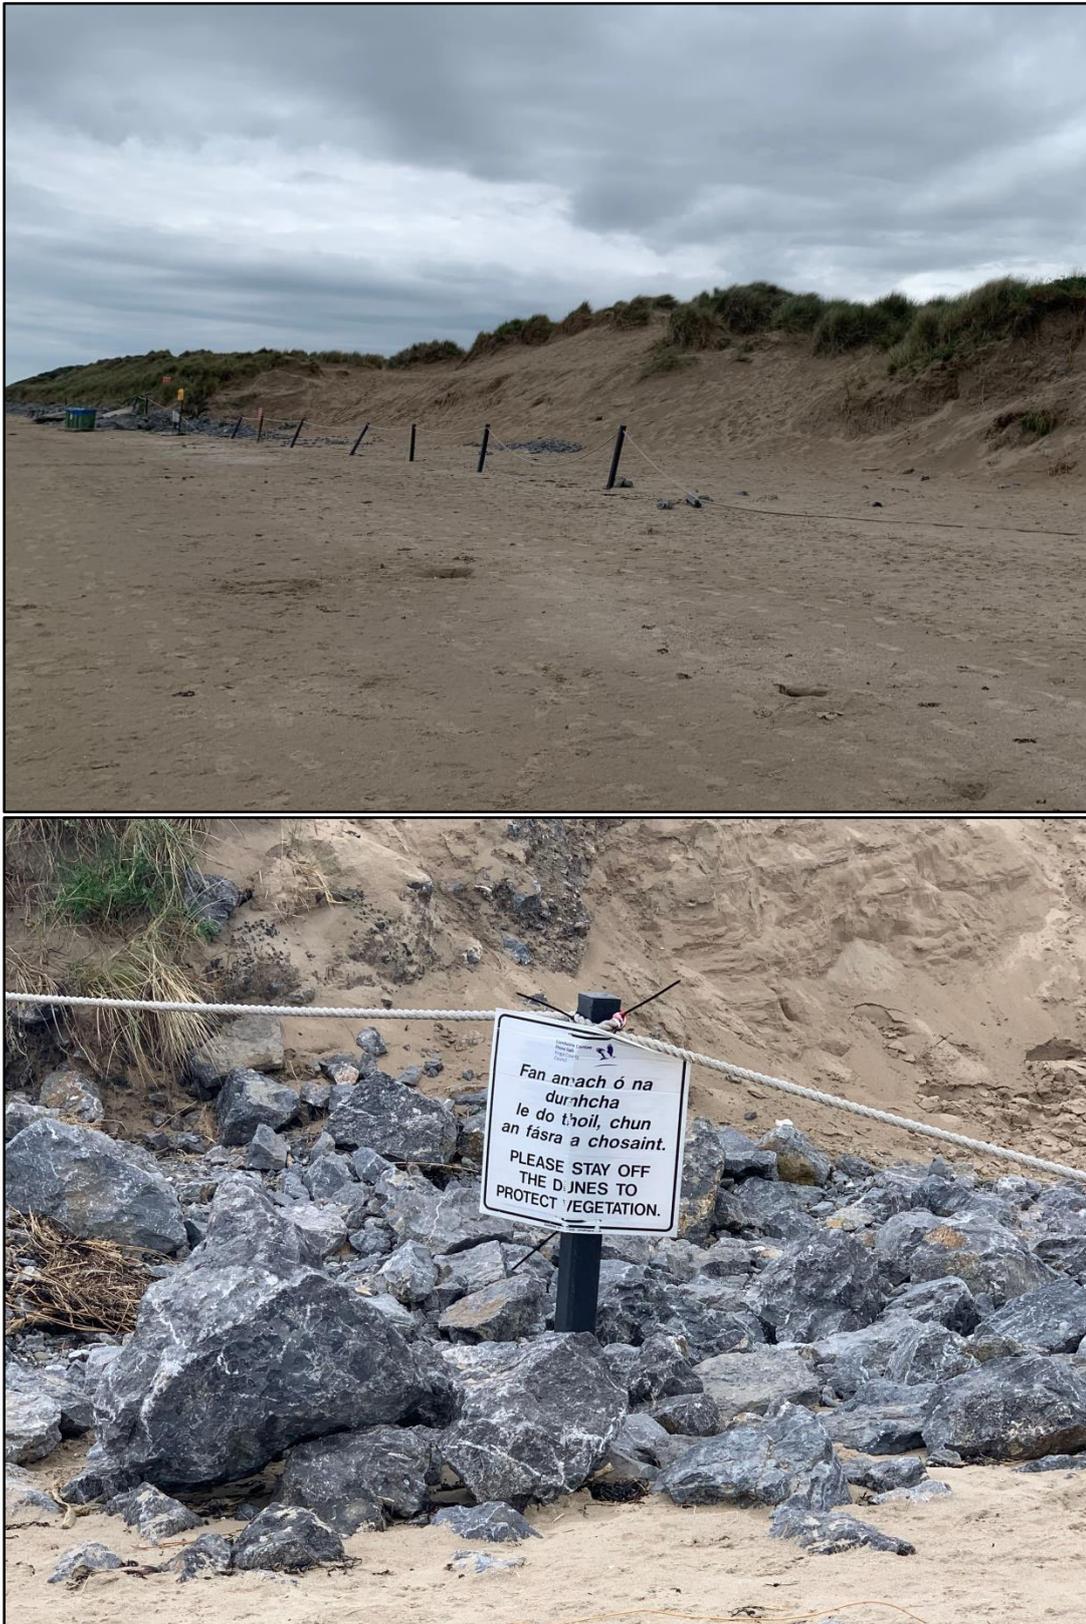
Plate 3.4 Signage and a falling rope barrier to protect dune habitats.

- Chestnut-pale or similar fencing should be considered along the dunes to prevent people from walking through them, which has led to erosion and habitat loss. On similar sites in Ireland, chestnut pale fencing has been used to protect and restore dunes.

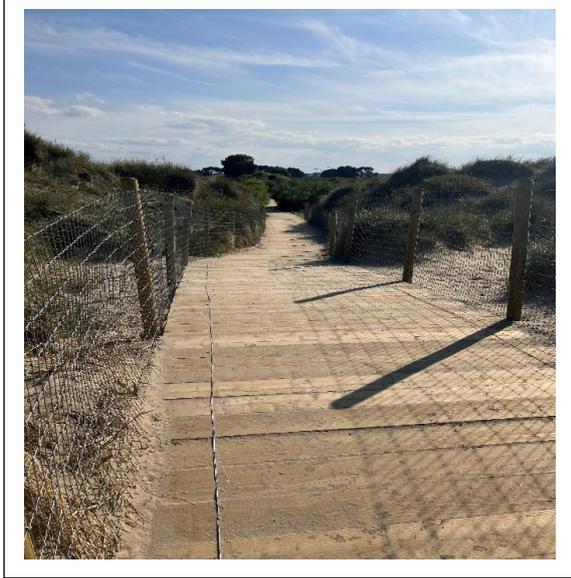
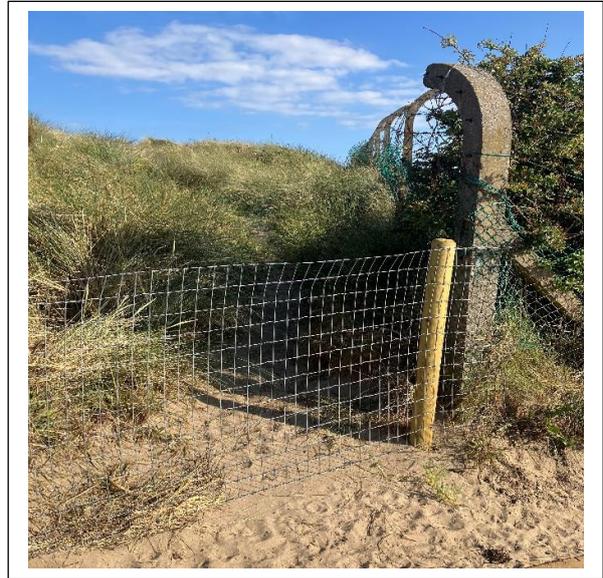
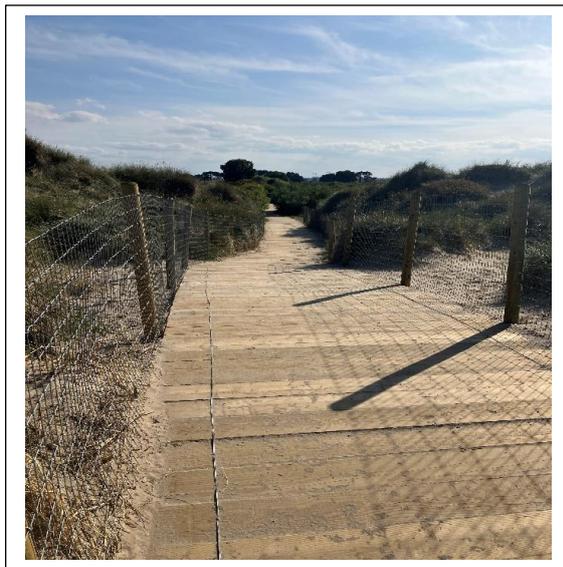
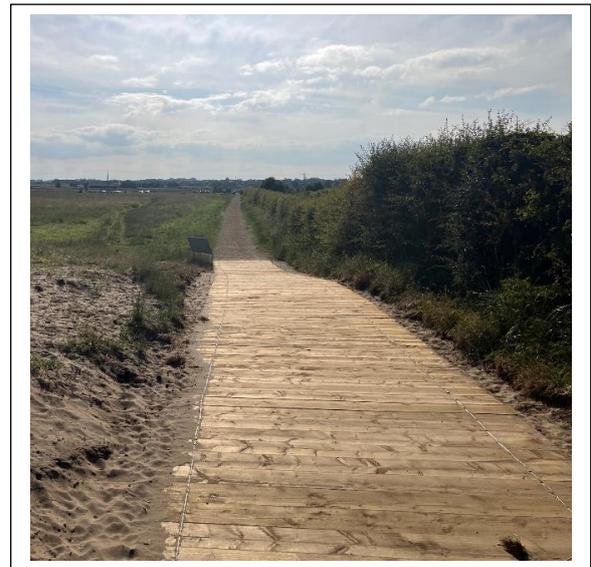
The site survey coincided with the completion of a newly constructed boardwalk (and dune protection fencing) linking the South beach Carpark and the temporary lifeguard hut as detailed in photographs below from the survey 12th June 2024.
