National Tourism and Environmental Monitoring Programme Portumna 2024

Report for Portumna 2024

Portumna – Visitor Monitoring Assessment

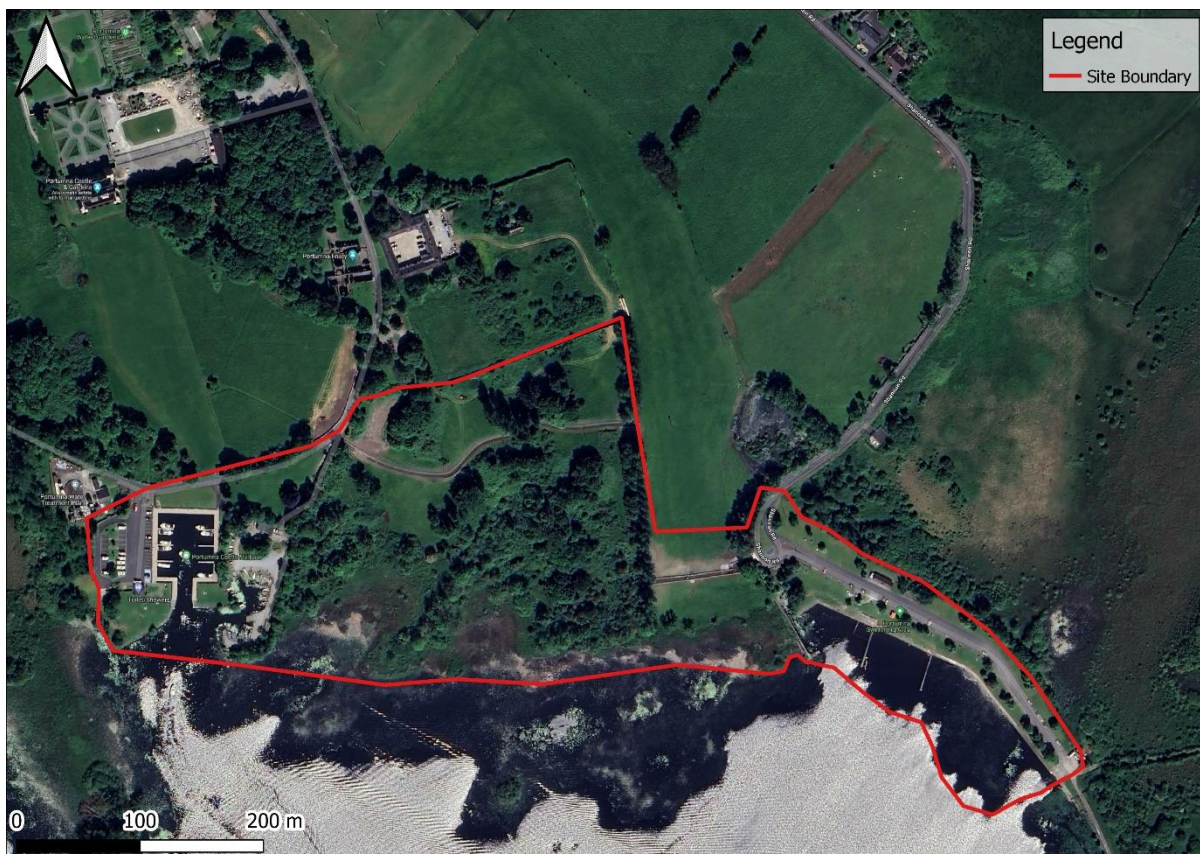
The site is located within the boundaries the Lough Derg, North-east Shore Special Area of Conservation (SAC), the River Shannon Callows SAC, the Lough Derg (Shannon) Special Protection Area (SPA) and the Middle Shannon Callows SPA.

Figure 1.2 Site Location. Basemap provided by Google.

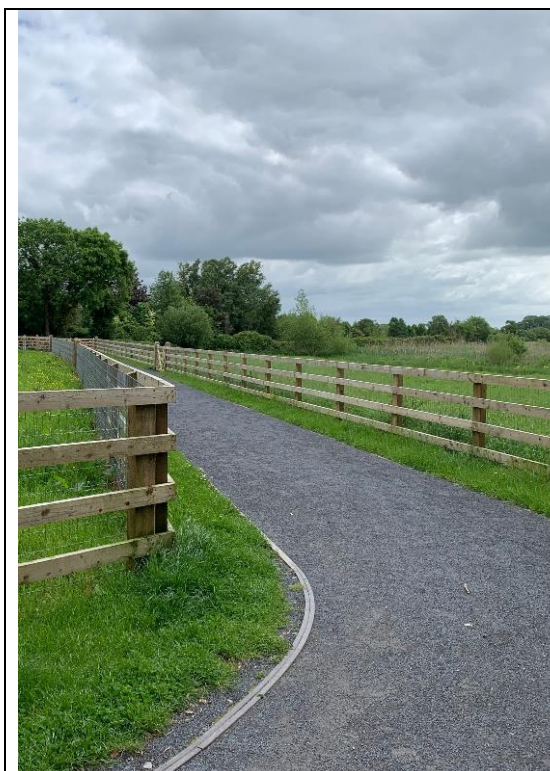
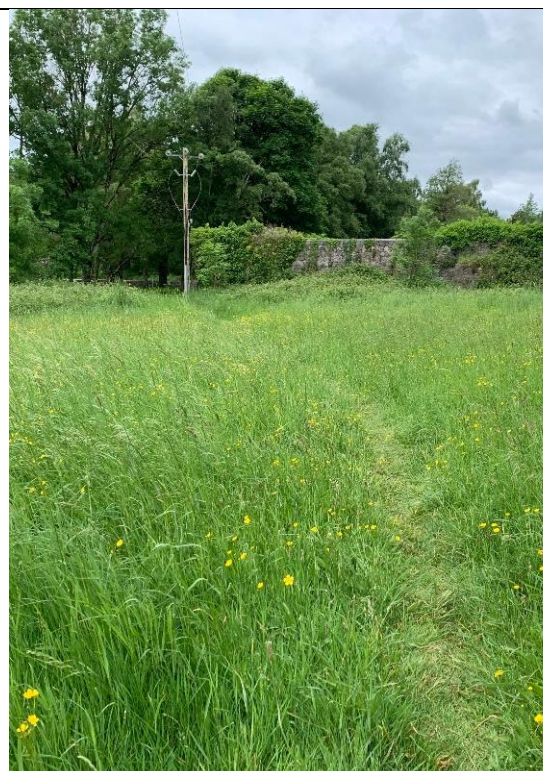
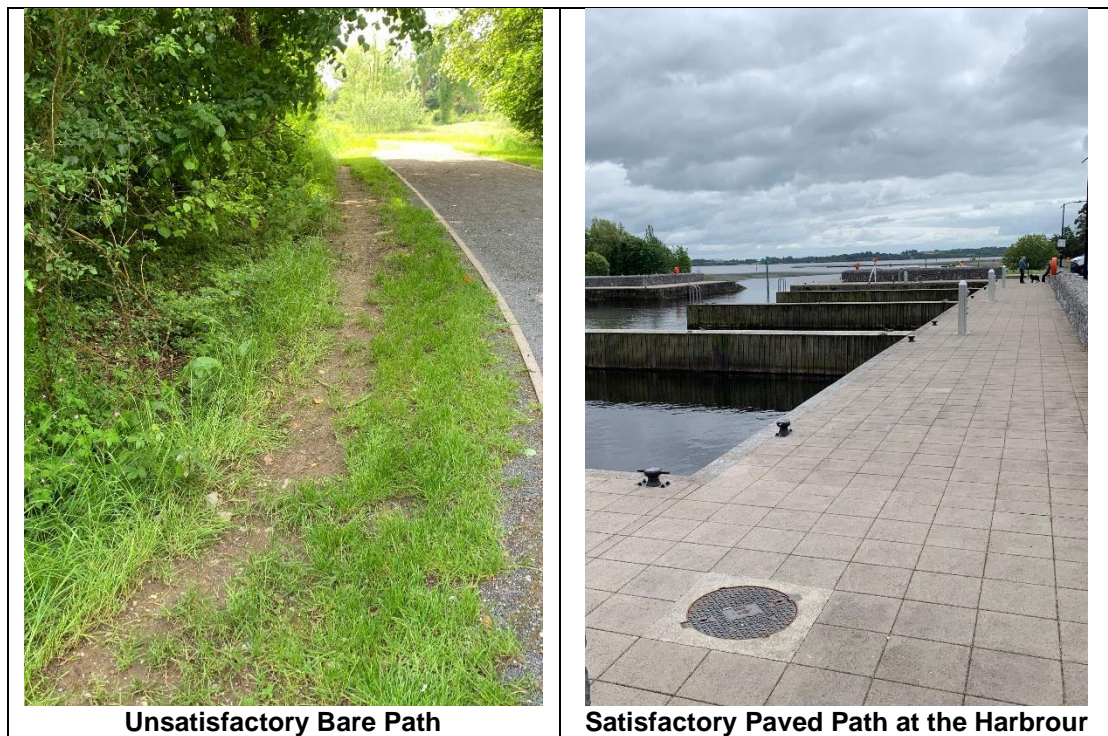
Plate 3.1 Examples of pathways in Portumna

All of the pathways are in satisfactory condition, with the exception of one small pathway, which is discussed below. A paved car park is located in Portumna Swimming Area and runs parallel to a paved path along the lakeshore area. Leading westward from Portumna Swimming Area, the new Blueway trail is a gravel path utilised by walkers and cyclists to access Portumna Harbour. Fencing separates it from the agricultural fields which it runs through. This is displayed in the top left corner of Plate 3.1. A number of informal grassy paths stray from the Blueway trail into the surrounding habitats. An example of this is displayed in the top right corner of Plate 3.1. A bare ground path also leads from the Blueway trail into a mixed conifer and broadleaved woodland, where a firepit is located. The only unsatisfactory path in Portumna is a small bare ground path measuring 1-2 ft. in width that temporarily strays from the Blueway trail for a few paces. This is displayed in the bottom left corner of Plate 3.1.

Satisfactory Gravel Path (Blueway trail)

Satisfactory Grassy Path

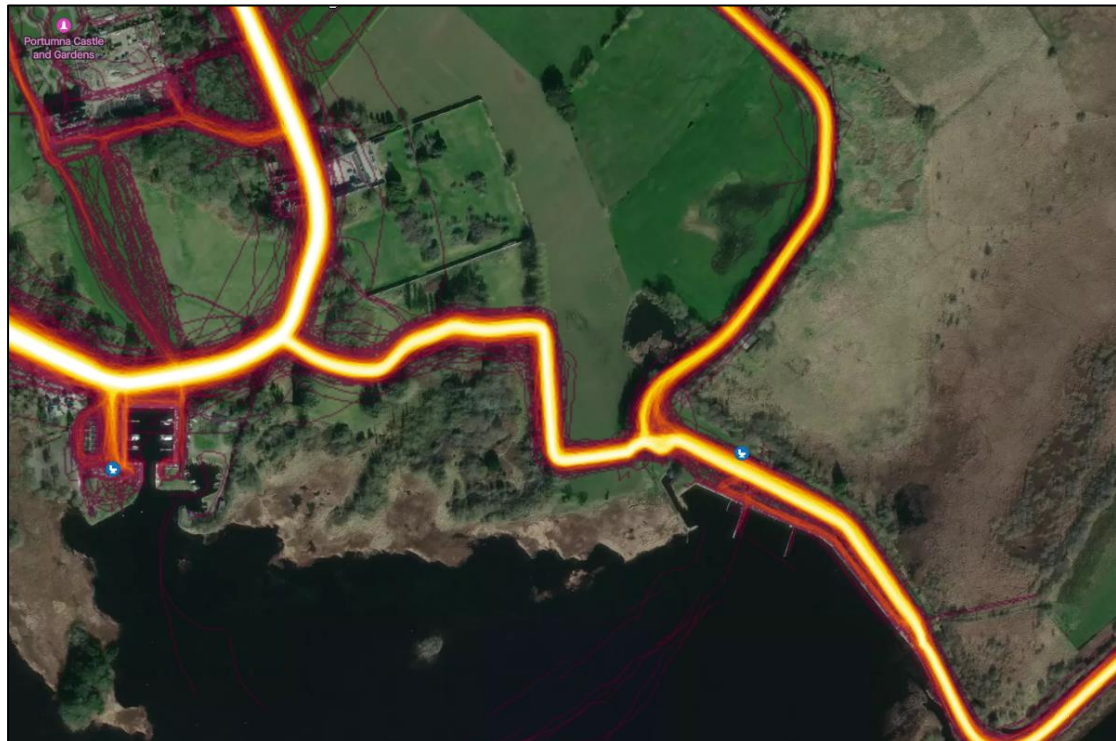
Figure 3.4 presents a Strava heat map for the site. Strava aggregates data from users on its app who opt-in to share their activities and locations. The pathway condition assessment map is presented in Figure 3.5 below.

Figure 3.4 Heat map of visitor movements in Portumna (Strava, 2024).

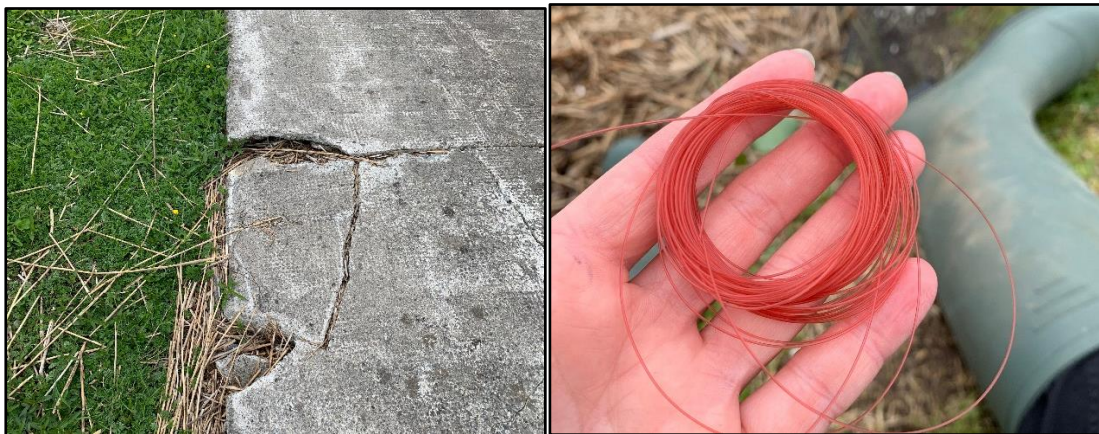
Plate 3.4 Cracked pavement in Portumna Swimming Area (left) and discarded fishing line (right).

The site is located on the shore of Lough Derg. As such, the open water creates a risk to recreation and amenity users, however, there are life buoys available at Portumna Swimming Area and Portumna Harbour. Additionally, there is a lifeguard hut is present at the swimming area. Also at the swimming area, a section of the pathway at the water's edge was cracked, creating a significant trip hazard. The location of this is provided in Figure 3.5 above. Abandoned fishing line was found on the amenity lawn by the lake edge in Portumna Harbour. Mallards and rooks were observed using this area for foraging. Discarded fishing line is a hazard for wildlife, as they can become tangled in it, and injured or killed as a result. The hazards discussed here are displayed below in Plate 3.4. It should be noted that the fishing line was wrapped up by the surveyor, but was found in a long line which was difficult to see.

- The large crack in the paved path in Portumna Swimming Area should be repaired or the pathway replaced.
- Signage along the Blueway trail instructing recreation and amenity users to remain on the path should be considered, along with signage relating to keeping dogs on leashes should also be considered.
- Where habitat is being managed for amenity purposes, a staggered mowing regime should be considered to enhance biodiversity.
- Informative signage regarding the dangers that discarded fishing line and other waste poses to wildlife should be considered.

- The paved path at the water in Portumna Swimming Area has a large crack, which creates a trip hazard for recreation and amenity users. This section of the pathway should be repaired or replaced.

- Discarded fishing line was found in Portumna Harbour. While rubbish bins are provided, informative signage regarding the dangers to wildlife of not properly disposing fishing line would be beneficial.

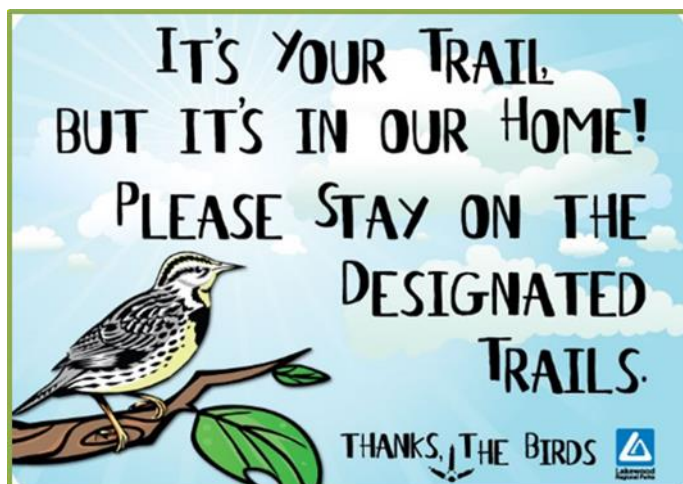
- Where instructional signage is being implemented, teleological signage (signage with instruction and justification for the instruction) should be used. An example of teleological signage is presented below.

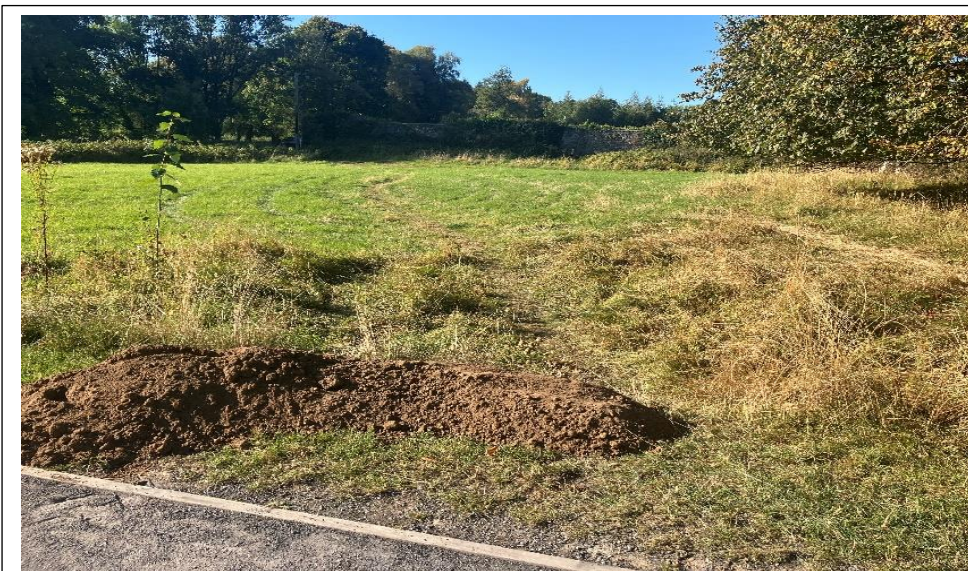
Photo 3: Berms at potential 'desire line' locations from Blueway Path

The site survey was undertaken on the 18th of September just following the official opening of the new cycle and walking trail linking Connaught Harbour to Portumna town and Lough Derg Blueway. Shallow berms were observed at locations most likely to keep walkers on the established path and to reduce the establishment of off-track desire lines.
