# National Tourism and Environmental Monitoring Programme Sliabh Liag 2024

## Report for Sliabh Liag 2024

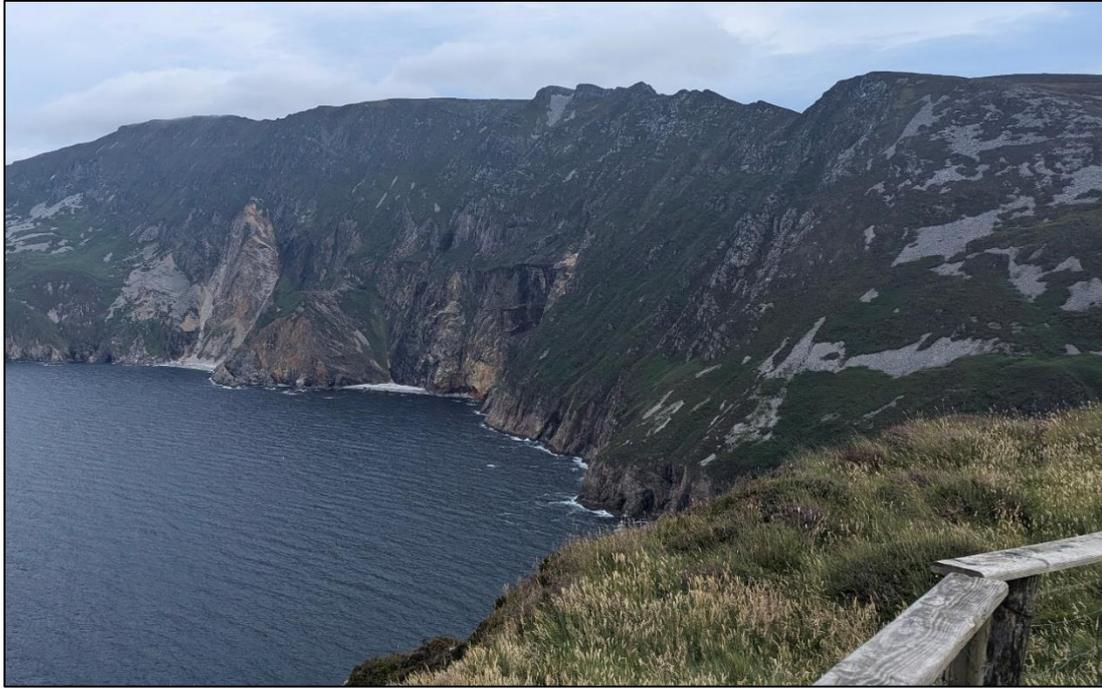
**Plate 3.1 Mosaic of Dense bracken (HD1), Dry siliceous heath (HH1) and Siliceous scree and loose rock (ER3) habitats at Sliabh Liag.**

This habitat is present along the land-sea interface at the site. The cliffs are composed of quartzite (McClure et al., 2019). The slopes above the cliffs exhibit a mosaic of bare rock and a number of different habitats, namely, Dense bracken (HD1), Dry siliceous heath (HH1) and Siliceous scree and loose rock (ER3). It corresponds to the Annex I habitat 'Vegetated sea cliffs of the Atlantic and Baltic coasts (1230)'. This habitat is shown below in Plate 3.1.

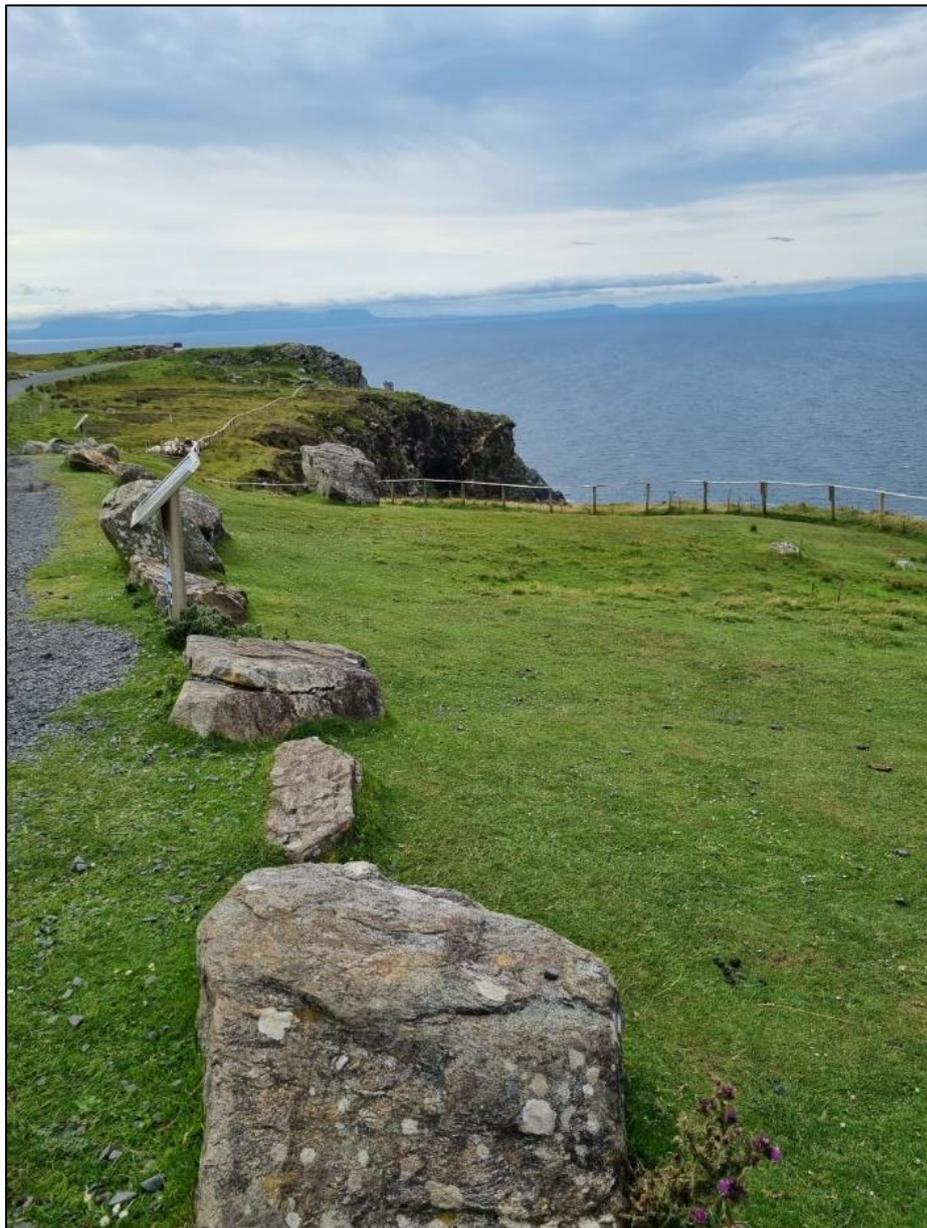
This habitat predominately occurs to the south of the road leading to the Bunglass viewing area, with some small patches also occurring adjacent to the path along the cliffs. Much of this habitat has been heavily grazed by sheep, resulting in a low sward. Species found in this habitat include Bird's-foot Trefoil (*Lotus corniculatus*), Bog Pimpernel (*Angagallis tenella*), Buck's-horn Plantain (*Plantago coronopus*), Crested Dog's Tail (*Cynosurus cristatus*) Daisy (*Bellis perrenis*), English Stonecrop (*Sedum anglicum*), Fairy Flax (*Linum catharticum*), Field Scabious (*Knautia arvensis*), Harebell (*Campanula rotundifolia*), Heath bedstraw (*Veronica officinalis*) Red Fescue (*Festuca rubra*), Self-heal (*Prunella vulgaris*), Spear Thistle (*Cirsium vulgare*) Thrift (*Ameria maritima*) Thyme-leaved speedwell (*Veronica serpyllifolia*), Tormentil (*Potentilla erecta*) and White Clover (*Trifolium repens*). This habitat corresponds to the Annex I habitats 'Species-rich *Nardus* grasslands on siliceous substrates in mountain areas (and submountain areas in continental Europe) (6230)' and 'Calaminarian grasslands of the *Violetalia calaminariae* (6130)'. This habitat is shown below in Plate 3.2.

**Plate 3.2 Dry-humid acid grassland (GS3) habitat which has been heavily grazed at Sliabh Liag.**

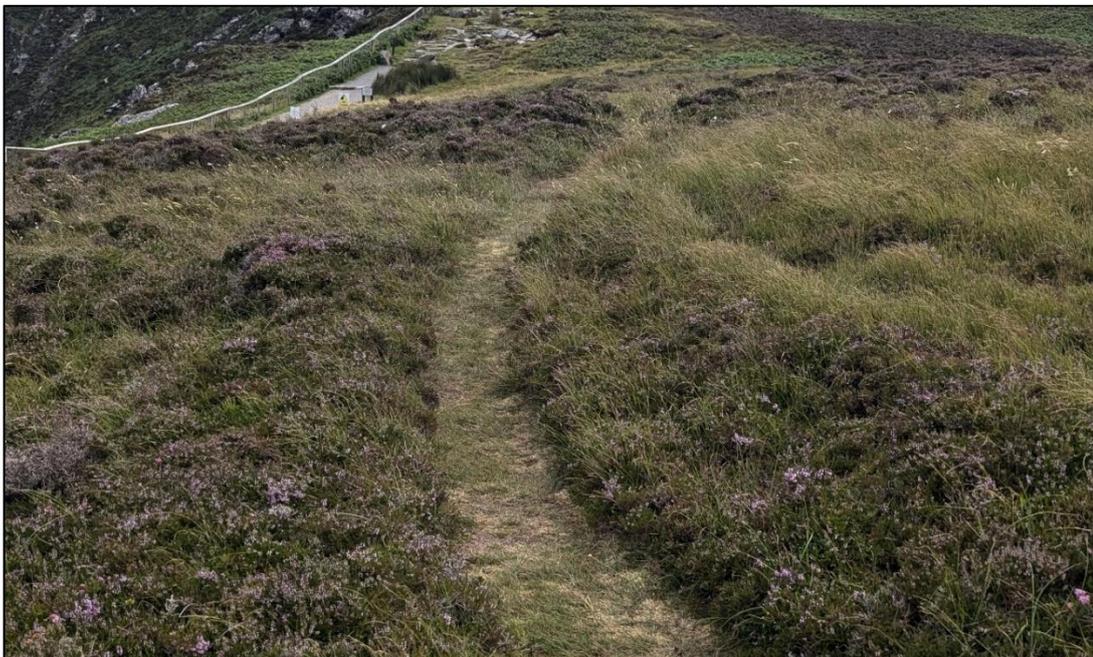
This habitat occurs in large expanses on both sides of the road leading to the Bunglass viewing area and in the areas adjacent the path traveling along the cliff. In some areas it has been damaged by trampling caused by visitors. It is largely dominated by Ling (*Calluna vulgaris*). Other species found in this habitat include Bell heather (*Erica cinerea*), Bent grasses (*Agrostis* spp.), Common Cotton-grass (*Eriophorum angustifolium*), Compact Rush (*Juncus conglomeratus*), Green-ribbed Sedge (*Carex binervis*), Heath Wood Rush (*Luzula multiflora*), Heath Rush (*Juncus squarrosus*), Jointed Rush (*Juncus articulatus*), and Yorkshire Fog (*Holcus lanatus*). This habitat corresponds to the Annex I habitat 'European dry heaths (4030)' and 'Juniperus communis formations on heaths or calcareous grasslands (5130)'. This habitat is shown below in Plate 3.3.

**Plate 3.3 Dry siliceous heath (HH1) habitat exhibiting damage due to trampling at Sliabh Liag.**

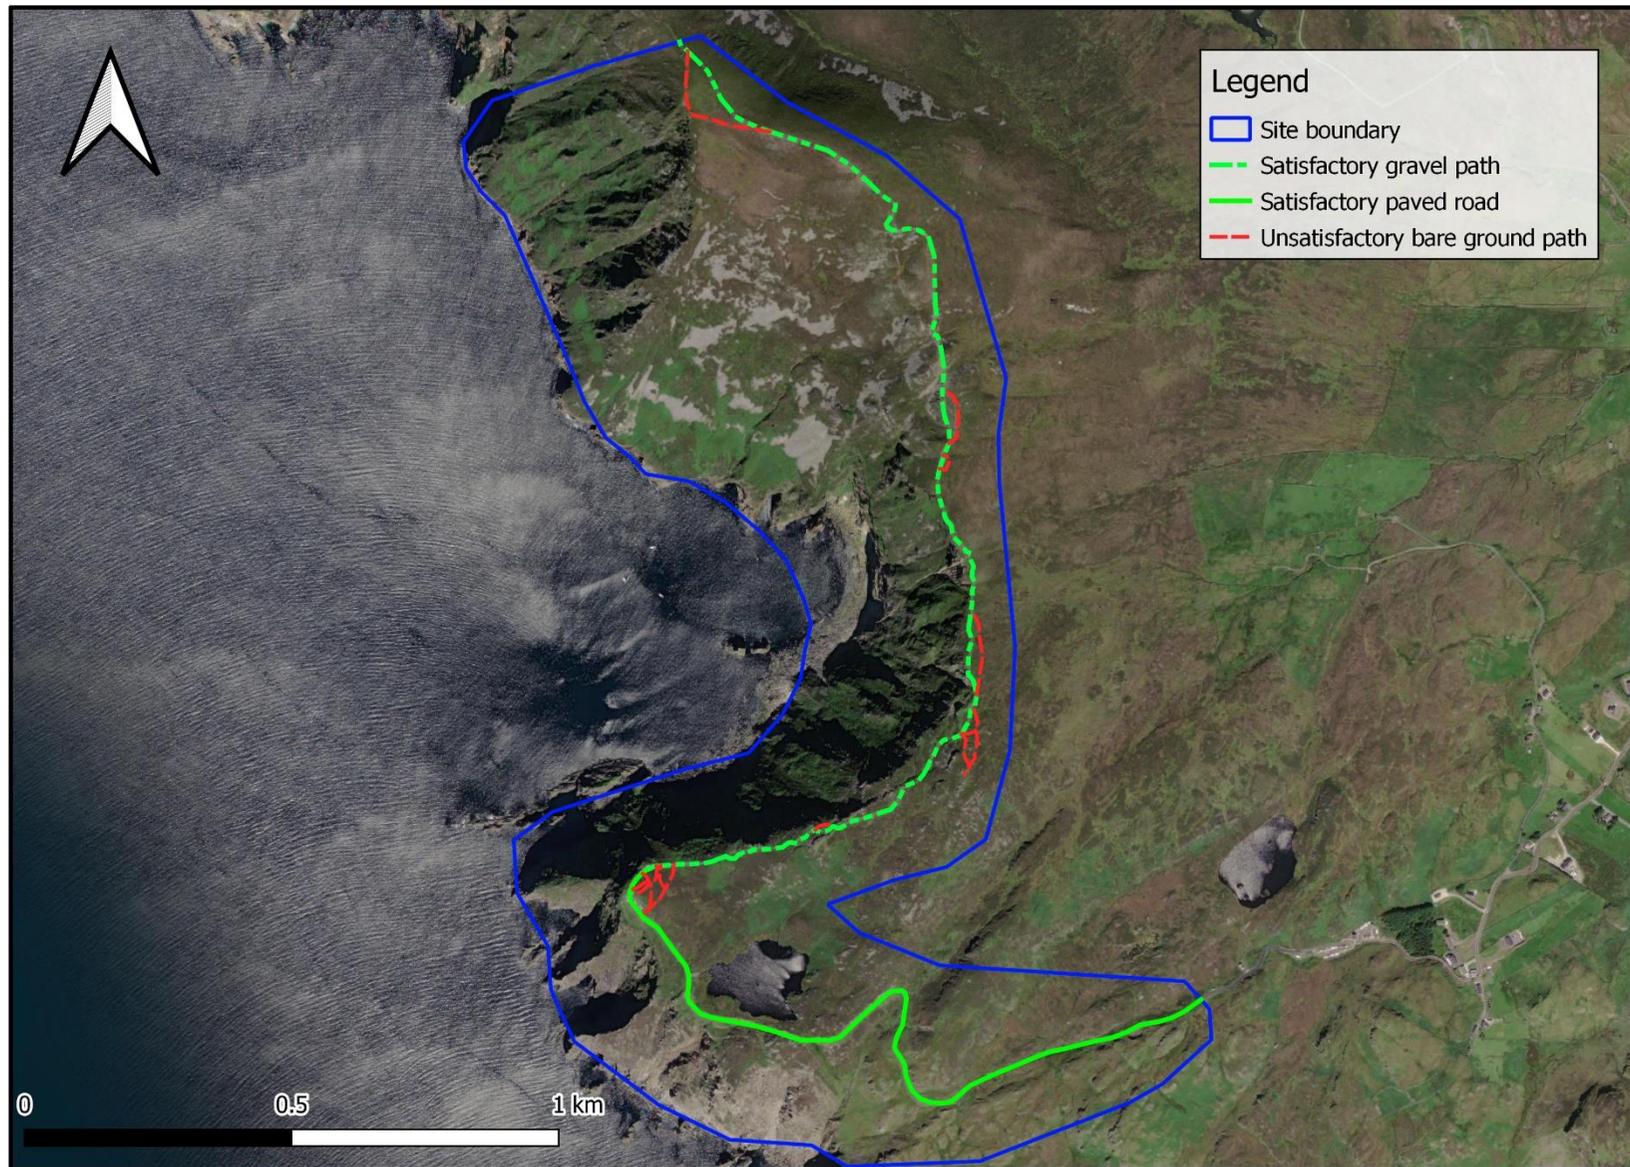
Figure 3.4 Pathway types and conditions present on the site. Basemap provided by ESRI.

Commencing from the lower car park, a c. 1.6 km paved road in satisfactory condition leads visitors westward up the mountain towards the upper car park / Bunglass viewing area where a viewing platform and a number of vendors selling gifts, food and drinks are located. Within the heath habitat adjacent to the viewing area are several informal bare ground paths which are in an unsatisfactory condition. These trails surround the start of the cliff path and the viewing platform. Travelling northward from the viewing platform, the cliff path is comprised of a mixture of gravel and stone which has been inlaid into the ground as far as the Cnoc Ramhar viewing area. This path is in a satisfactory condition. Branching off this main pathway into the surrounding heath areas are a number of small bare ground paths which are in unsatisfactory condition due to the trampling of vegetation which has eroded and widened the path and damaged the surrounding heath habitat. These trampled pathways are short in length and generally occur to access various viewpoints. The majority of these paths occur close the Bunglass viewing area and become less frequent the further along the trail, presumably as a smaller proportion of visitors reach Cnoc Ramhar. Plate 3.4. below presents images of the main pathways found at the site.

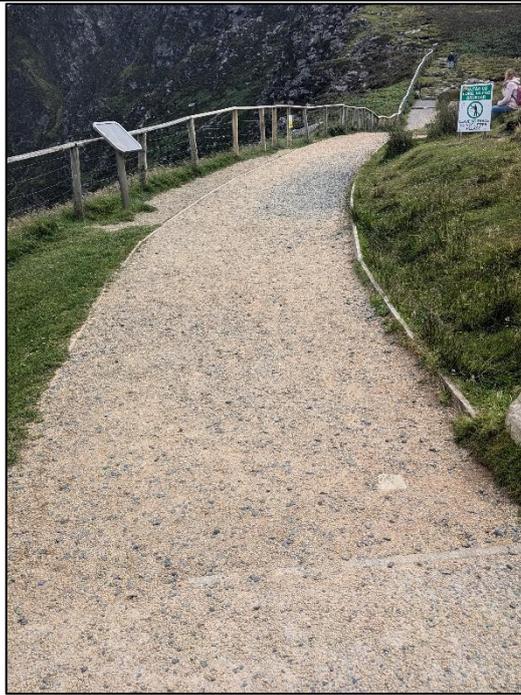
**Satisfactory gravel path (Bunglass viewing area)**

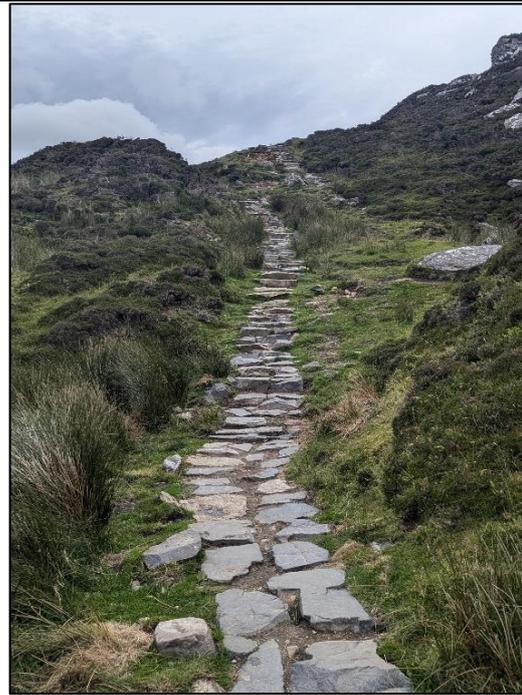
**Satisfactory gravel path (with inlaid stone)**

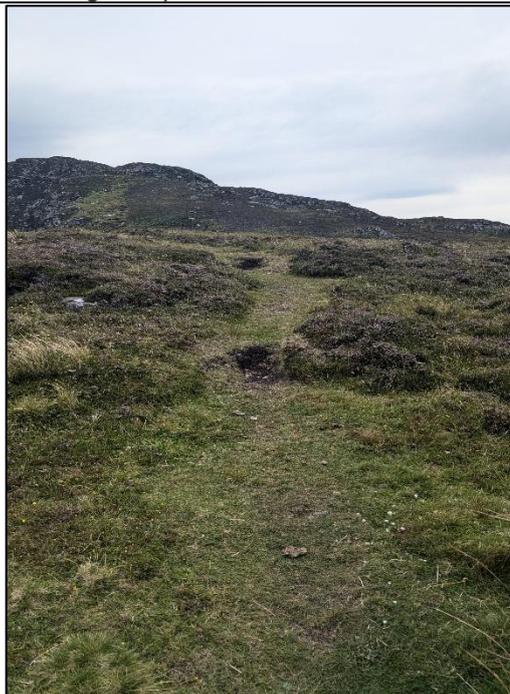
**Unatisfactory bare ground path (through heath habitat)**

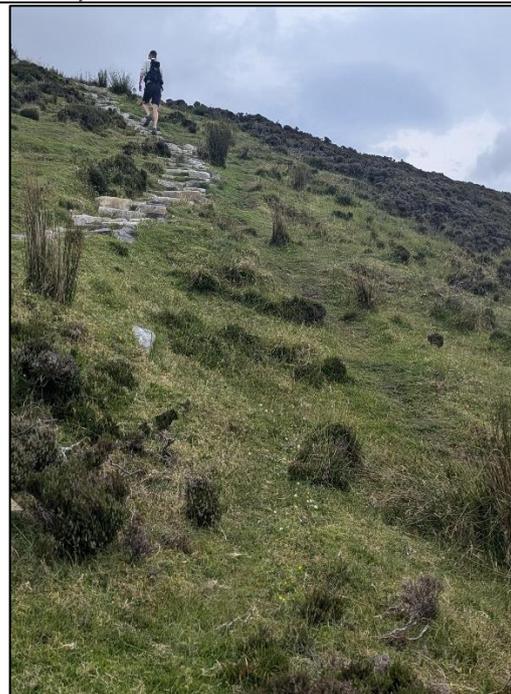
**Unatisfactory bare ground path (adjacent to the cliffside path)**

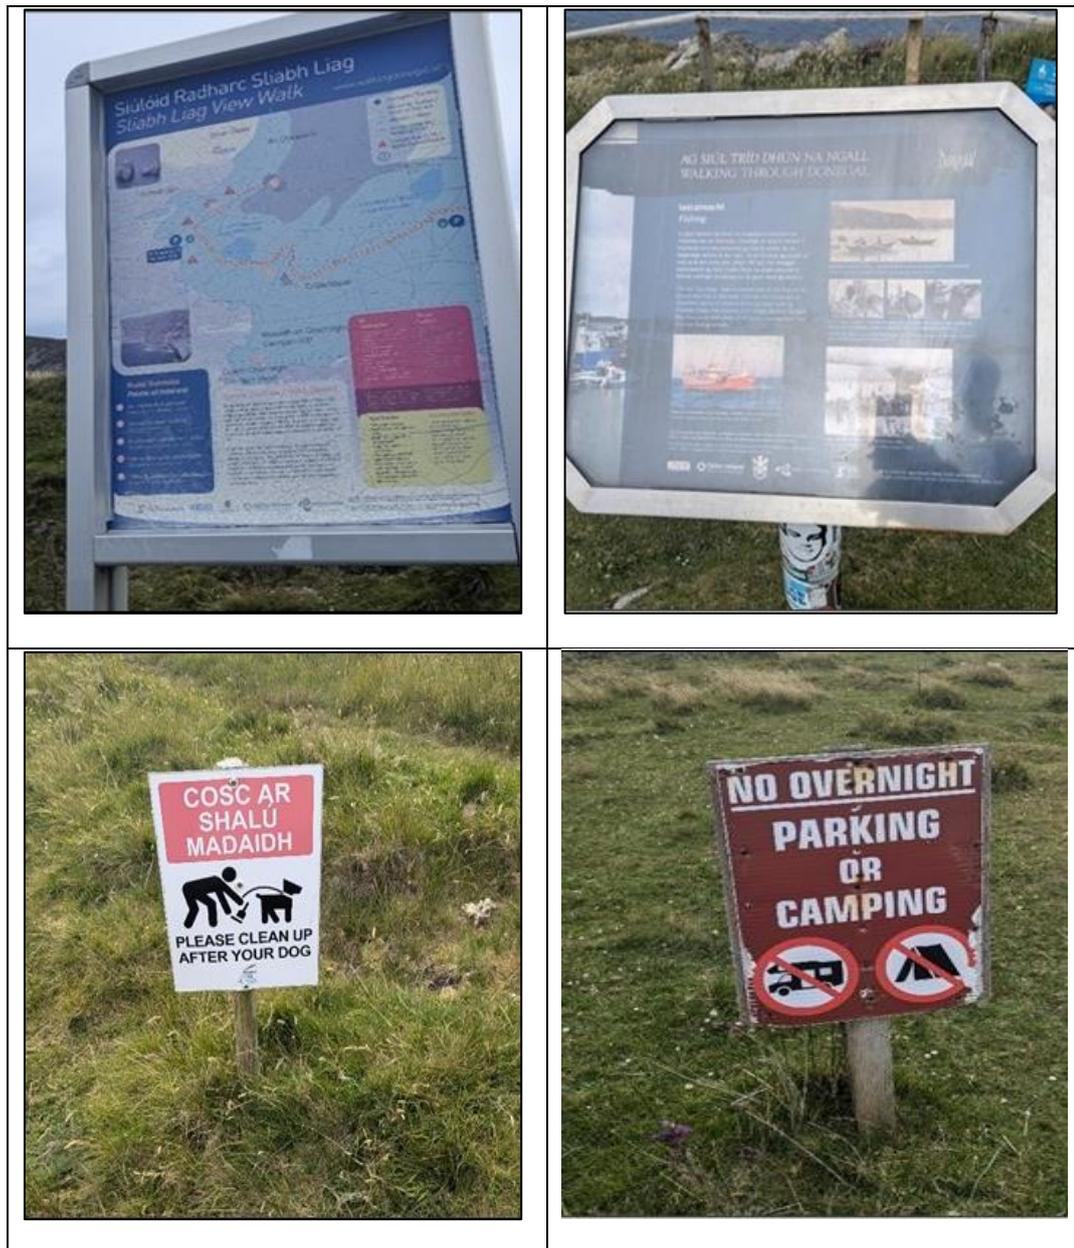
Plate 3.5 Informational and instructional signage at Sliabh Liag.

No bicycle parking facilities are available at the Sliabh Liag car parks or viewing area, but are found at the visitor centre. Toilet facilities are available at the lower car park. Bins are available at the upper car park / Bunglass viewing area where gifts, food and drink are sold from a number of vendors. Picnic benches, a viewing platform constructed from wood and instructional signs warning visitors to avoid littering, clean up dog waste and to avoid camping at the site are also located in this area. A number of signs throughout the site warn visitors from getting too close to the cliff edges. Several other signs display information about the history, geography and ecology of the site. Way-markers direct visitors along the cliff path throughout the site. Plates 3.5 and 3.6 below show selected signs and features at the site.

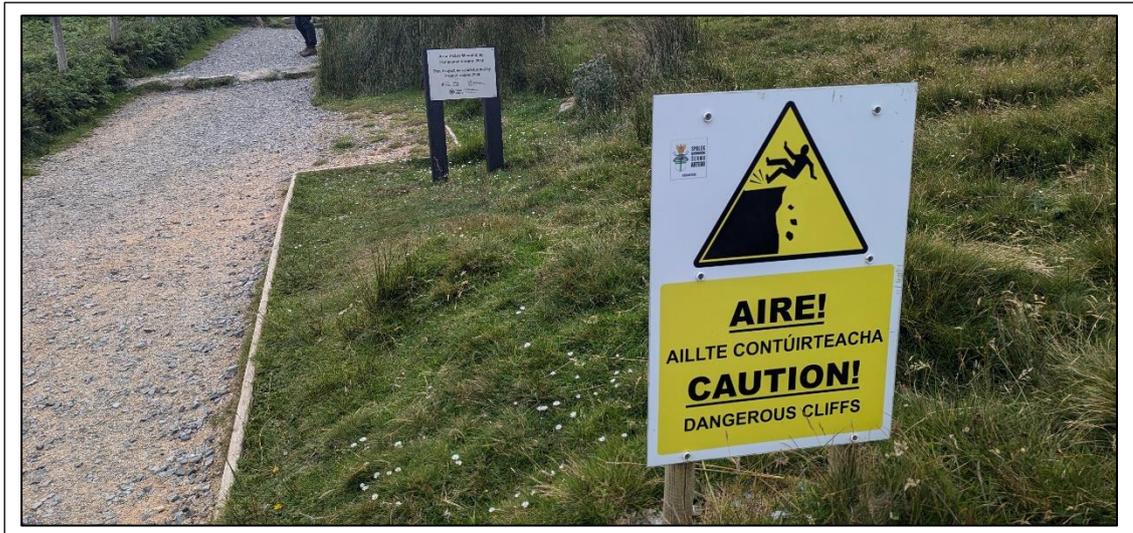
The main hazard at the site is presented by the cliffs. Barriers have been erected along some sections of the cliffs, mainly at Bunglass, and there are numerous signs warning visitors of this hazard are located throughout the site (See Plate 3.7 below). Figure 3.5 presents a map showing the location of features, signage and hazards at the site.

**Plate 3.7** Sign warning visitors to approach the cliffs with caution.

- As detailed in Section 3.2.2 above, there are exposed cliffs around the viewing area at Cnoc Ramhar and at other areas which present a hazard. A review of the safety along the paths, particularly at the viewing points and at heavily trafficked locations should be undertaken, taking learning's from similar interventions underway e.g. Cliffs of Moher, Co. Clare.

- Signage advising of the safety risk beyond Bunglass should be considered. Signage should indicate that inexperienced hikers are not advised to proceed beyond this point, and that hiking here is not to be undertaken in poor weather conditions.

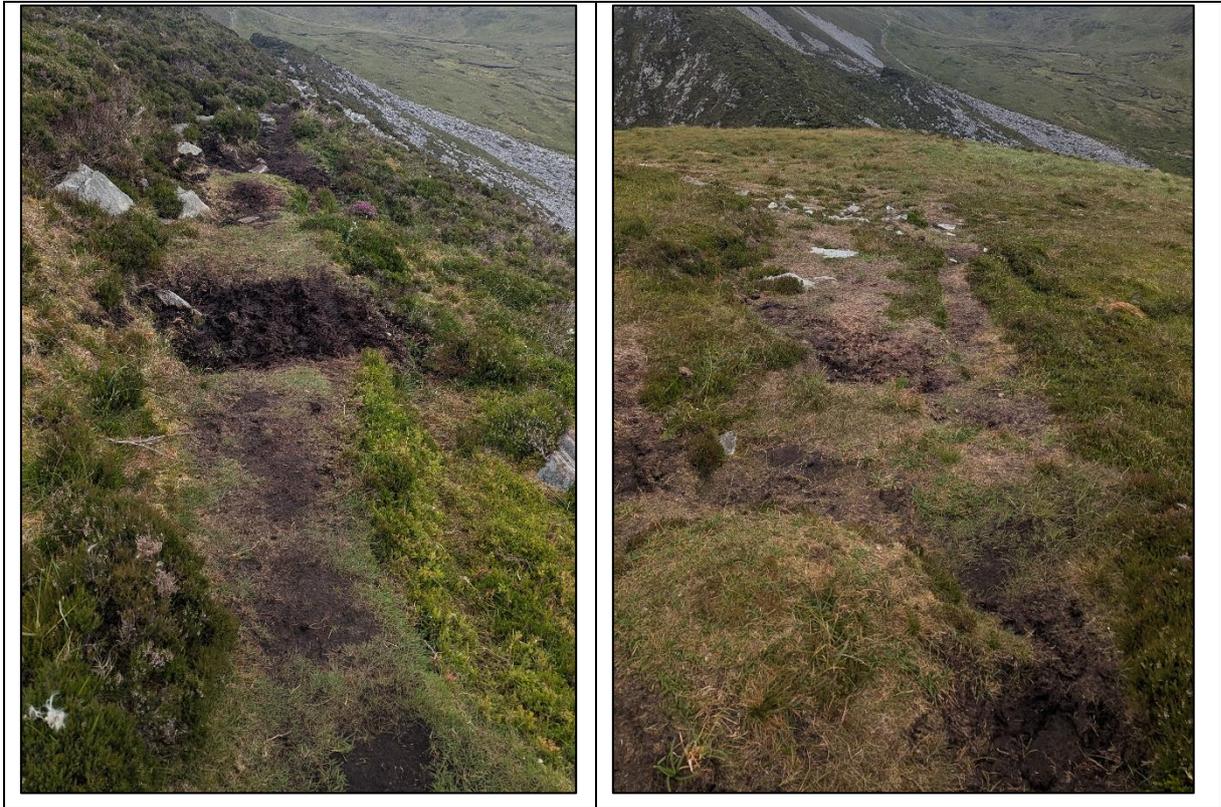
An informal bare ground pathway is present between the Pilgrim's Path and the Cnoc Ramhar viewing area. This path travels along the landward side of the mountain and offers an alternative route to visitors who do not wish to proceed to the peak of Sliabh Liag to join with the Pilgrim's Path. This path is in unsatisfactory condition due to the high level of trampling and erosion present in some sections (See Plate 3.7 below).

**Plate 3.7 Heavy trampling on the path leading from Cnoc Ramhar to the Pilgrim's Path.**

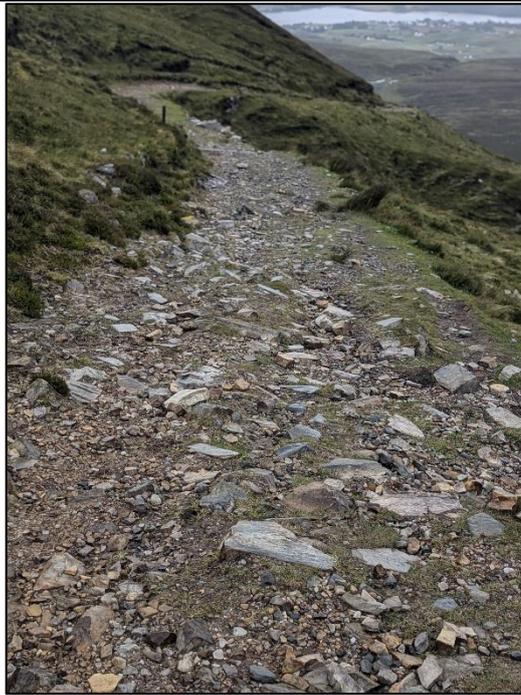
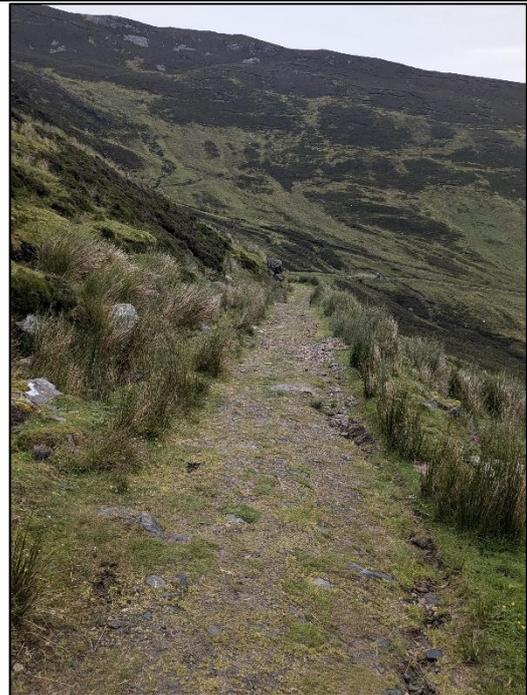
This informal path travels northward for c. 500m before connecting to the Pilgrim's Path. At this location and towards the cliff ridge, the Pilgrim's Path is in an unsatisfactory condition due to erosion caused by weather and walkers. The erosion on this section of the Pilgrim's Path (which is comprised of gravel, cobbles, boulders and vegetation) renders the path unsuitable for vehicular use, given the hazard presented by the rocky and uneven terrain.

**Gravel path in unsatisfactory condition**

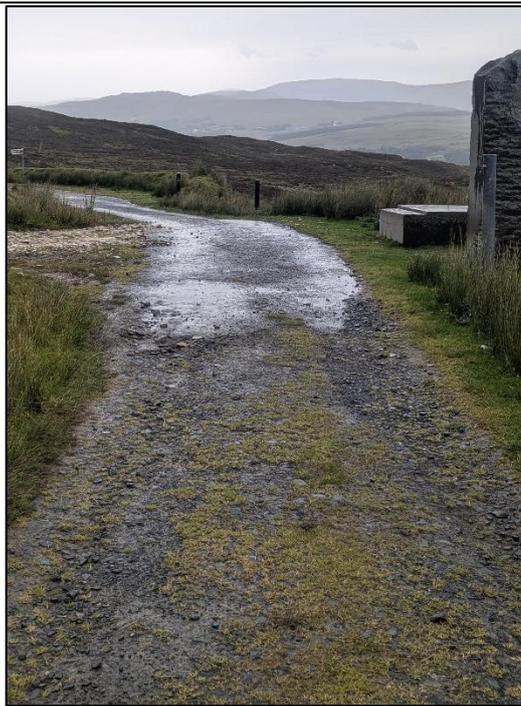
This gravel path eventually grades to a stretch of pathway that is in satisfactory condition, devoid of significant potholes and erosion and the surface is largely even. This section, suitable for vehicular access, and begins c. 250m west of the westernmost stone monument on the Pilgrim's Path and continues for c. 1.3km in a southeasterly direction as far as the car park which is located at the starting point of the Pilgrim's Path. A map showing the condition of the Pilgrim's Path pathway is presented in Figure 3.6. Plate 3.8 show sections of the pathway that are in satisfactory and unsatisfactory condition (for vehicle access).

**Gravel path in satisfactory condition**

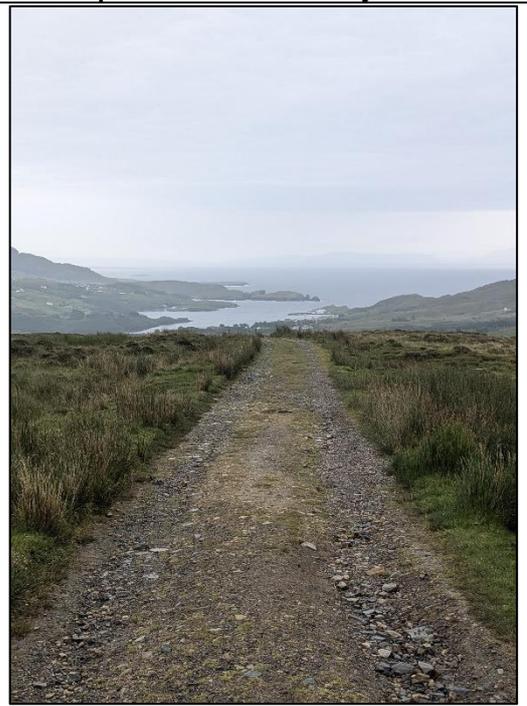
**Gravel path in satisfactory condition**
