National Tourism and Environmental Monitoring Programme Tramore 2024

National Tourism and Environmental Monitoring Programme

Annual Report for Tramore 2024

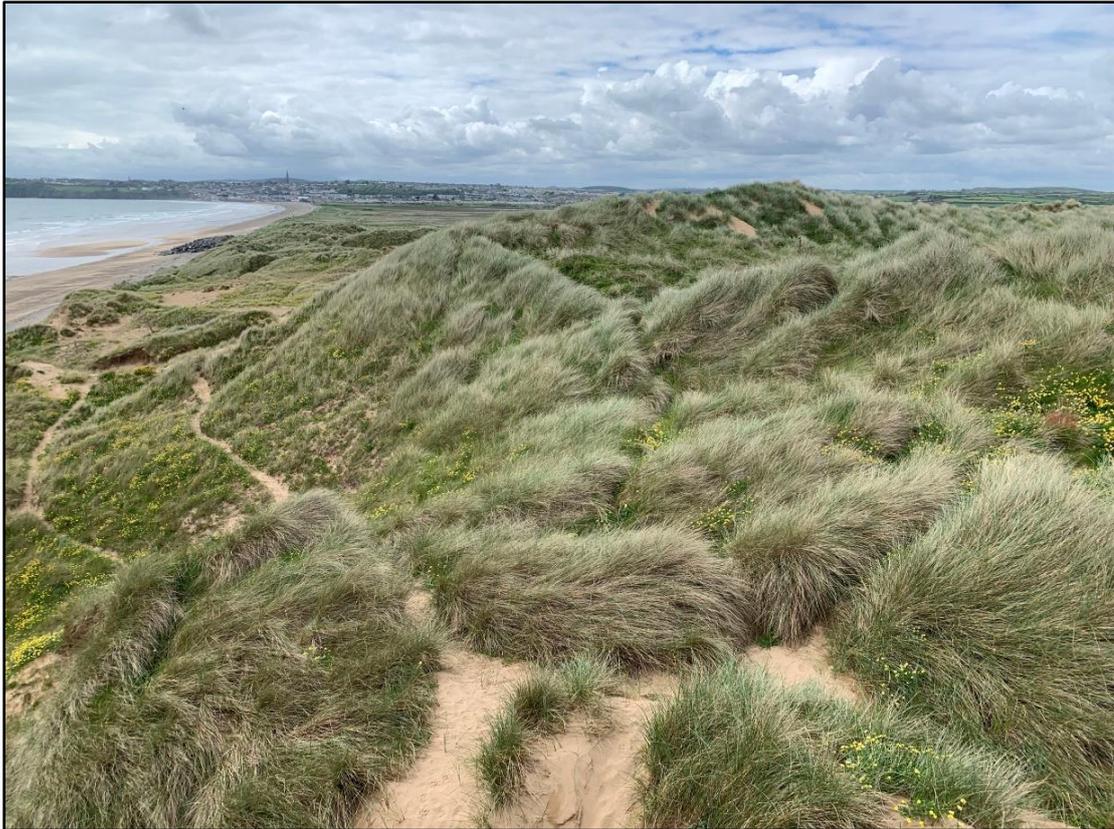
Figure 3.1 Fixed dune (CD3) habitat in Tramore Burrow.

Fixed dunes (CD3) is the dominant dune habitat type on the site. Fixed dunes cover most of Tramore Burrow, and extend west towards the car park. Marram dunes (CD2) are present along the southern (seaward) side of Tramore Burrow, with Embryonic shifting dunes forming the interface between the Marram dunes and the beach.

Given that visitor impacts were consistent throughout the different dune habitats, they are discussed collectively here. The western stretch of the dunes is severely impacted by recreation and amenity users, with clear signs of trampling and multiple informal paths being utilised. In Tramore Burrow, visitor movements through the dunes have resulted in trampling and braiding to such an extent that it is visible from satellite imagery, as well as on the Strava heatmaps. This has resulted in the collapse of some areas and dune and the loss of vegetation. Chestnut pale fencing, rope boundaries and signage are present within the dunes to prevent recreation and amenity users from entering, however much of this has fallen and has visibly been trampled, and informal paths continue throughout the dunes. Areas of deterioration and collapse of the dunes were noted as a result of recreation and amenity users accessing them from the beach. This decreased with distance from the promenade and was less prominent on the easternmost side of the burrow, where the dunes are steeper.

Marram grass (*Ammophila arenaria*), daisy (*Bellis perennis*), and kidney vetch (*Anthyllis vulneraria*) were the dominant species recorded in the dunes. Other species present include dandelion (*Taraxacum vulgaria*), common stork's-bill (*Erodium cicutarium*), sand pansy (*Viola tricolor ssp. curtisii*), buck's-horn plantain (*Plantago coronopus*), common sorrel (*Rumex acetosa*), ribwort plantain (*Plantago lanceolata*), wild radish (*Raphanus raphanistrum ssp. raphanistrum*), swiss chard (*Beta vulgaris*), wild carrot (*Daucus carota*), common milkwort (*Polygala vulgaris*), common bird's-foot-trefoil (*Lotus corniculatus*), wild pansy (*Viola tricolor ssp. tricolor*), sea-holly (*Eryngium maritimum*), burnet rose (*Rosa spinosissima*), sedges (*Carex sp.*), hawthorn (*Crataegus monogyna*), germander speedwell (*Veronica chamaedrys*), bramble (*Rubus fruticosus*), bush vetch (*Vicia sepium*), eyebright (*Euphrasia officinalis*), bluebell (*Hyacinthoides non-scripta*), meadow buttercup (*Ranunculus acris*), and some ferns. This habitat is displayed in **Figure 3.1**.

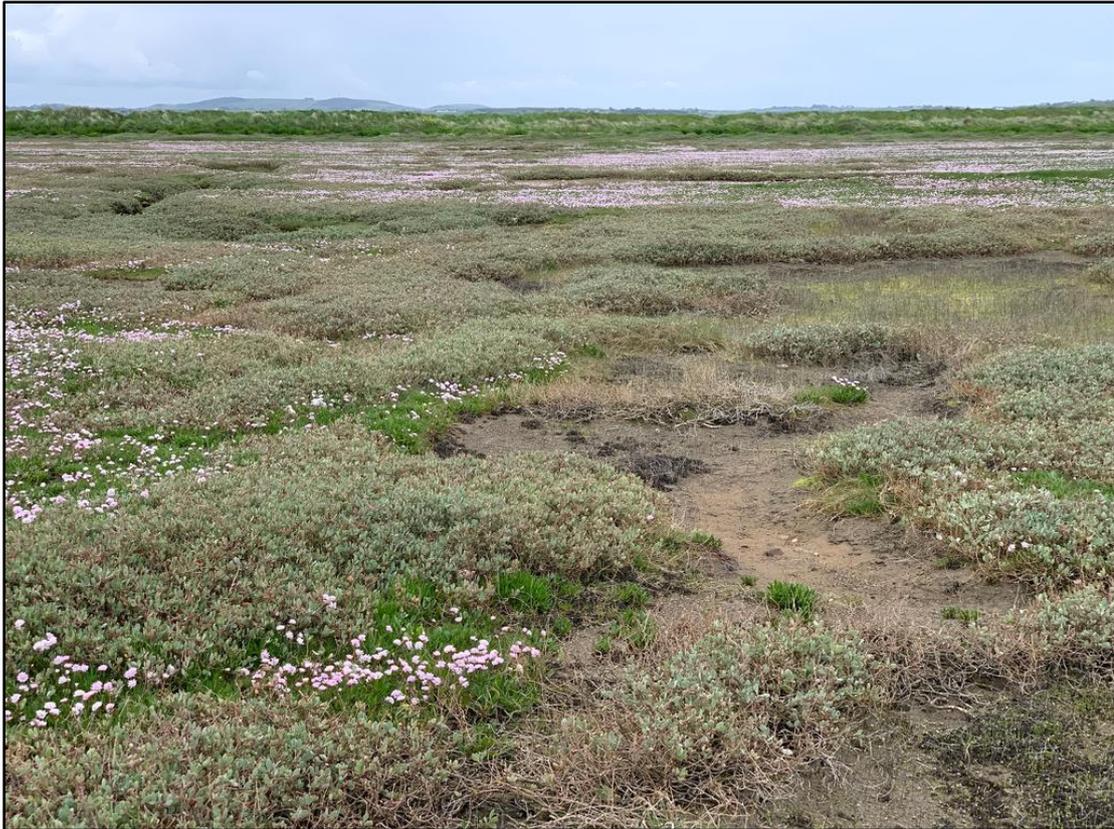
Figure 3.2 Lower salt marsh (CM1) habitat in Tramore Burrow.

Lower salt marsh is present between the car park and Tramore Burrow. There is also a small pocket of this habitat (approximately .5 hectares) in the northeastern part of the burrow. There are small drainage channels leading to the mud shores and mudflats north of the site within the saltmarsh. Given the difficulty of the terrain and the large number of channels present, the exact locations of these channels are not mapped. To the south of this habitat, it slowly transitioned to recolonizing bare ground. It is possible that this habitat has slowly regressed over time as a result of the impacts from visitor movements between Tramore Burrow and the car park. Small amounts of litter in the marsh noted in the salt marsh. Unleashed dogs were also noted entering this habitat. No other impacts from recreation and amenity users were observed within the marsh, likely due to it being difficult to traverse. Thrift (*Armeria maritima*), Sea Purslane (*Atriplex portulacoides*), and English Scurvygrass (*Cochlearia anglica*) are the dominant species. Grasses are present to the south of this habitat where it transitions to recolonising bare ground, but do not dominate. Dead crabs were noted throughout the marsh in large numbers, which were likely deposited during high tide. Oystercatchers and other wetland birds were observed foraging north of this habitat in Tramore Strand. This habitat is displayed in **Figure 3.2**.

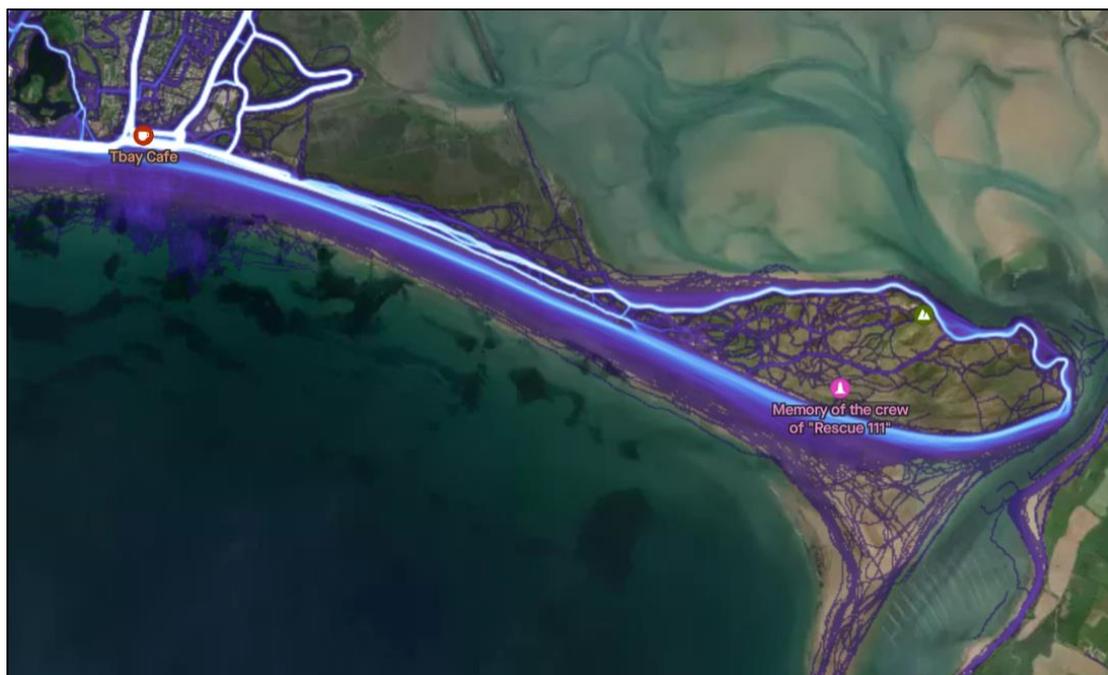
Figure 3.4 Heat map of visitor movements in Tramore (Strava, 2024).

Figure 3.4 presents a heat map of visitor movements at the site, provided by Strava. Strava aggregates data from users on its app who opt-in to share their activities and locations. The pathway condition assessment map is provided in Figure 3.5. Plate 3.1 displays some of the pathways encountered in Tramore.

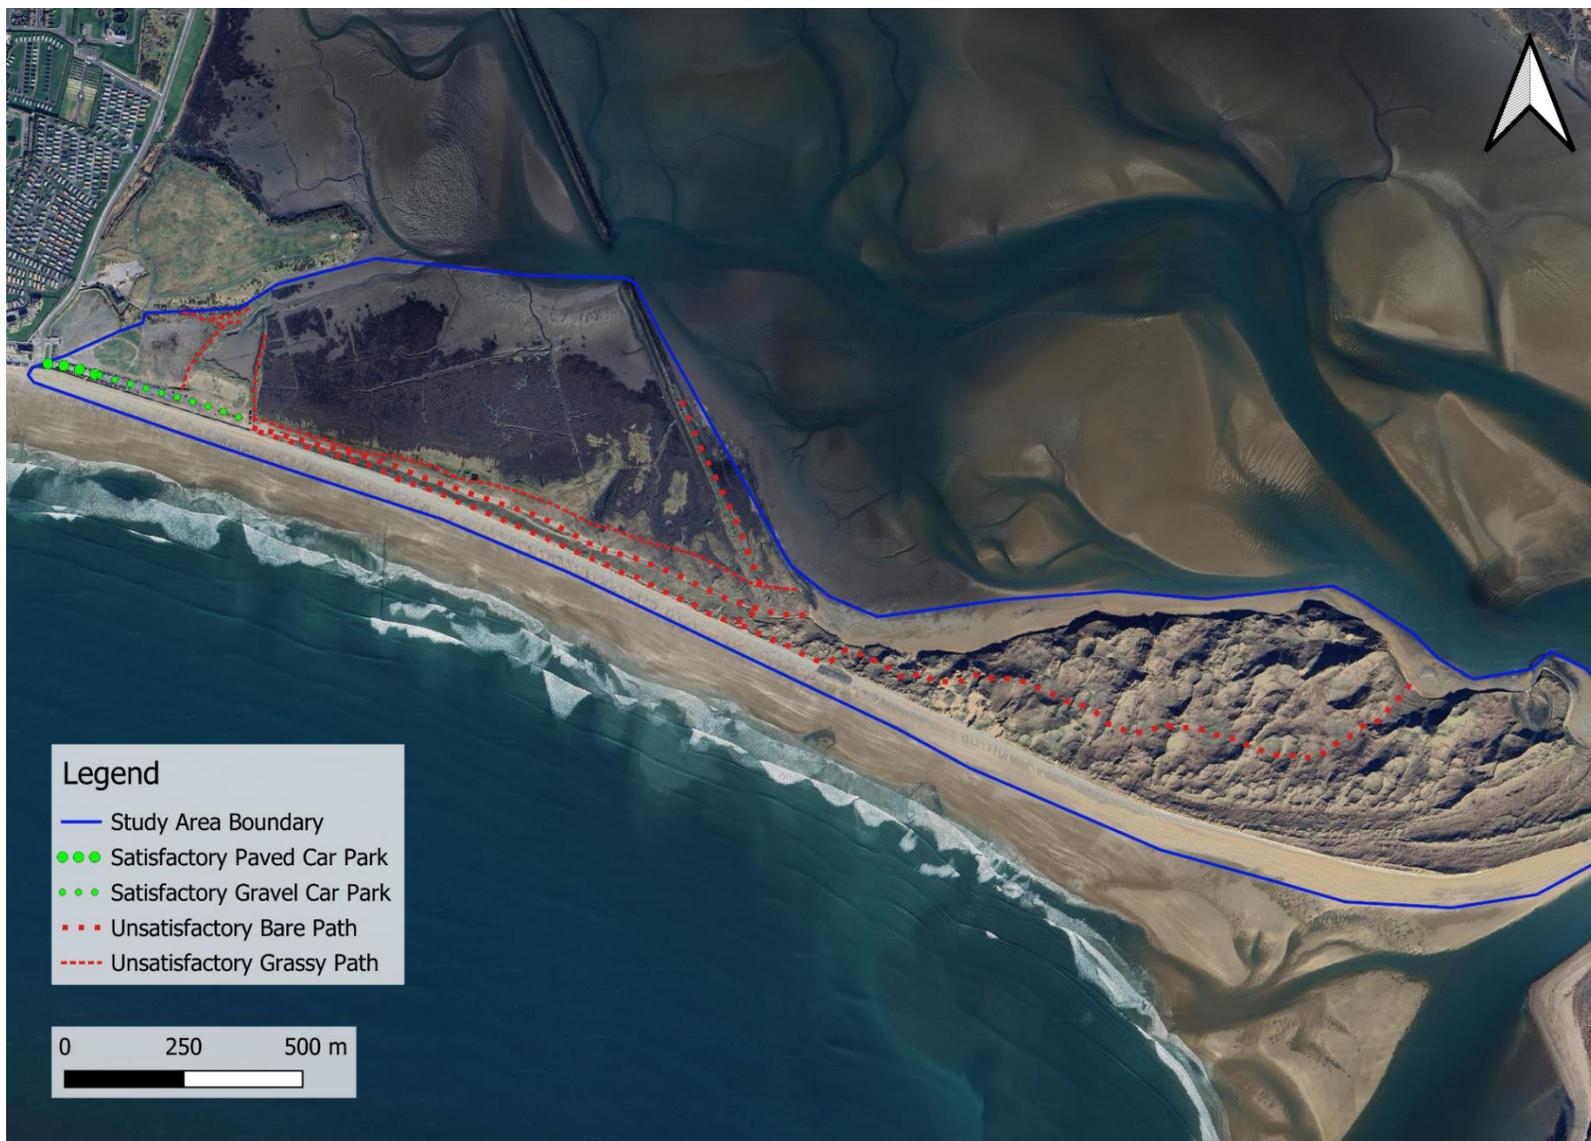
Figure 3.5 Path types and conditions present on the site. Basemap provided by Google. Given the number of paths in Tramore Burrow, they are not mapped above.

Much of the paths on this site are unsatisfactory. The most concerning damage is present in the dune habitat within and leading to Tramore Burrow. In the narrow stretch of fixed dunes leading to Tramore Burrow, trampling and braiding has caused the deterioration of the habitat in this area. In Tramore Burrow, much of the fencing in the dune habitat has fallen, and numerous paths have led to erosion and habitat loss.

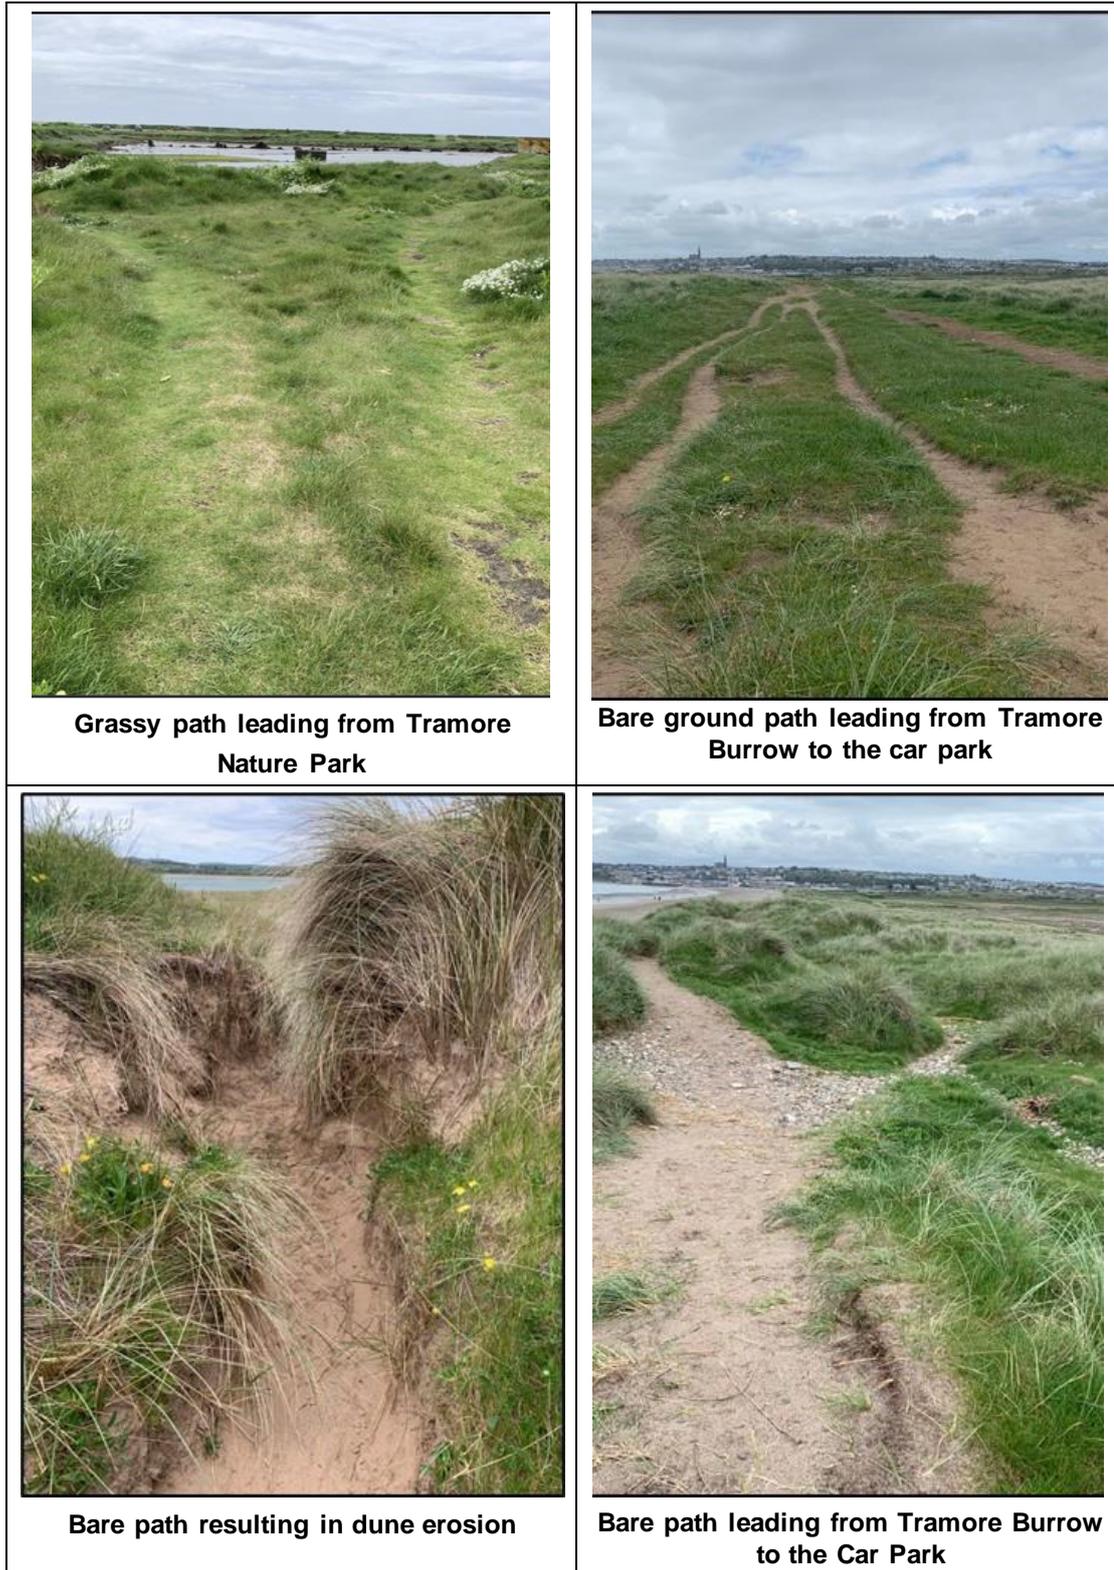
Plate 3.1 Some unsatisfactory paths recorded in on site.

North of the main carpark, there is an overflow carpark. There are a number of informal paths linking the car parks north to Tramore Nature Park. The main path has been mapped; however, it should be noted that there are numerous informal paths that were not easily defined. The condition of this path and the paths in the general area is unsatisfactory. The paths between the car parks and Tramore Nature Park traverses through an area of wet grassland, which has resulted in some trampling in this area. Continued use of this informal route will likely result in further damage to the wet grassland, and potentially to the mud shore habitat adjacent to it. An example of this is displayed in the top left corner of Plate 3.1.

The earth bank which appears to have been used to reclaim an area of the sea for the former racecourse is heavily trampled and exhibited braiding. There was also evidence of horse riding in this area which has contributed to the damage to the path.

From the carpark, visitors are directed towards Tramore Burrow on a bare track running parallel to the beach. This is displayed in the top right corner of Plate 3.1. There are a number of informal trails running through this area and into the dunes to the east, resulting in the regression and deterioration of the surrounding habitat. An example of this is displayed in the bottom right corner of Plate 3.1. The informal paths do not traverse into the salt marsh habitat, though given the extent of path braiding, erosion may have led to the regression of the salt marsh habitat over time, which has resulted in recolonising bare ground.

- The construction of a formal path from car park to lead visitors along already established walking route would help reduce habitat degradation adjacent to the path. The replacement and extension of the old boardwalk (displayed in Plate 3.4) should be considered, as this would create a path with a clear boundary between it and the surrounding habitats. This would allow for the restoration of the surrounding dune habitat. Visitors should be directed along designated paths and discouraged from venturing into the dunes using both signage and fencing. The existing damaged fencing should be removed.

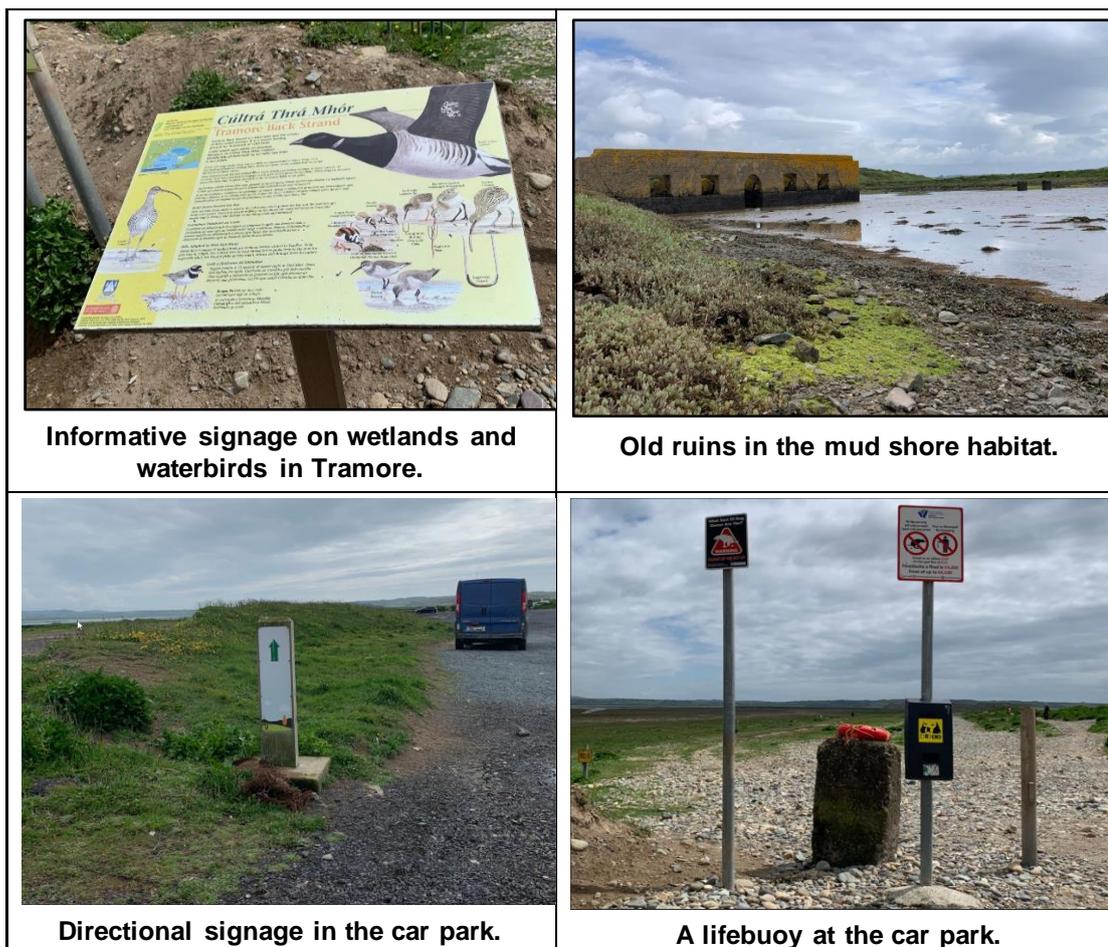
Plate 3.2 Features and signage on the site.

There are some bins in the car park, including dog waste bag dispensers and bins with signage. There are also two bins located on the path to Tramore Burrow. A lifebuoy is present in the car park. There is a sign in the car park with information on the wetlands and waterbirds found in the area. As discussed in Section 3.1, ruins of a 20th century racecourse are present in the mud shore habitat. There is no informative signage pertaining to these ruins. There is little to no directional signage on the site, and as such it is unclear where visitors should walk, and where should be avoided. Images of the signage and features on the site are shown in **Plate 3.2** below.

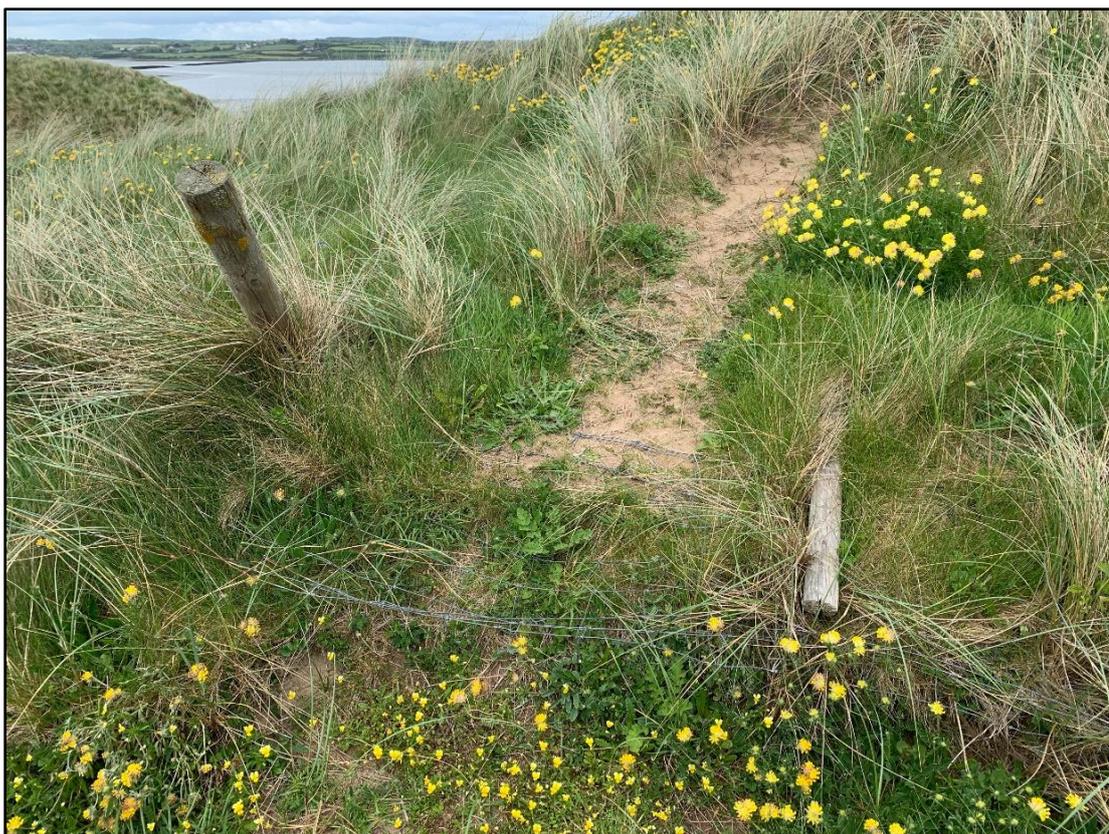
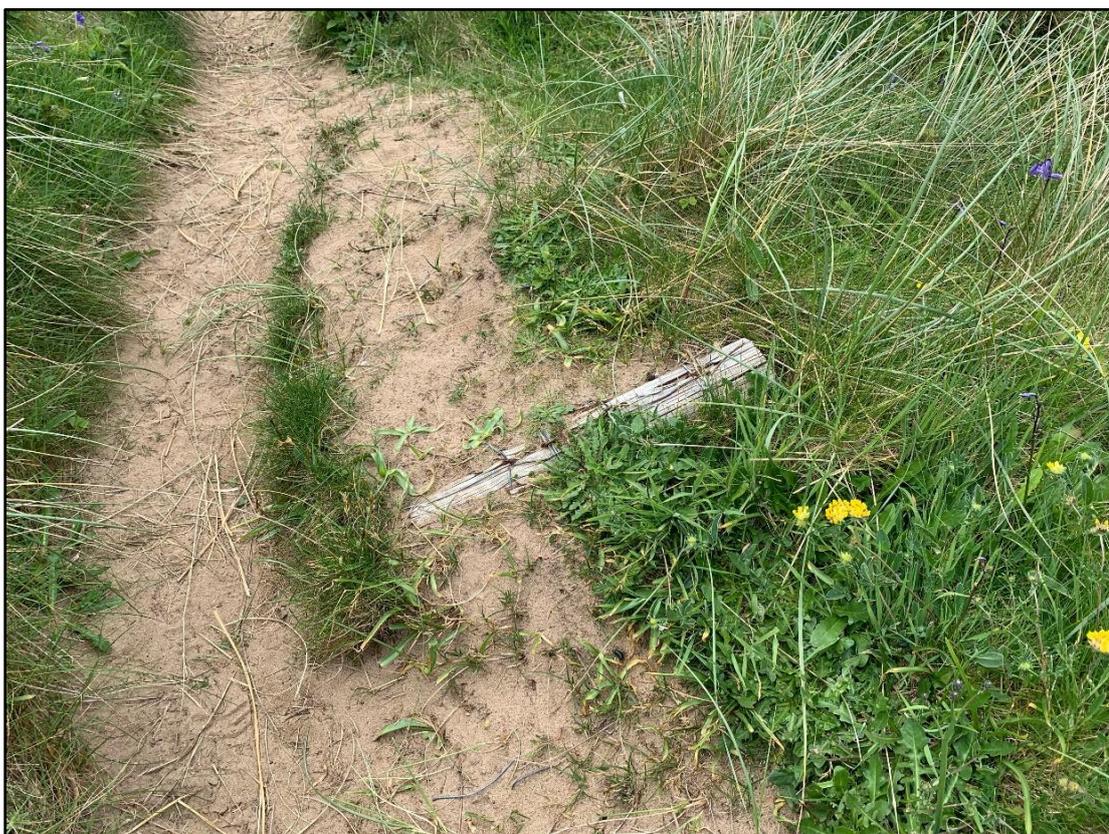
Plate 3.3 Fallen stock proof fencing (top) and old wooden fencing (bottom).

Hazards were recorded in Tramore Burrow. The broken fencing (**Plate 3.3**) and old boardwalk (**Plate 3.4**) are trip hazards, particularly given that some of the broken fencing has fallen and is difficult to see. Furthermore, as various informal paths have formed in the dunes, many of them are steep and suddenly drop steeply. This also creates a hazard for people walking. Hazards are displayed in **Plate 3.3** and **Plate 3.4** below.. As uneven pathways were found throughout Tramore Burrow, they are not mapped. It should also be noted that given the nature of the dunes and that some of the fencing was trampled and difficult to find, there may be additional locations of damaged fencing in Tramore Burrow. Mapping of notable features and hazards recorded on the site are displayed below in Figure 3.6.

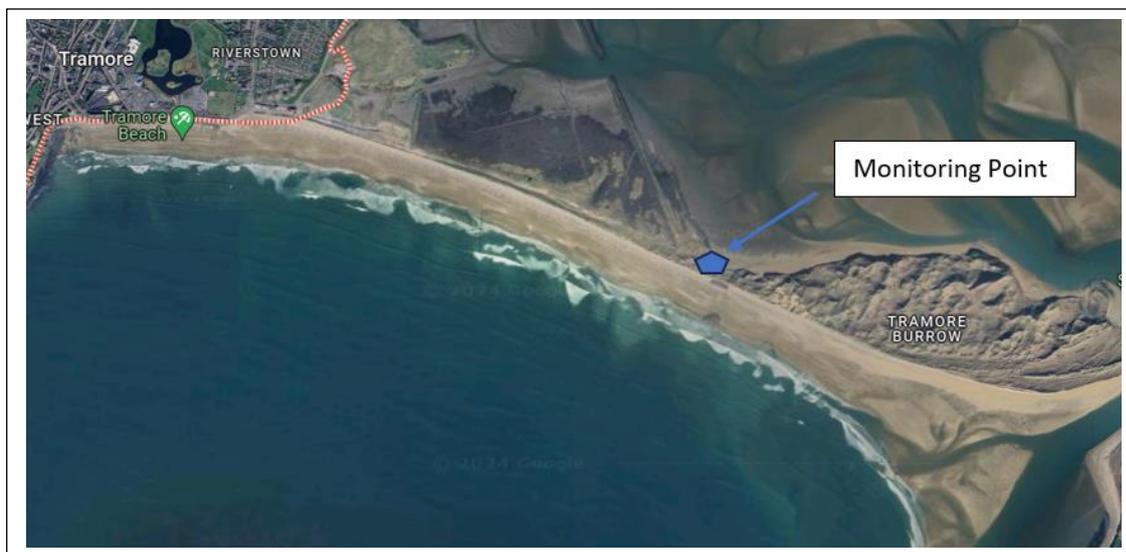
Plate 1: Visitor Monitoring Survey undertaken from point as indicated below:

The visitor characterisation surveys were undertaken at Tramore Beach and Dunes on the 5th of June (Wednesday) 2024 and 16th August (Friday) 2024. The surveys were undertaken using one surveyor to gauge typical visitor usage and behaviours over the survey periods. The surveys were undertaken towards the eastern edge of Tramore beach at the narrow point 'the neck' of the dunes system adjacent to the rock armour giving a good vantage point of observing activities along beach, access to the rear of the Burrows and activity within the dune system itself (See Plate 1 below).

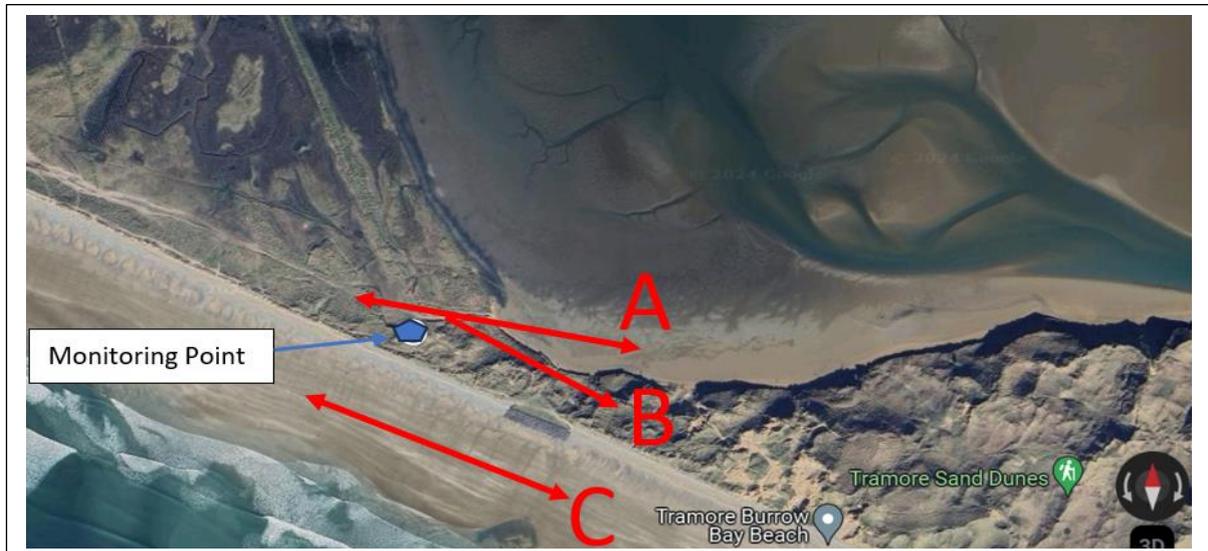
Plate 2: Main visitor movements direction of movement (A, B and C)

Plate 2 below indicates the 3 main movement areas within the beach system observed on site:

- A – Walking running along the established track to the rear of the beach;
- B – Walking running along the heavily braided tracks within the dune system; and
- C – Walking, running, swimming etc.. along the beach
