BEARA BREIFNE WAY TRAIL PLAN

Technical Trail Audit and Design

Section B - Trail Audit Findings

Prepared by Outdoor Recreation NI
on behalf of Fáilte Ireland

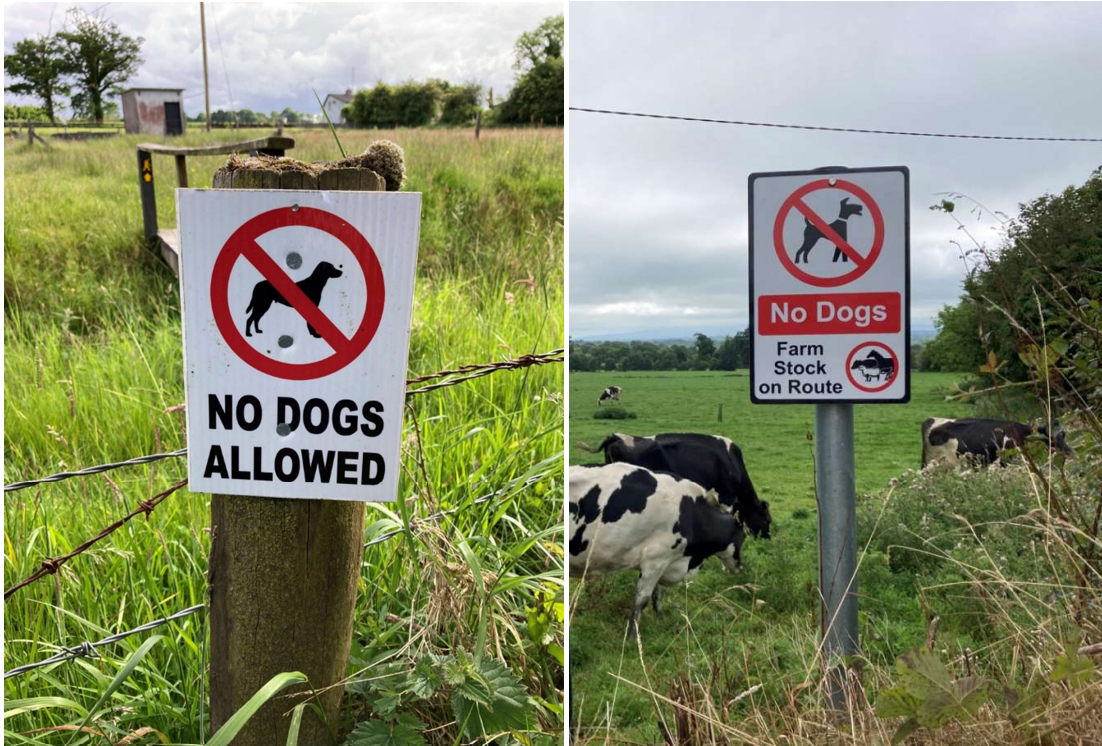
Figure 8 Images of dog warning signs along the route

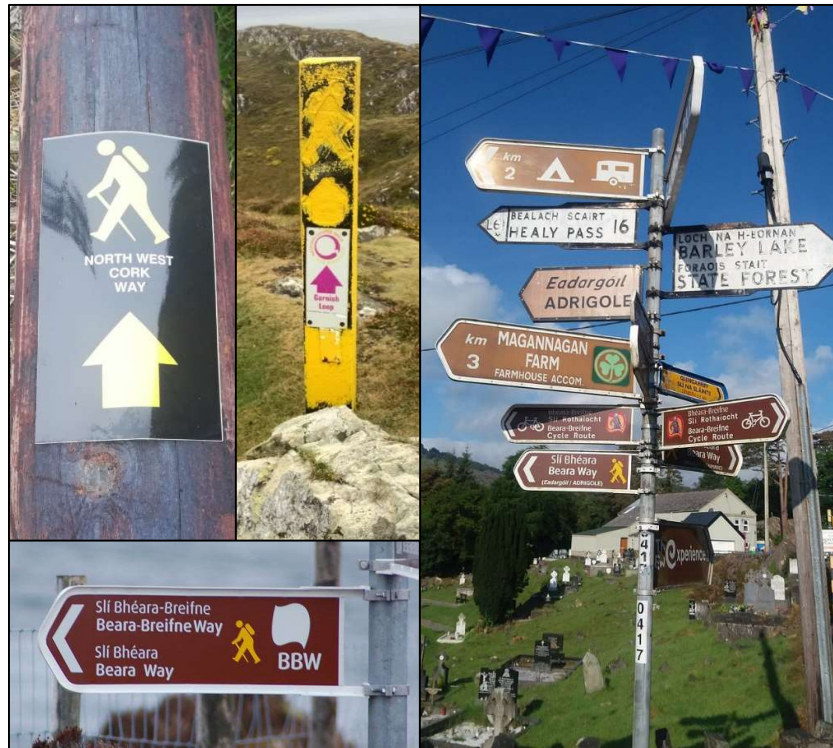
- There has been a piecemeal approach to waymarking to date.

- Not all sections of the route meet Sport Ireland’s trail standards or have been assessed against these standards.
- The BBW is not fully waymarked.
- Confusion with other walk routes and the BBW Cycle route.

Figure 12 A selection of signage examples from the BBW

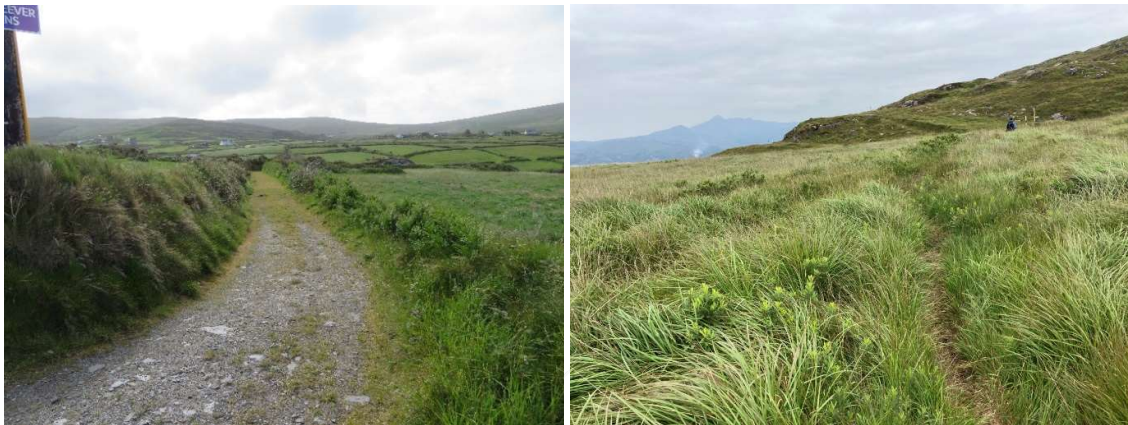
Off-road sections of the trail consist of used and disused vehicle tracks, open hillside with and without desire lines (some of which can be boggy or very wet under foot), and sections of pastoral farmland that are intended to be maintained for walkers (see Figure 15).

Figure 15 Off-road trail on the Beara Way

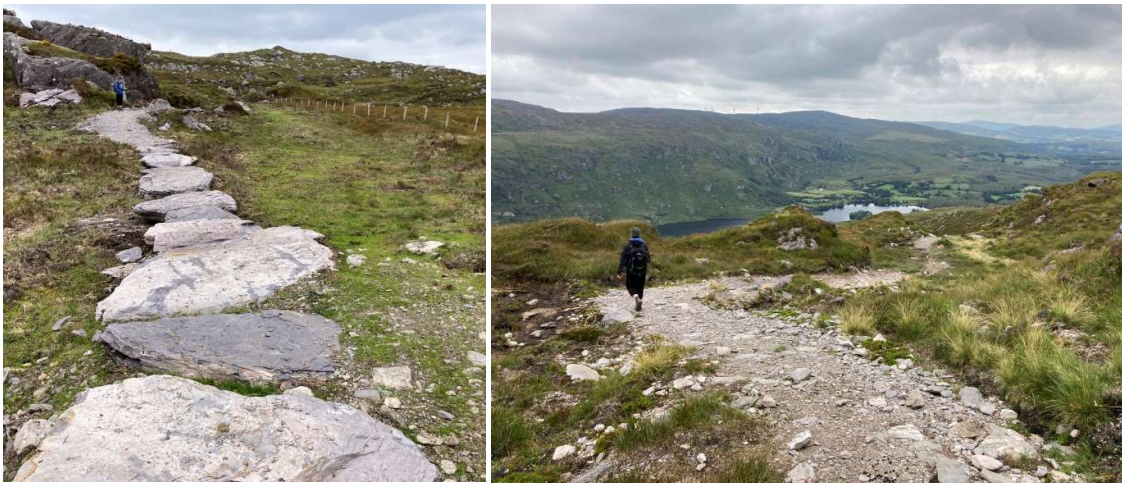
Off-road sections of the trail consist of used and disused vehicle tracks (farm and forestry), open hillside with and without desire lines (some of which can be boggy or wet under foot), built gravel trail (Figure 17), bog bridge, stone stepping and sections of pastoral farmland intended to be maintained for walkers.

Figure 17 Off-road trail on the Sli Gaeltacht Mhuscraí

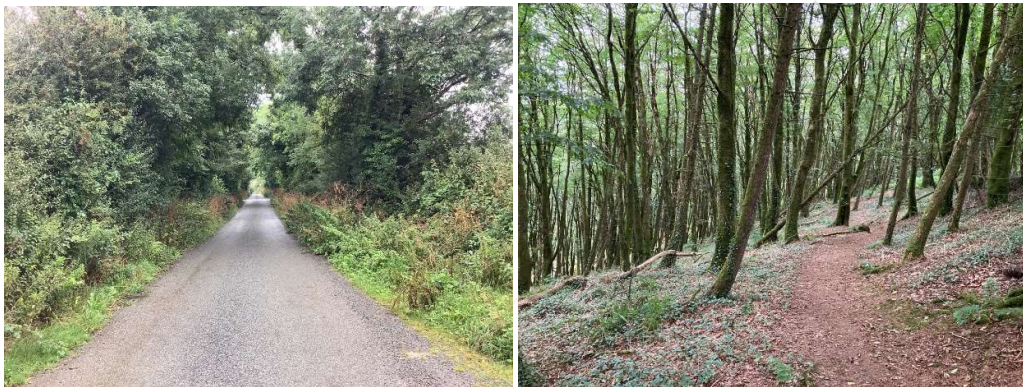
Off-road sections of the trail consist of farm track, built forest trails and desire lines across wooded areas. Farm tracks and forest trails are constructed using compacted gravel, are robust and provide a welcome alternative to walking on bitmac. Figure 19 shows trail surfaces on the NWCW.

Figure 19 On-road and off-road trail on the North West Cork Way

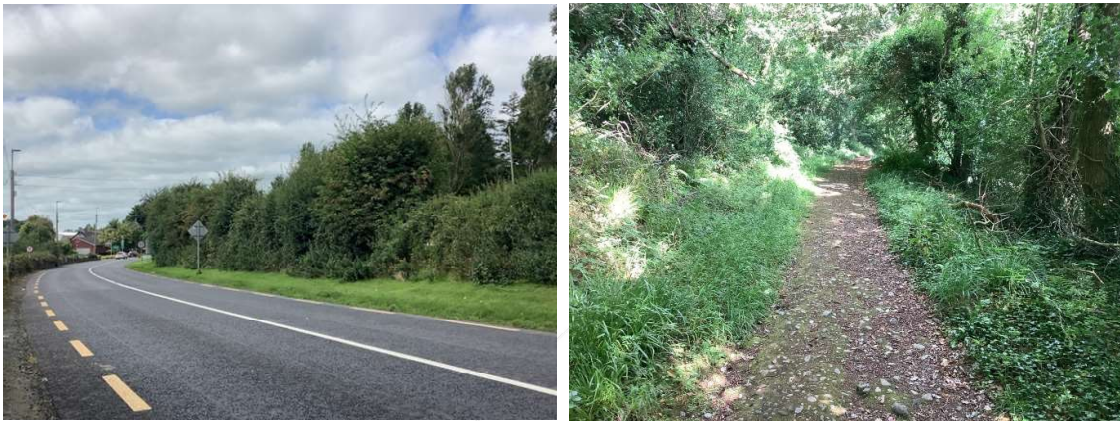
Off-road sections of the trail consist of open hillside which can be boggy underfoot, forest trails and roads, vehicle track and local roads that are not consistently surfaced. See Figure 21.

Figure 21 On-road trail and off-road trail on the Ballyhoura Way

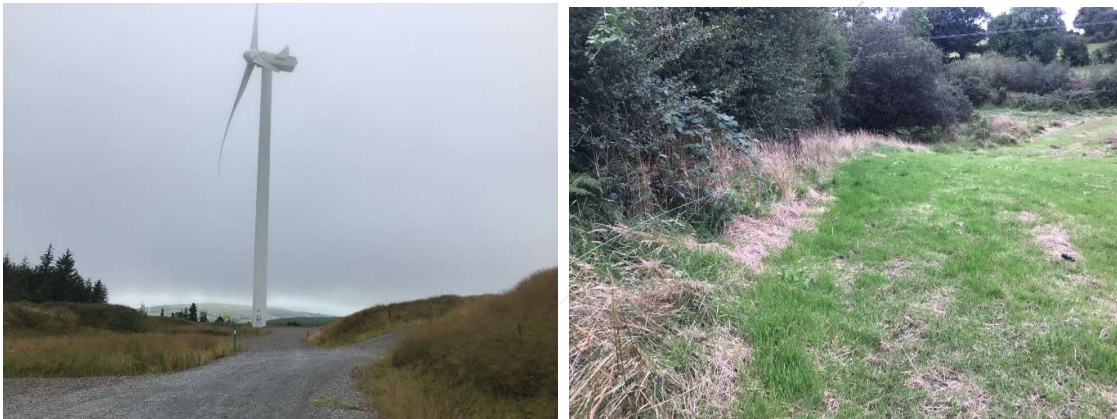
Figure 23 Off-road trail on the Multeen Way

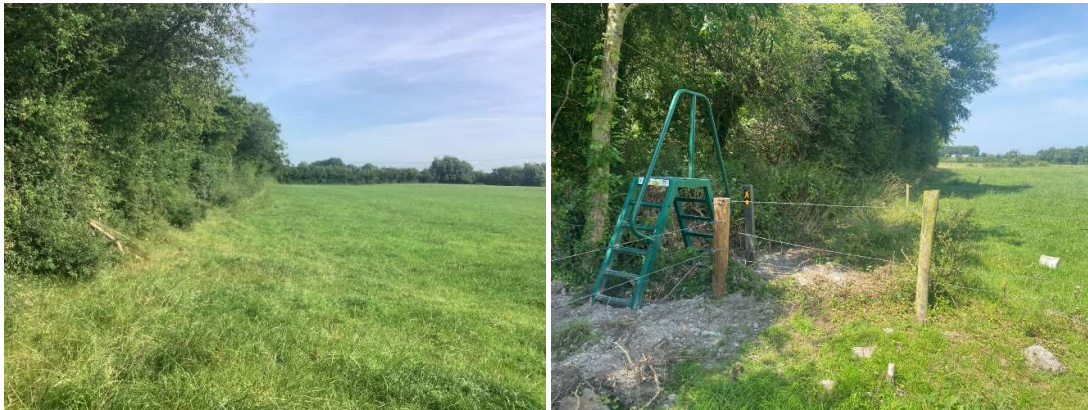
Off-road sections of the trail consist of forest track, pastoral farmland that is (intended to be) maintained for walkers (Figure 25), vehicle tracks and local roads with grass in the middle.

Figure 25 Off-road trail on the Ormond Way

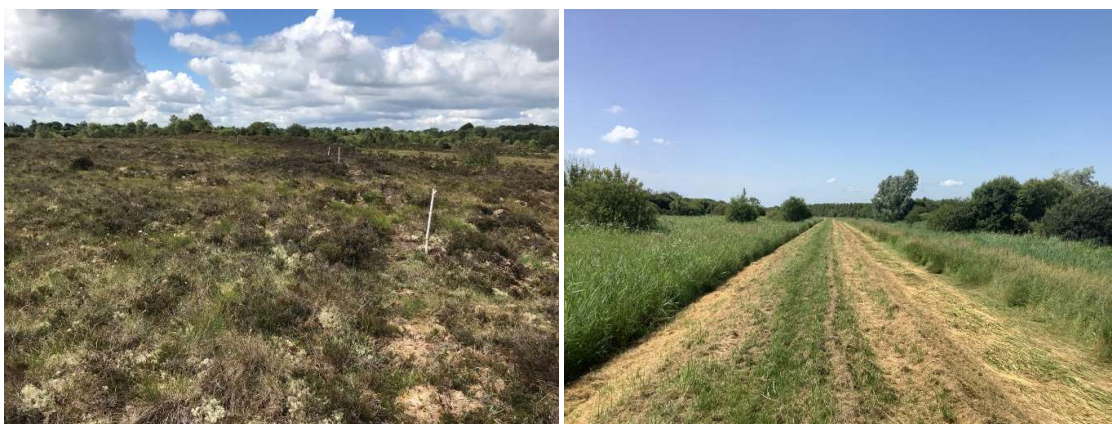
Figure 27 Off-road trail on the Hymany Way

Off-road sections of the trail consist of pastoral farmland that is (intended to be) maintained for walkers, vehicle tracks, open bog and local roads which are not consistently surfaced (Figure 27).

Sections that are currently located on pastoral farmland are often overgrown or impacted by livestock. It is recommended that a fenced corridor with built trail is developed, in order to reduce the amount of maintenance required, as well as preventing livestock accessing the trail in order to benefit the surface of the trail and comfort of the walker.

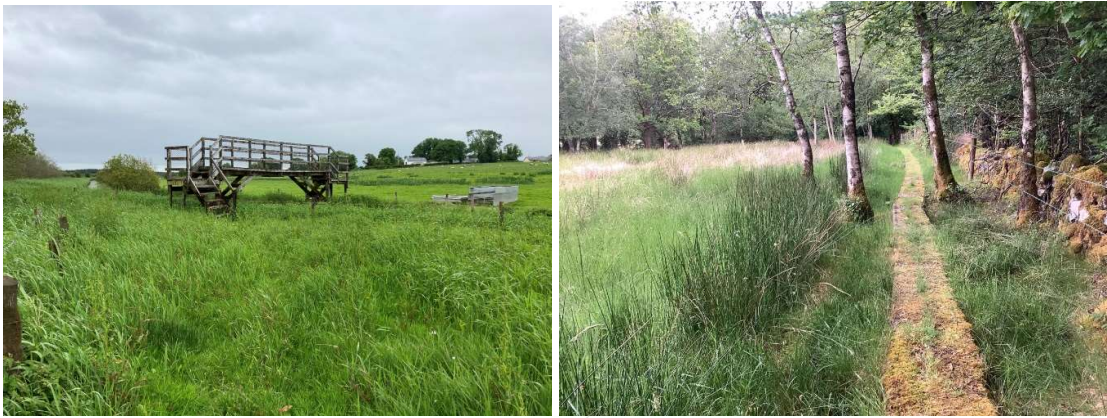
Figure 29 Off-road trail on the Suck Valley Way

Off-road sections of the trail consist of pastoral farmland that is (intended to be) maintained for walkers, vehicle tracks, forest trail, open bog and local roads which are not consistently surfaced (Figure 29).

Sections that are currently located on pastoral farmland are often overgrown or impacted by livestock. It is recommended that a fenced corridor with built trail is developed, in order to reduce the amount of maintenance required, as well as preventing livestock accessing the trail in order to benefit the surface of the trail and comfort of the walker.

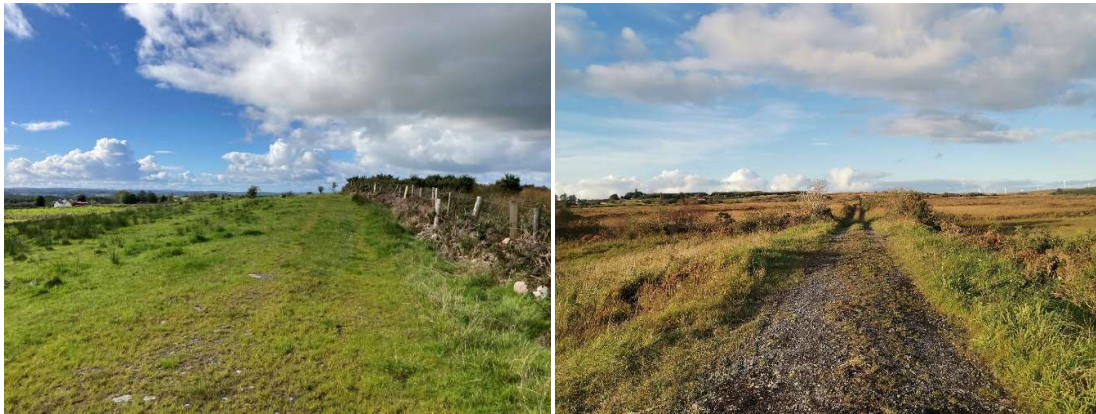
Figure 33 Off-road trail on the Lung Lough Gara Way

Off-road sections of the trail consist of pastoral farmland that is (intended to be) maintained for walkers, vehicle tracks, open bog and local roads that are not consistently surfaced (Figure 33).

Sections that are currently located on pastoral farmland are often overgrown or impacted by livestock. It is recommended that a fenced corridor with built trail is developed, in order to reduce the amount of maintenance required, as well as preventing livestock accessing the trail in order to benefit the condition of the trail and comfort of the walker.

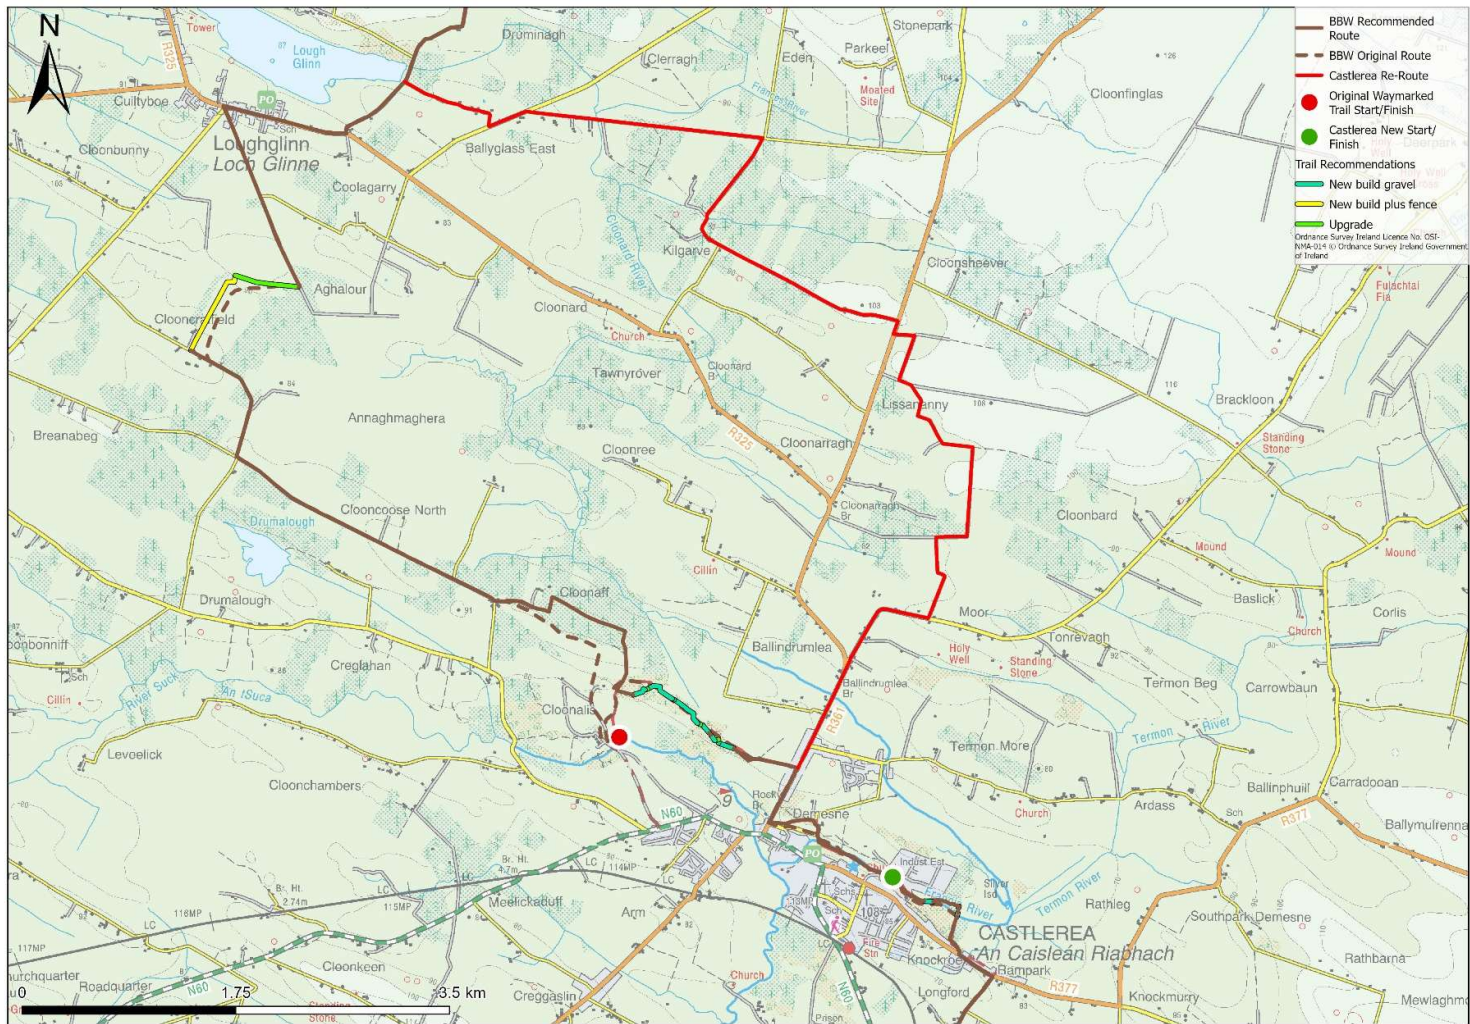
Figure 36 Lung Lough Gara re-route 2022

In order to address this request, local Community trail representatives have identified a new route to link the Suck Valley Way from Castlerea, to the Lung Lough Gara Way to the west of Lough Glinn. See Figure 36. It has been reported that waymarking for the original route has been removed, and new waymarking installed along the identified re-route. The new route uses a combination of footpaths, 'L' class roads and bog roads, along with two short sections on the R361. It is believed that the new route is a short-medium term solution while Community representatives work on a long-term solution, which is to secure permission to access private land linking a series of bogs between Castlerea and Loughglinn.

The new route of the trail also involves the suggested re-location of the start/ finish of the Lung Lough Gara way and the Suck Valley Way, from the grounds of Clonalis house, to Somers Park in Castlerea. Somers Park is a public park with walking trails, fitness equipment, a play park and public toilets, funding has also been secured for the development of an outdoor events and cultural space.

Due to the late submission of the Castlerea re-route, it has not been possible to audit this section of the route or make recommendations as to suitable works required along the new re-route or any long-term alternative routes. It has also not been possible to amend the report in terms of the recommended route (via Clonalis House). ***It should be noted that detailed recommendations and costings in terms of trail statistics, new build or upgrade of trail, plus recommendations for signage, waymarking and infrastructure for the section of the BBW between Castlerea and Loughglinn, are no longer applicable.***

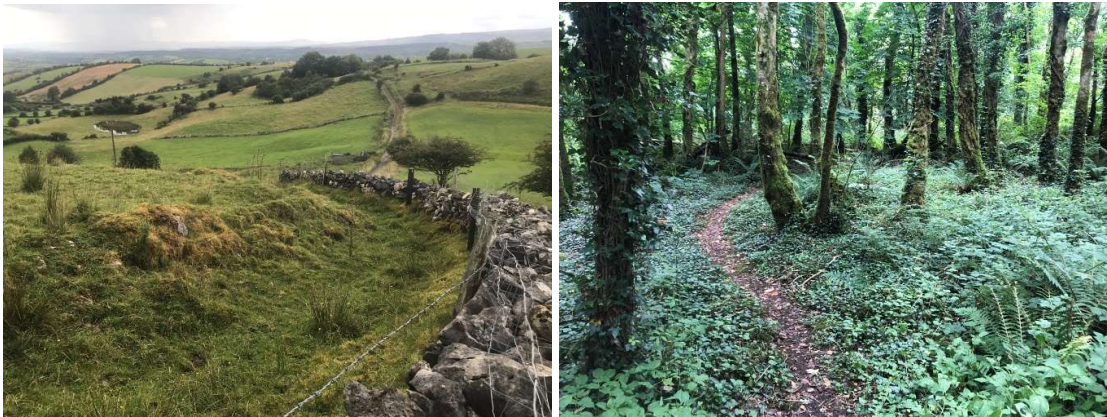
Figure 38 Off-road trail on the Miners Way

Off-road sections of the trail consist of used and pastoral farmland, built gravel trail, vehicle tracks, canal towpath and local roads that are not consistently surfaced (Figure 38).

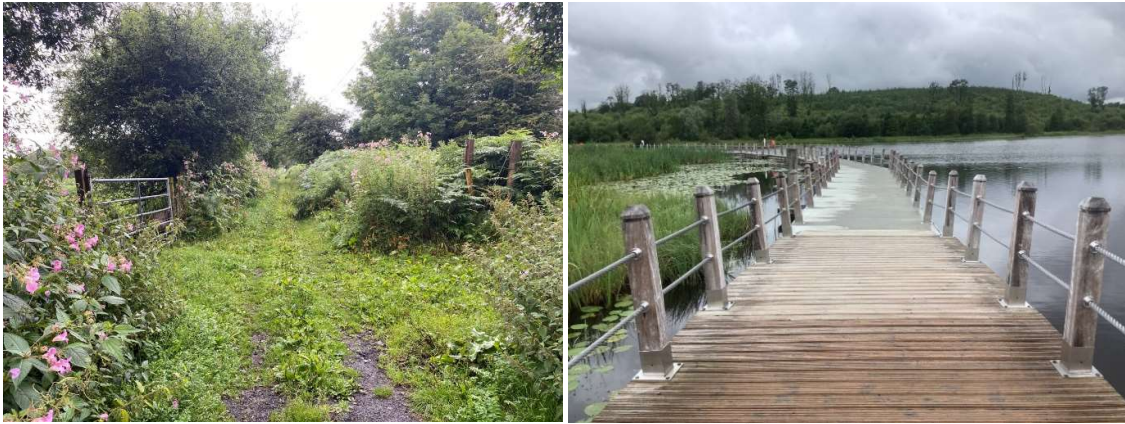
Figure 41 Off-road trail on the Leitrim Way

Off-road sections of the trail consist of pastoral farmland, bitmac path, grass track, gravel path, boardwalk and local roads with that are not consistently surfaced (Figure 41).

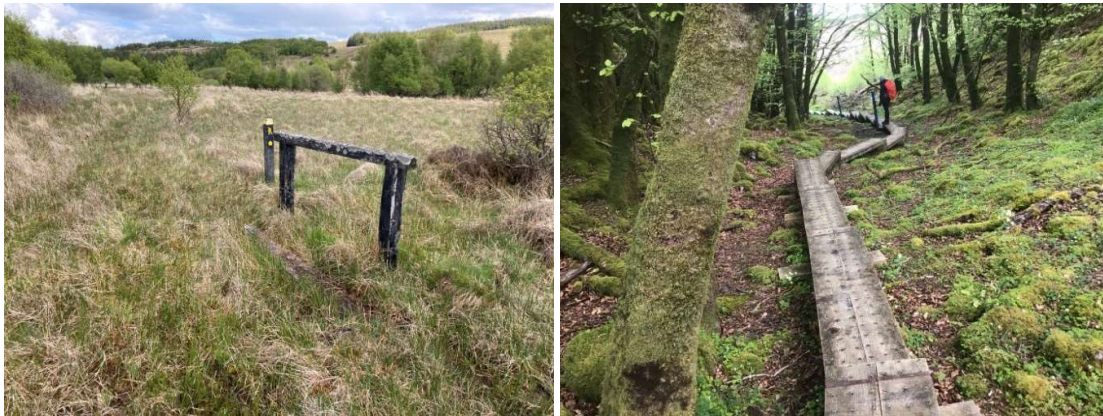
Figure 43 Off-road trail on the Cavan Way

The trail surface along the BBW on the Cavan Way is mixed. Off-road sections of the trail consist of pastoral farmland, gravel path, farm track, open bog and hillside, bog bridge (Figure 43) and local roads which are not consistently surfaced.
