Environmental Surveying and Monitoring Programme

Bray Head 2023

National Tourism and Environmental Monitoring Programme

Annual Report for Bray Head 2023

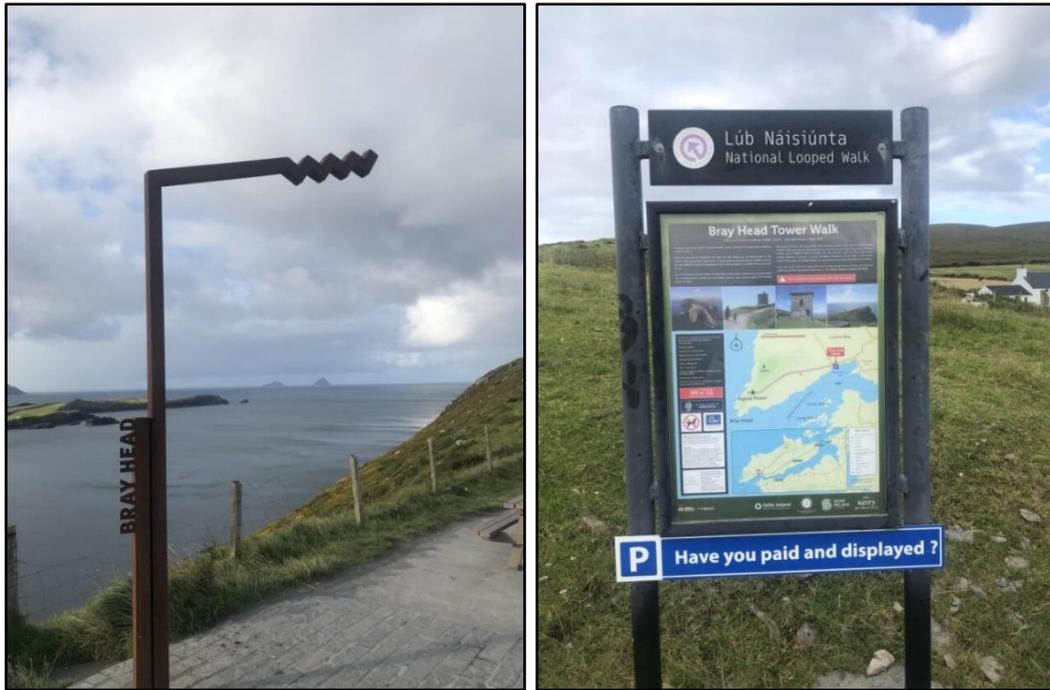
Plate 3.2 Car park features and signage.

There are various signs near the car park leading towards the viewpoint, notifying the public of the local rules and recommendations. Plate 4.1 below presents signs notifying that dog owners should keep dogs on leads and the main farm access gate must be closed at all times.
