# National Tourism and Environmental Monitoring Programme Dursey Island 2023

# National Tourism and Environmental Monitoring Programme

## Annual Report for Dursey Island 2023

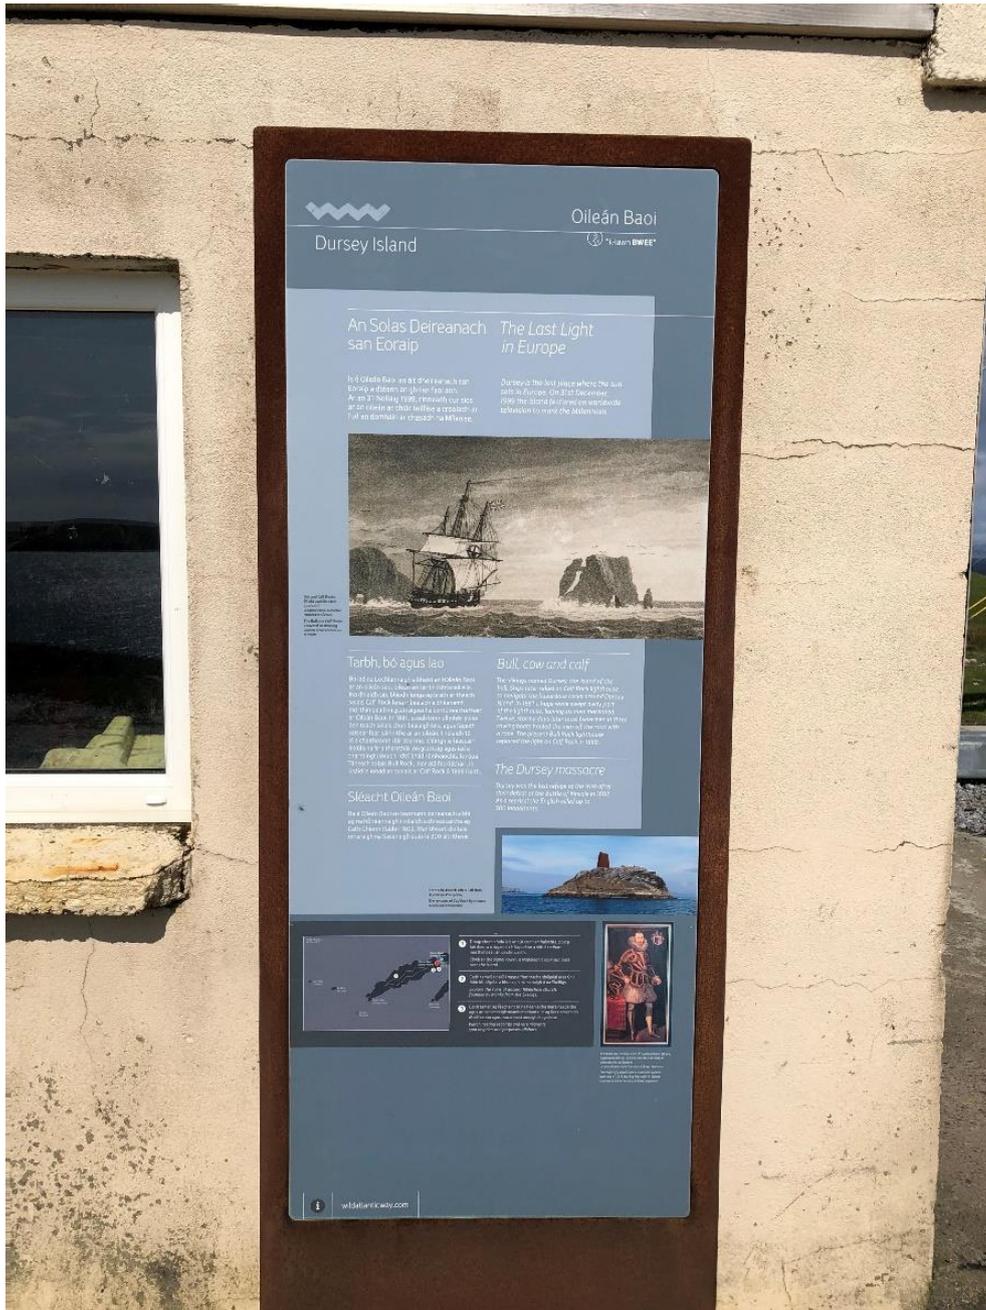
Plate 3.1 Wild Atlantic Way signage at cable car landing point on Dursey Island.

Figure 3.3 presents the number of visitor groups observed reading the available signage at the car park on Dursey Island, next to the cable car landing point. A higher proportion of visitor groups did not read the signage, with 58% of visitor groups not reading the signage, and only 42% of visitor groups reading the signage. However, it must be taken into consideration that a proportion of the visitor groups may be local to the area and may have previously read the signage on past visits. The signage close to the cable car landing point on Dursey Island is shown in Plate 3.1.

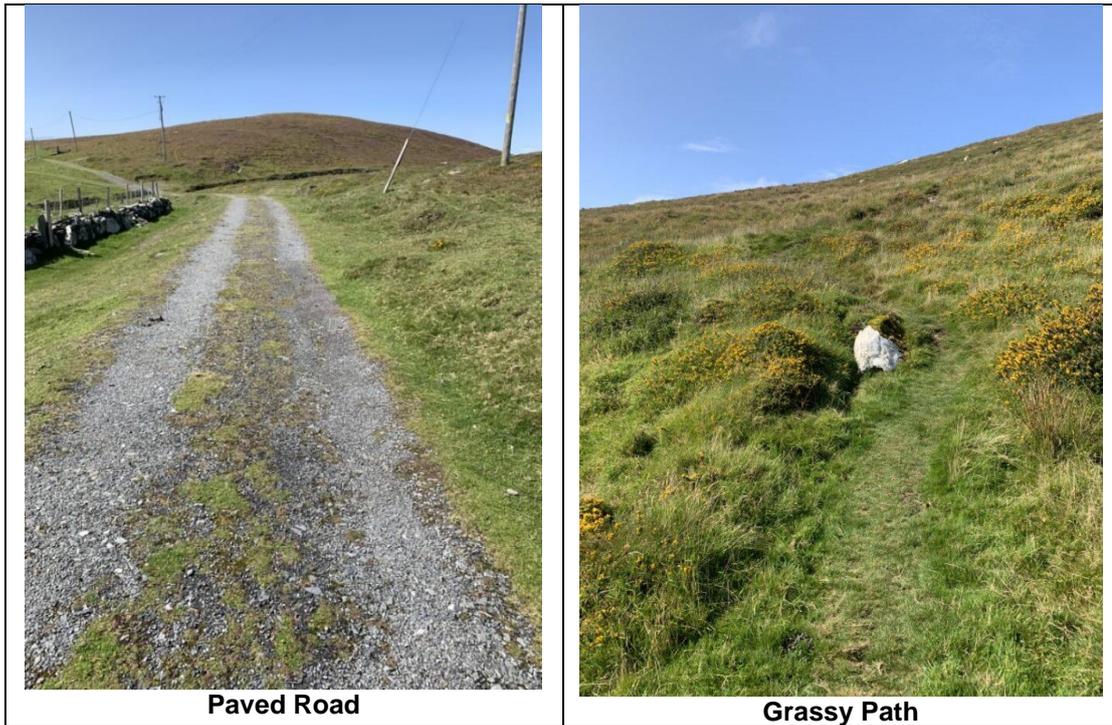
**Plate 3.2** The main pathway types recorded on Dursley Island.

The condition (good, moderate, bad) of the main pathway types (paved road and grassy path) are illustrated below in Figure 3.9. Examples of each of these pathway types are presented below in Plate 3.2.

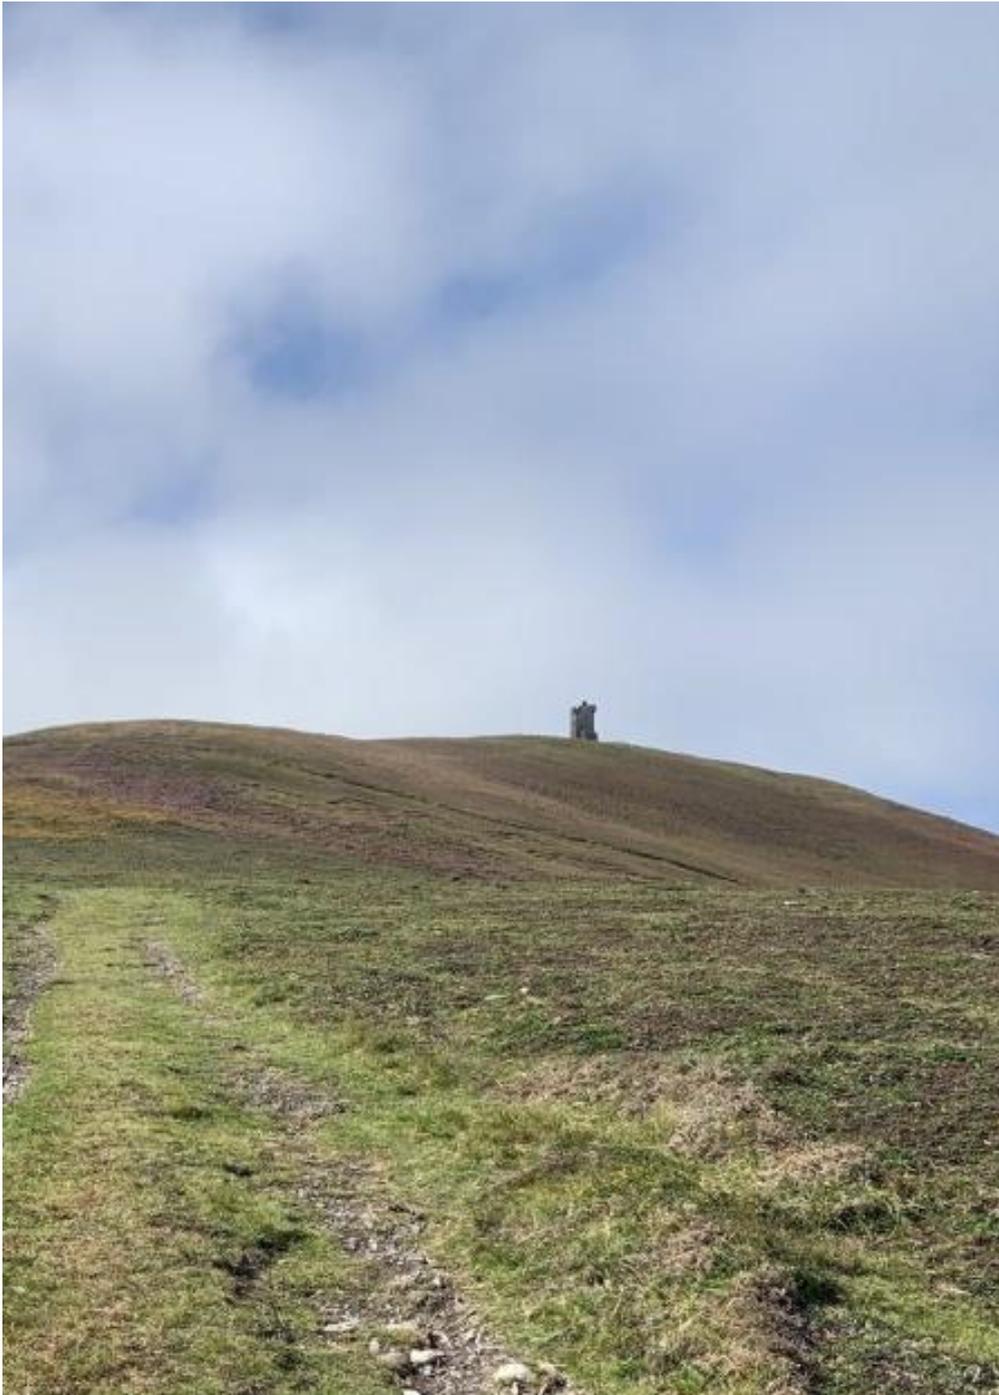
**Plate 3.5 View of Dursey Island Signal Tower**

Overall, the majority of the pathways were in good condition, however, a number of the pathways were in moderate to bad condition. An qualitative assessment of the paths on the island has concluded that given the low levels of use (See Plate 3.5), any formalisation of the paths would lead to greater habitat degradation and habitat loss than is currently occurring, and therefore the formalisation of paths has not been recommended. It should be noted that no major desire lines were mapped, but many small desire lines were noted as impacts, and as such, are discussed in the sub-sections below.
