National Tourism and Environmental Monitoring Programme

Banagher 2025

Report for Banagher 2025

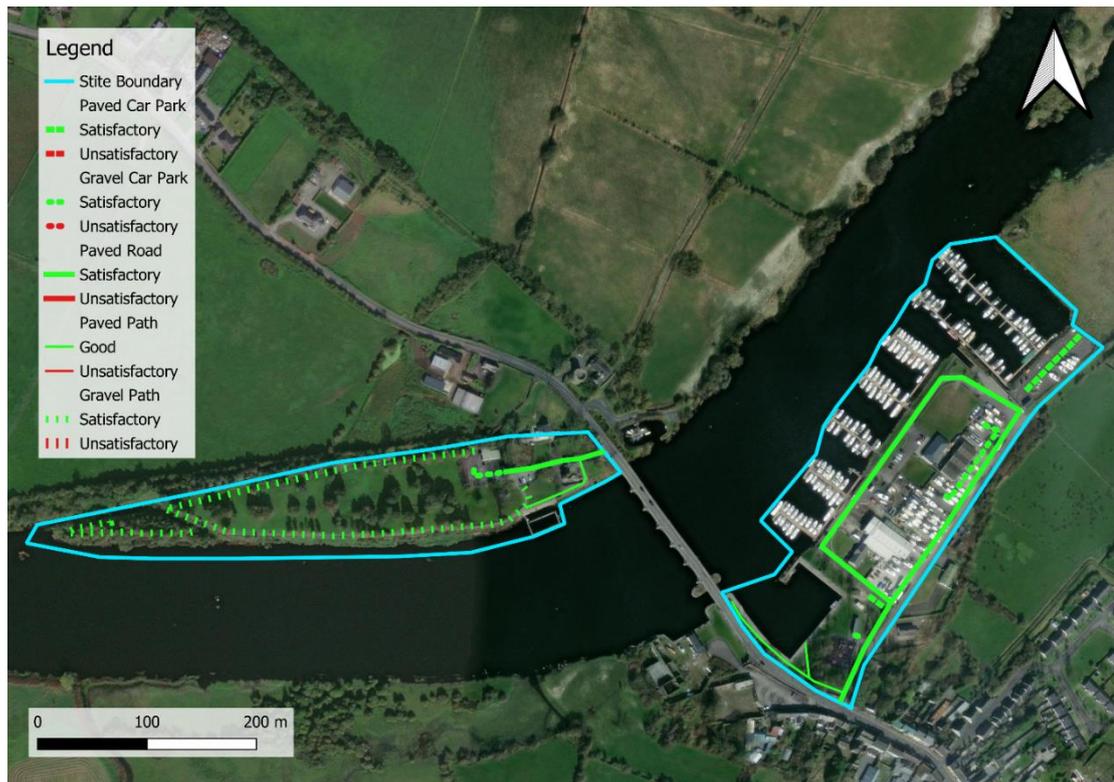
Figure 3.3 Pathway types and conditions present at Banagher.

All of the pathways are in good condition, and are well-maintained. The pedestrian walking areas on the paved roads at the marina were at times used for vehicle parking – this is discussed further in Section 3.3.1 below.

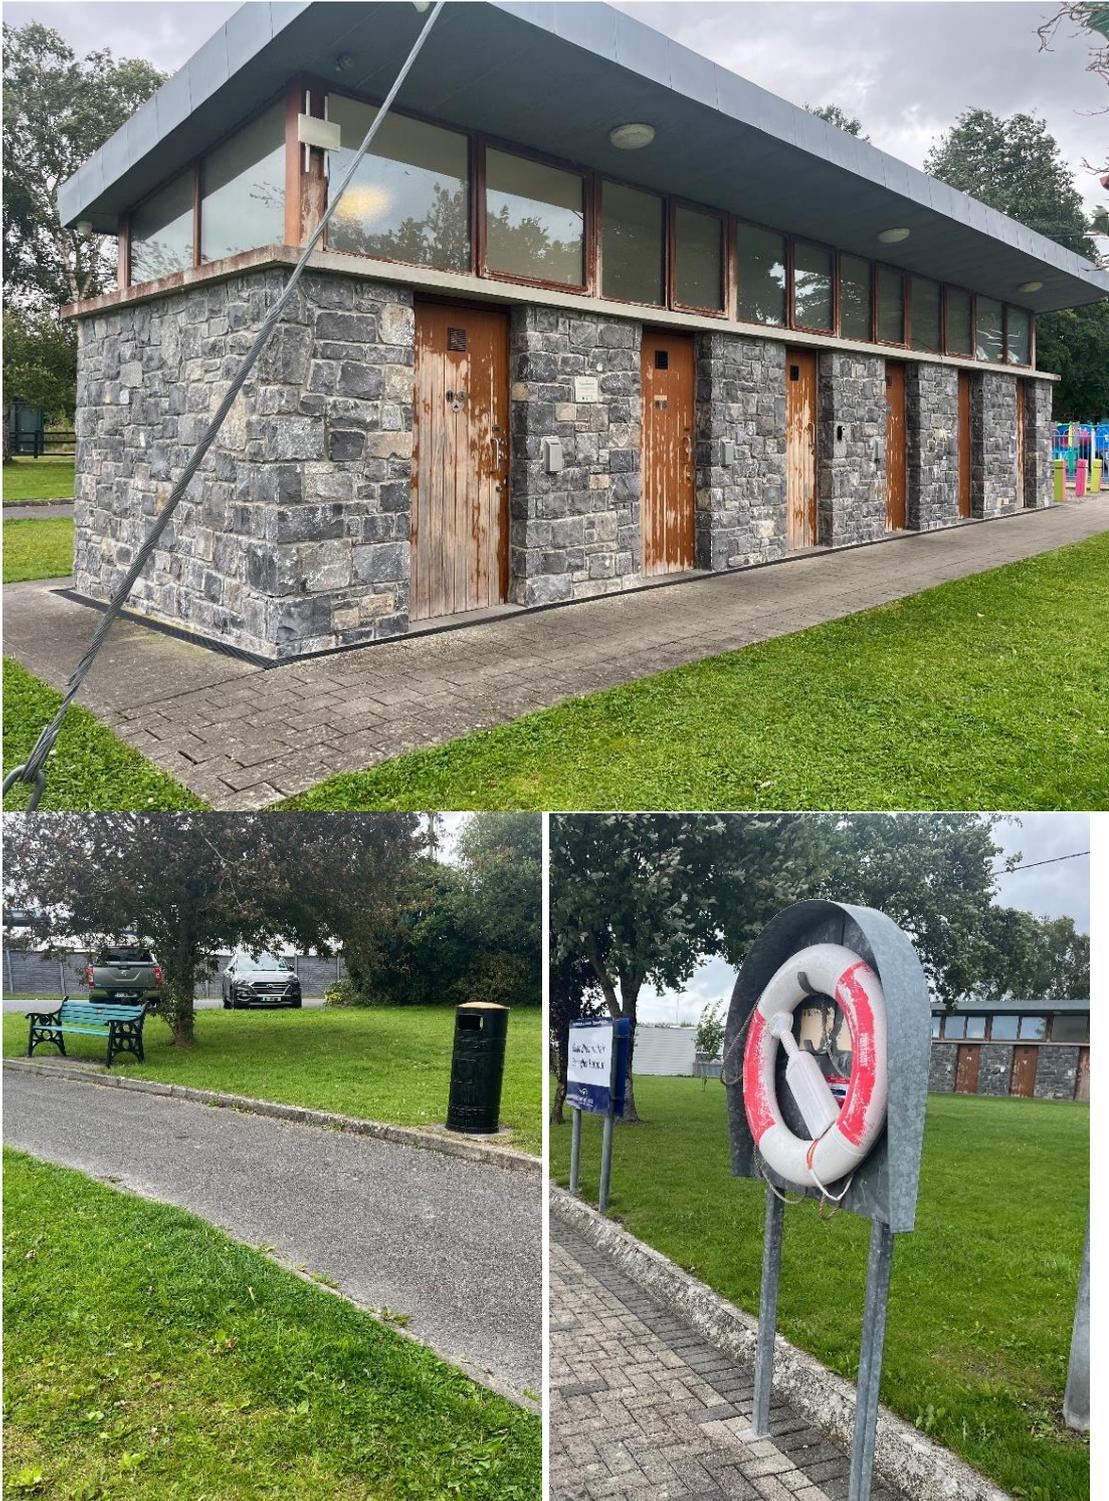
Plate 3.7 Toilet facilities (top), a rubbish bin and bench (bottom left), and a lifebuoy (bottom right) in Banagher Marina.

Given the nature of the site, the River Shannon itself could be considered a hazard, particularly in the Marina and outdoor pool where there is no barrier between the amenity areas and the water. However, life buoys are present throughout the site.
