# National Tourism and Environmental Monitoring Programme

## Sheep's Head 2024

## Report for Sheep's Head 2024

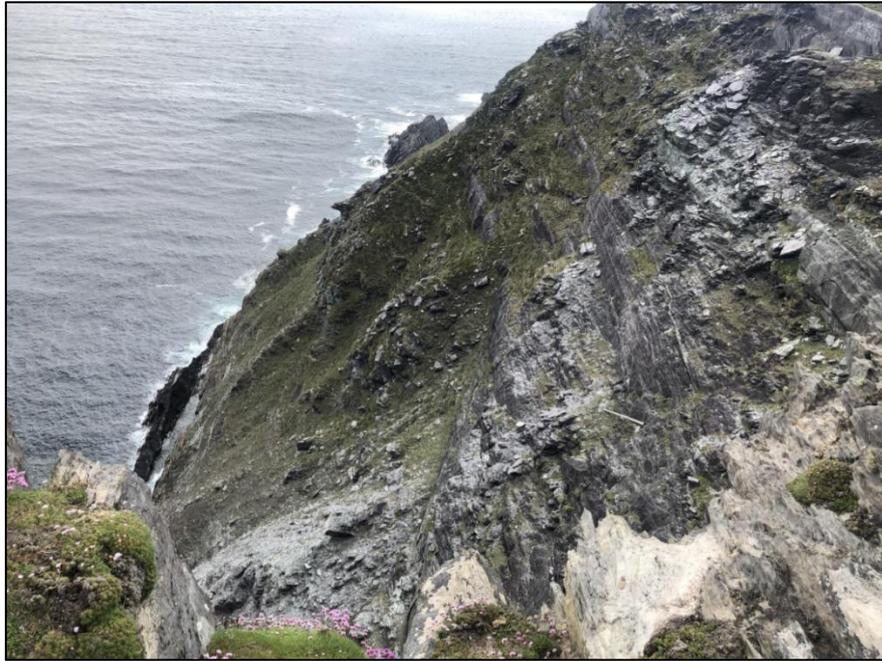
**Plate 3.1 Rocky sea cliff habitat with small pockets of thrift**

Due to the location of this site on the southwest coast, Rocky Sea Cliffs were recorded all around the southern, western and northern boundaries of the site. These cliffs are dangerous, with many warning signs posted at intermittent locations near the cliff edge. No visitor impacts were recorded on the cliffs due to their hazardous nature. Much of this habitat is comprised of rock; however plant species recorded in this habitat include grasses, Daisy (*Bellis perennis*) and Thrift (*Armeria maritima*), which were present in small pockets along the cliff edge (Plate 3.1).

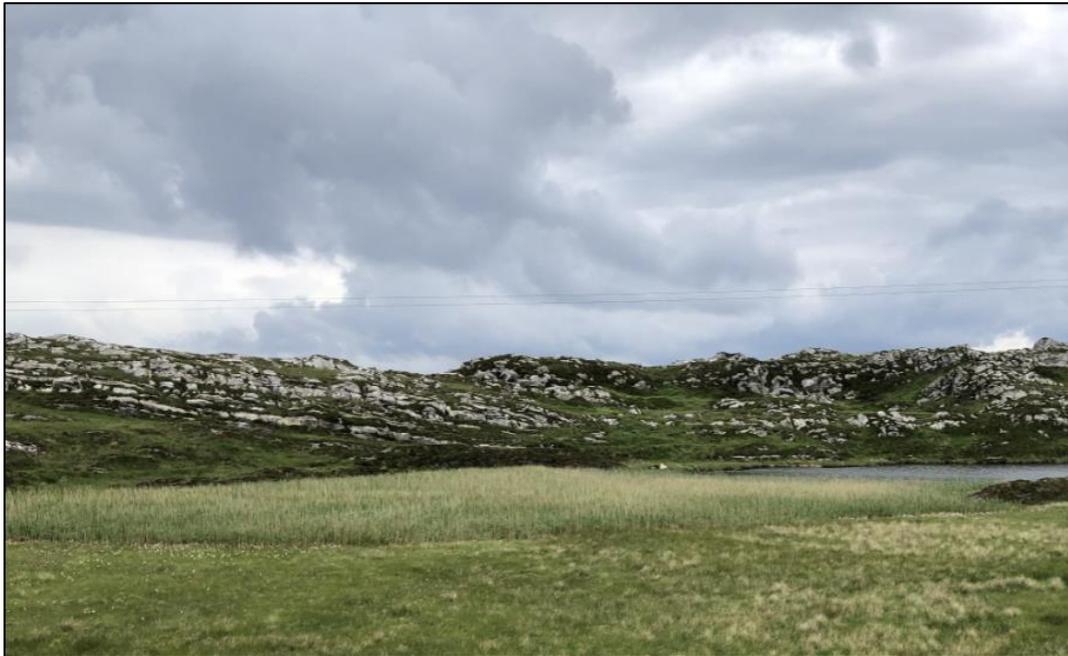
**Plate 3.2 Reed and large sedge swamp habitat adjacent to Lough Akeen**

This habitat was recorded on the west side of Lough Akeen. The area of this habitat was small, as pictured below in Plate 3.2. And was dominated by Reed Canary-grass (*Phalaris arundinaceae*) and Bulrushes (*Typha latifolia*).

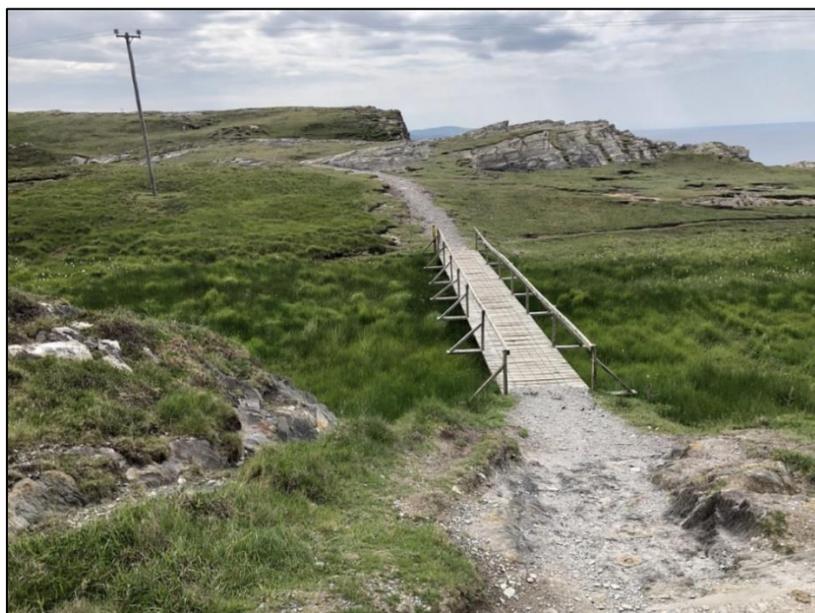
**Plate 3.4 Wooden Bridge crossing the Wet Grassland habitat**

This habitat was restricted to small areas west of the carpark and west of Lough Akeen where the lake drains to the sea. No watercourse was identified during the survey, however there is an EPA-identified watercourse running from Lough Akeen to the sea through this habitat. A wooden bridge has been installed to allow walkers to cross this area (Plate 3.4). Species recorded here include Sweet Vernal Grass, Rushes (*Juncus* spp.), Water Mint (*Mentha aquatica*), Marsh Thistle (*Cirsium palustre*), Cuckooflower (*Cardamine pratensis*), Lesser Spearwort (*Ranunculus flammula*), Ribwort Plantain (*Plantago lanceolata*) and Bog Cotton (*Eriophorum angustifolium*).

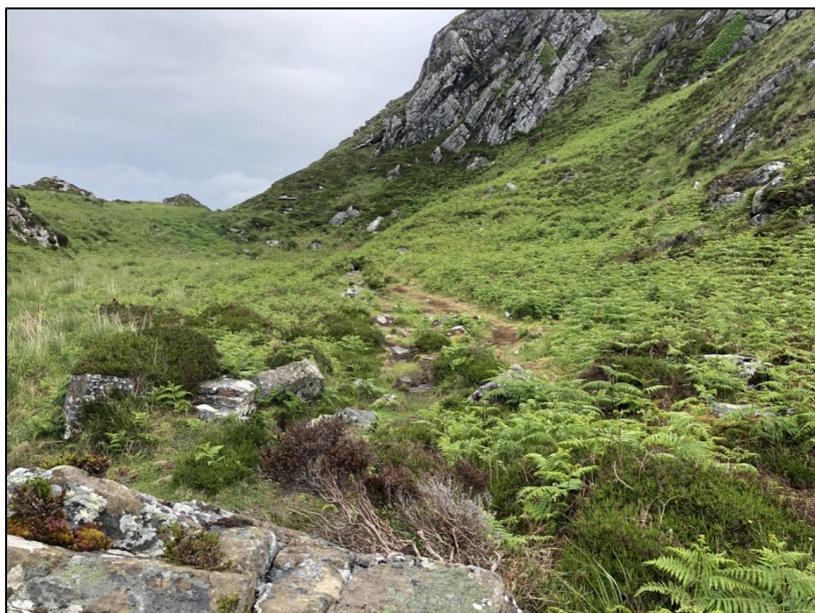
**Plate 3.5** Intersection of Dense Bracken, Dry Heath and Wet Heath habitat along the northern side of the site.

This habitat was recorded on the northern side of the site along the Lighthouse Loop. It was located between the main path and the lower part of the sloped hillside leading towards Lough Akeen. The habitat was dominated by Bracken (*Pteridium aquilinum*) with Ling heather (*Calluna vulgaris*) recorded on the sloping hillside. This habitat, where it intersects with Dry heath and Wet heath habitat, is shown in Plate 3.5 below.

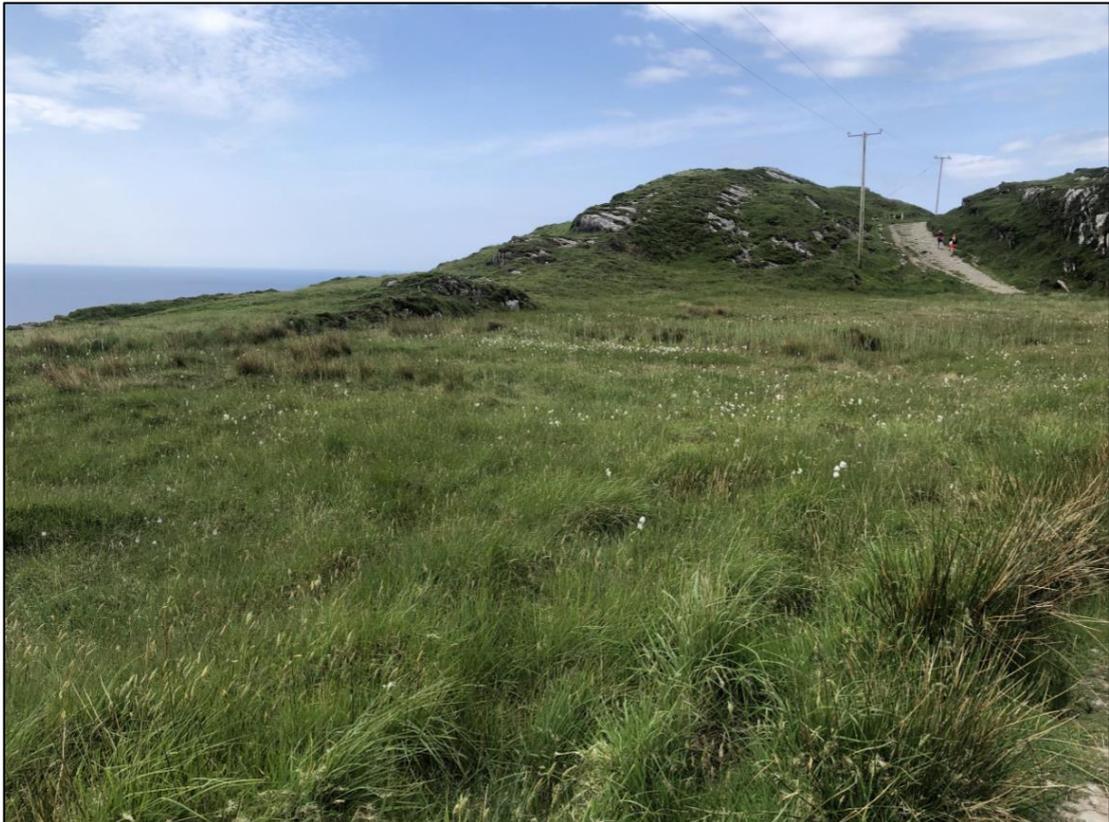
**Plate 3.6**      **Small pocket of bog habitat adjacent to the southern track.**

This habitat was restricted to a small area south of Lough Akeen, bordered by dry and wet heath habitat (see Figure 3.2). This habitat was located immediately adjacent to the main gravel path and was dominated by grasses and rushes including Black Bog-rush *Schoenus nigricans*, Sweet Vernal grass (*Anthoxanthum odoratum*), Bog Cotton (*Eriophorum angustifolium*). Other species recorded in this habitat include Cross-leaved Heath (*Erica tetralix*), Heath Spotted-orchid (*Dactylorhiza maculata*), Green-ribbed Sedge (*Carex binervis*) and Tormentil (*Potentilla erecta*). The western side of this habitat was noticeably wetter and localised, dominated by *sphagnum* and Reed Canary-grass (Plate 3.6).

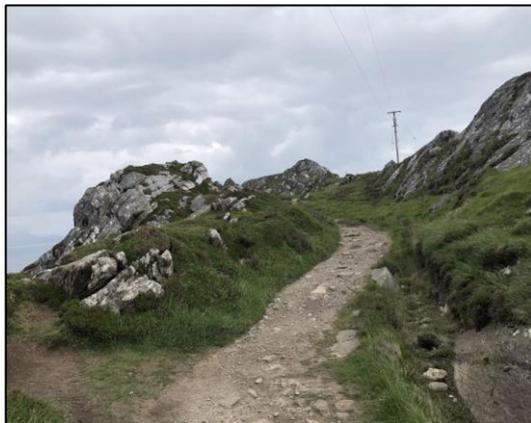
**Bare ground track**

Overgrazed areas of short-sward grassland habitat have likely caused visitors to widen the track between the lighthouse and the Eire 31 sign, likely as a viewpoint to the southern coastline. Other areas of grassy paths are exposed to soil erosion and high foot traffic and have started to degrade into bare ground.

- Existing fencing and barriers should continue to be maintained and improved along areas where the path get close to the cliff face.
- Consideration should be given to improving areas of the path that are in poor condition.

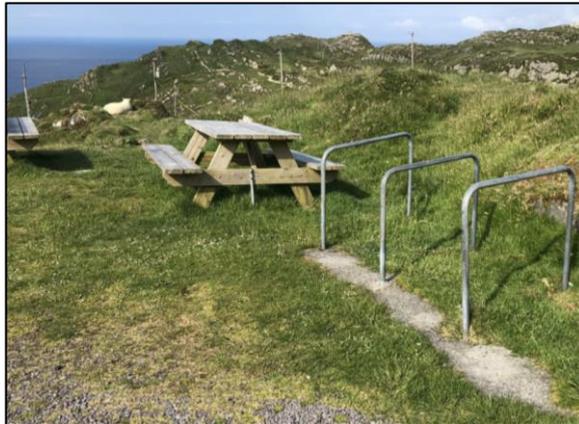
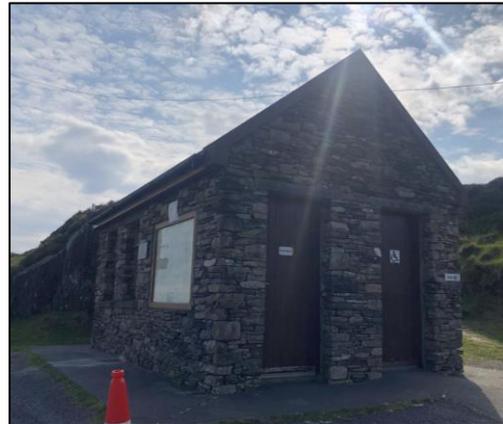
Plate 3.10 Amenities at the start of the Lighthouse Loop of Sheep's Head.

Car and bike parking, a café and toilet facilities are available in at Tooreen carpark at the starting point of the Lighthouse Loop (Plate 3.10). Informative signage on the various walks of the Sheep's Head Way, the no-littering and no-dog policies are clearly highlighted at the carpark (Plate 3.11).

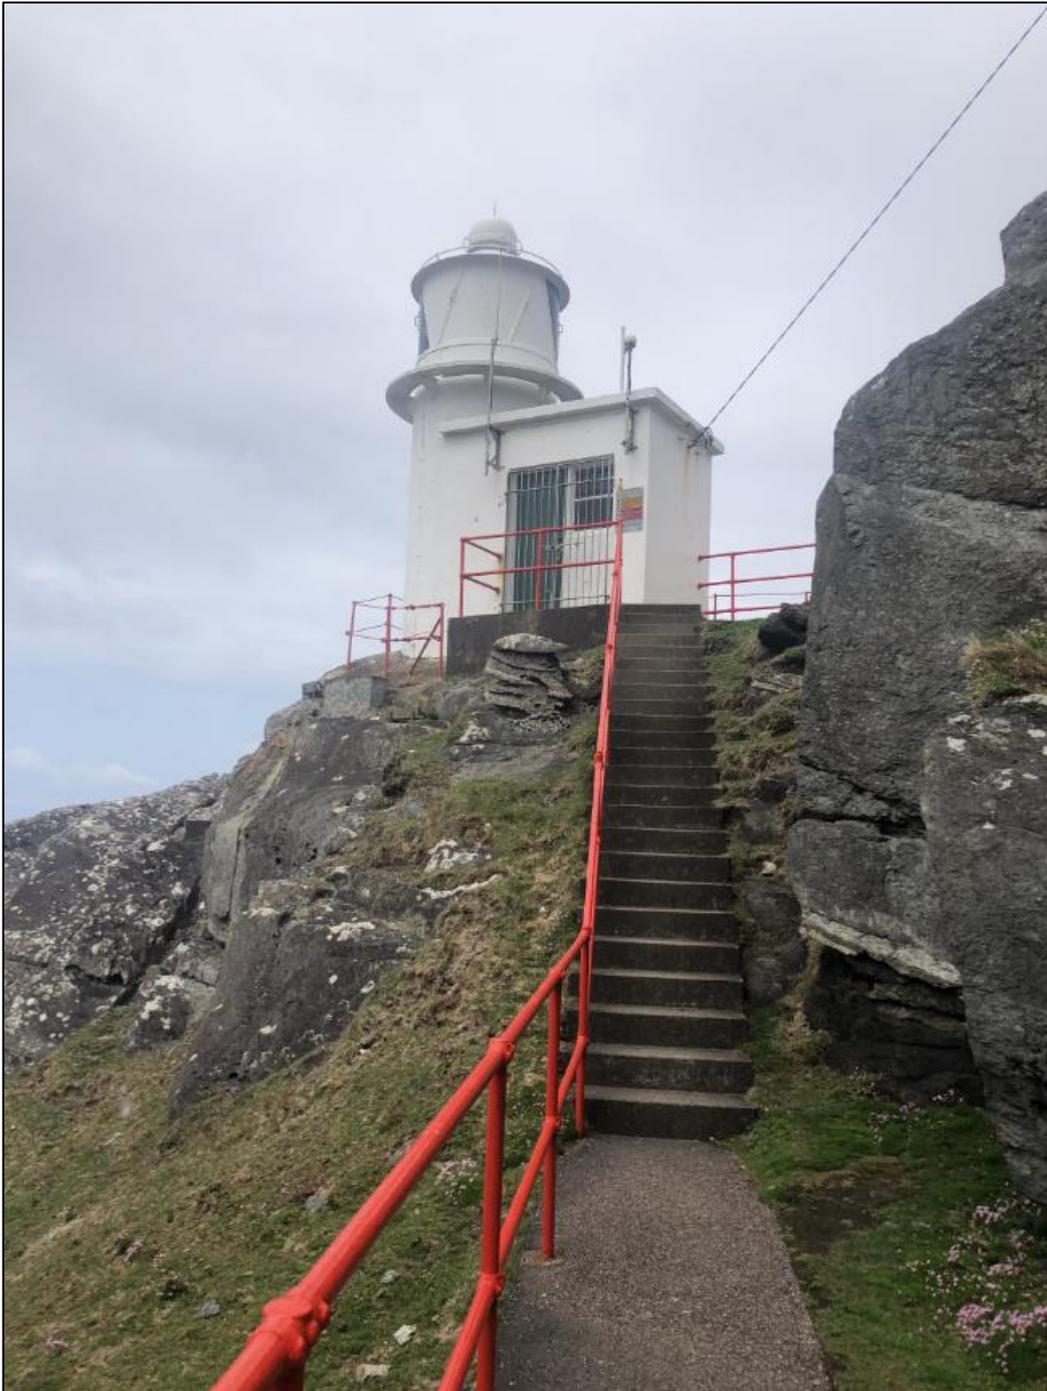
**Plate 3.12** Sheep's Head Lighthouse on the tip of the Sheep's Head Peninsula

A Grotto dedicated to Our Lady of the Wayside is a feature of the walk southeast of Lough Akeen. One of the most well-known features of the site is the Sheep's Head Lighthouse, which is located on the western tip of the Sheep's Head Peninsula (Plate 3.12). While visitors can walk to the lighthouse, public access inside the lighthouse is not permitted.
